Data Center Cooling System Failure

CRAH – Computer Room Air Handler Coils

Jim Dillon, Dorothy Collins and Philip Yu

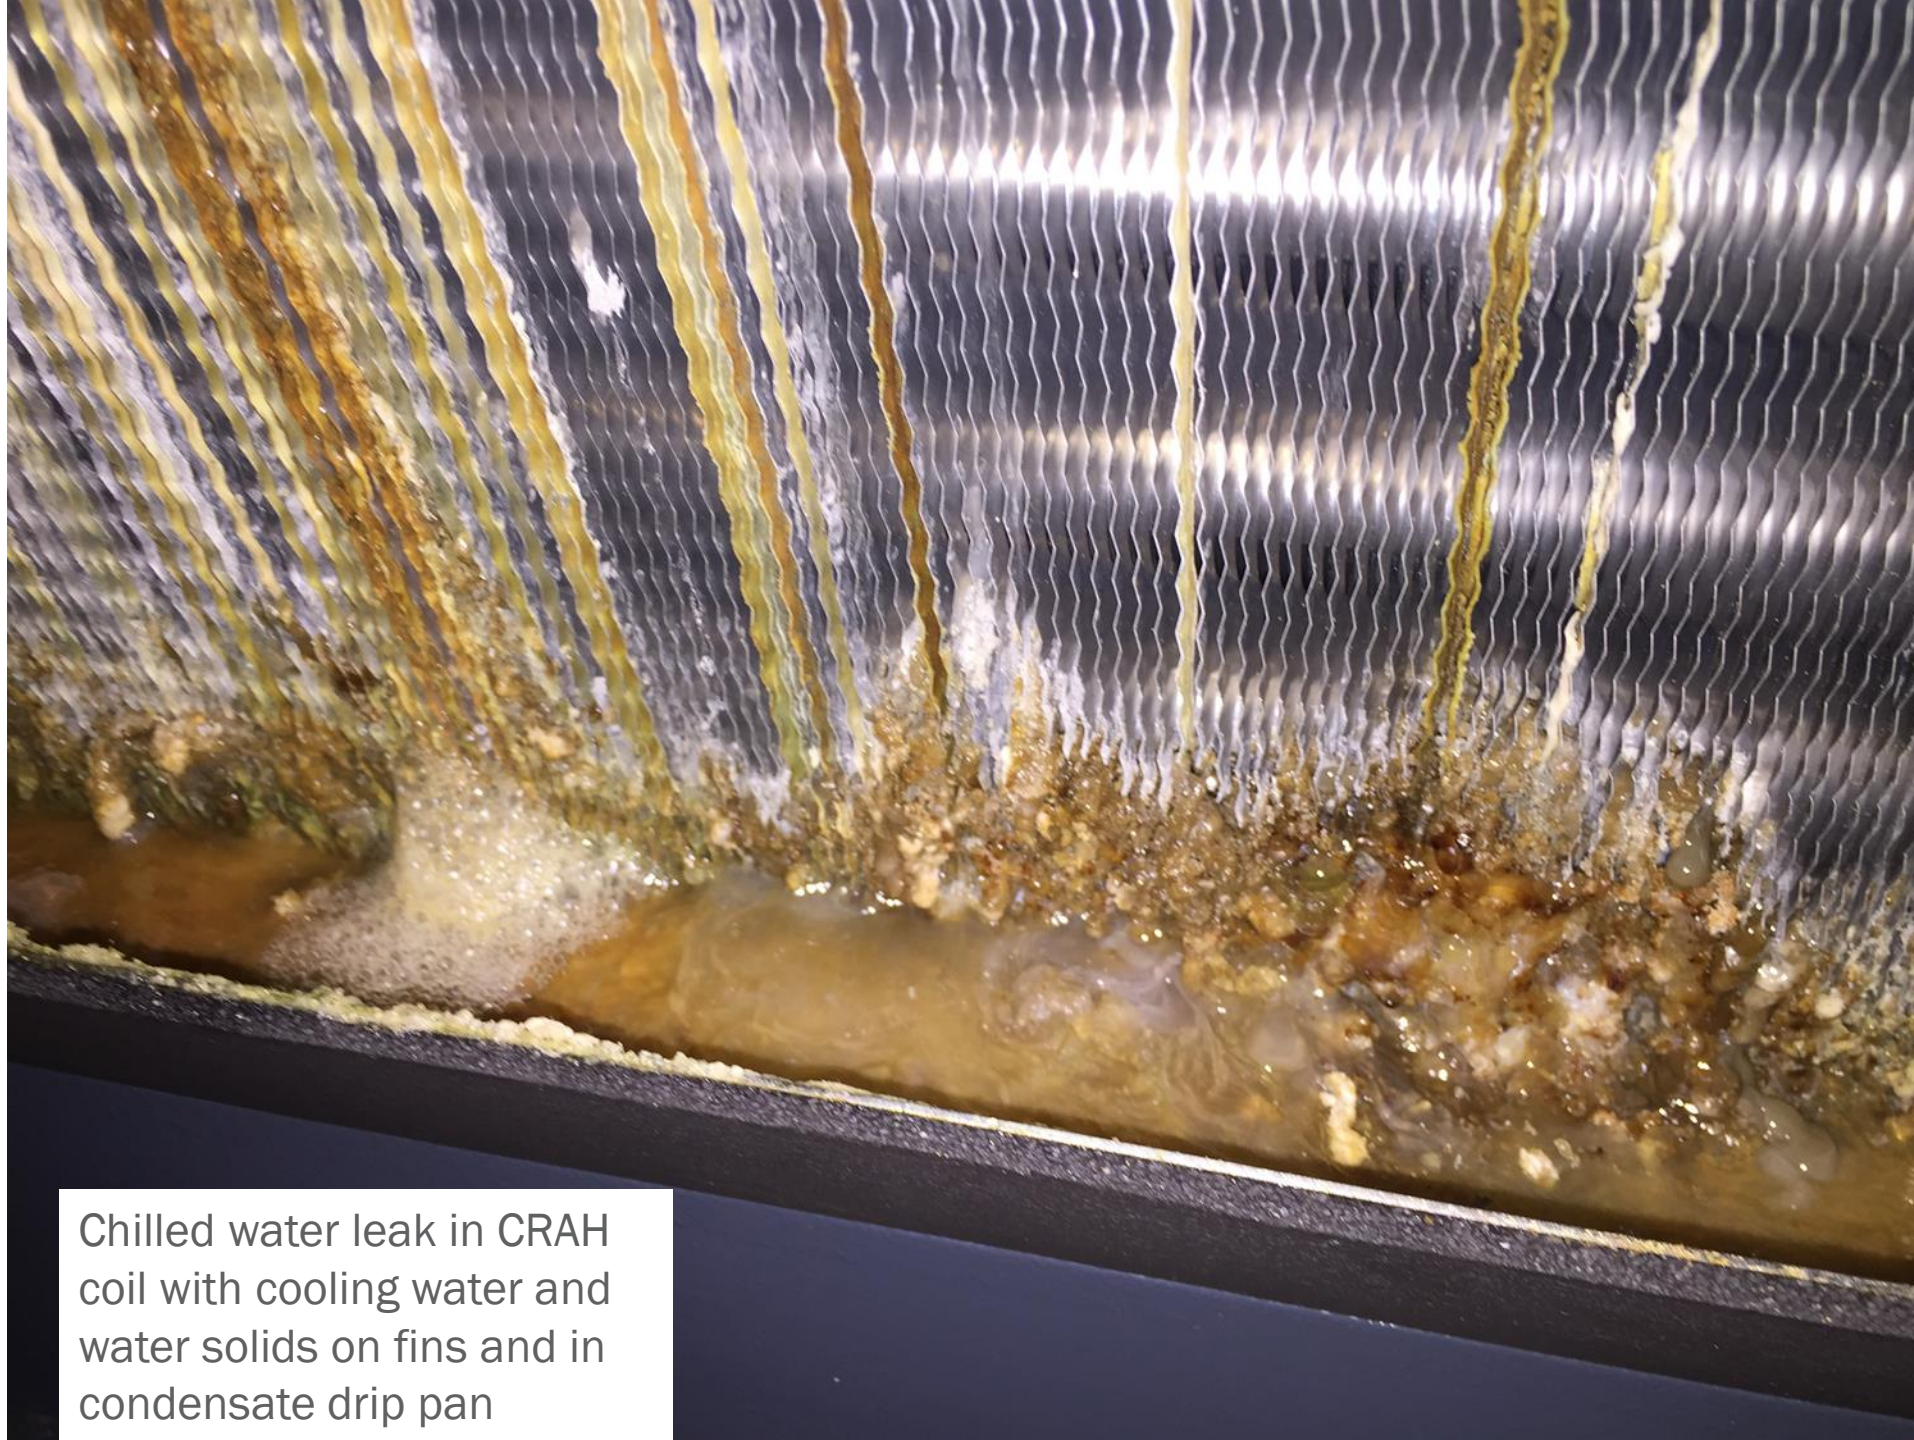
Chilled water leak in CRAH
coil with cooling water and
water solids on fins and in
condensate drip pan

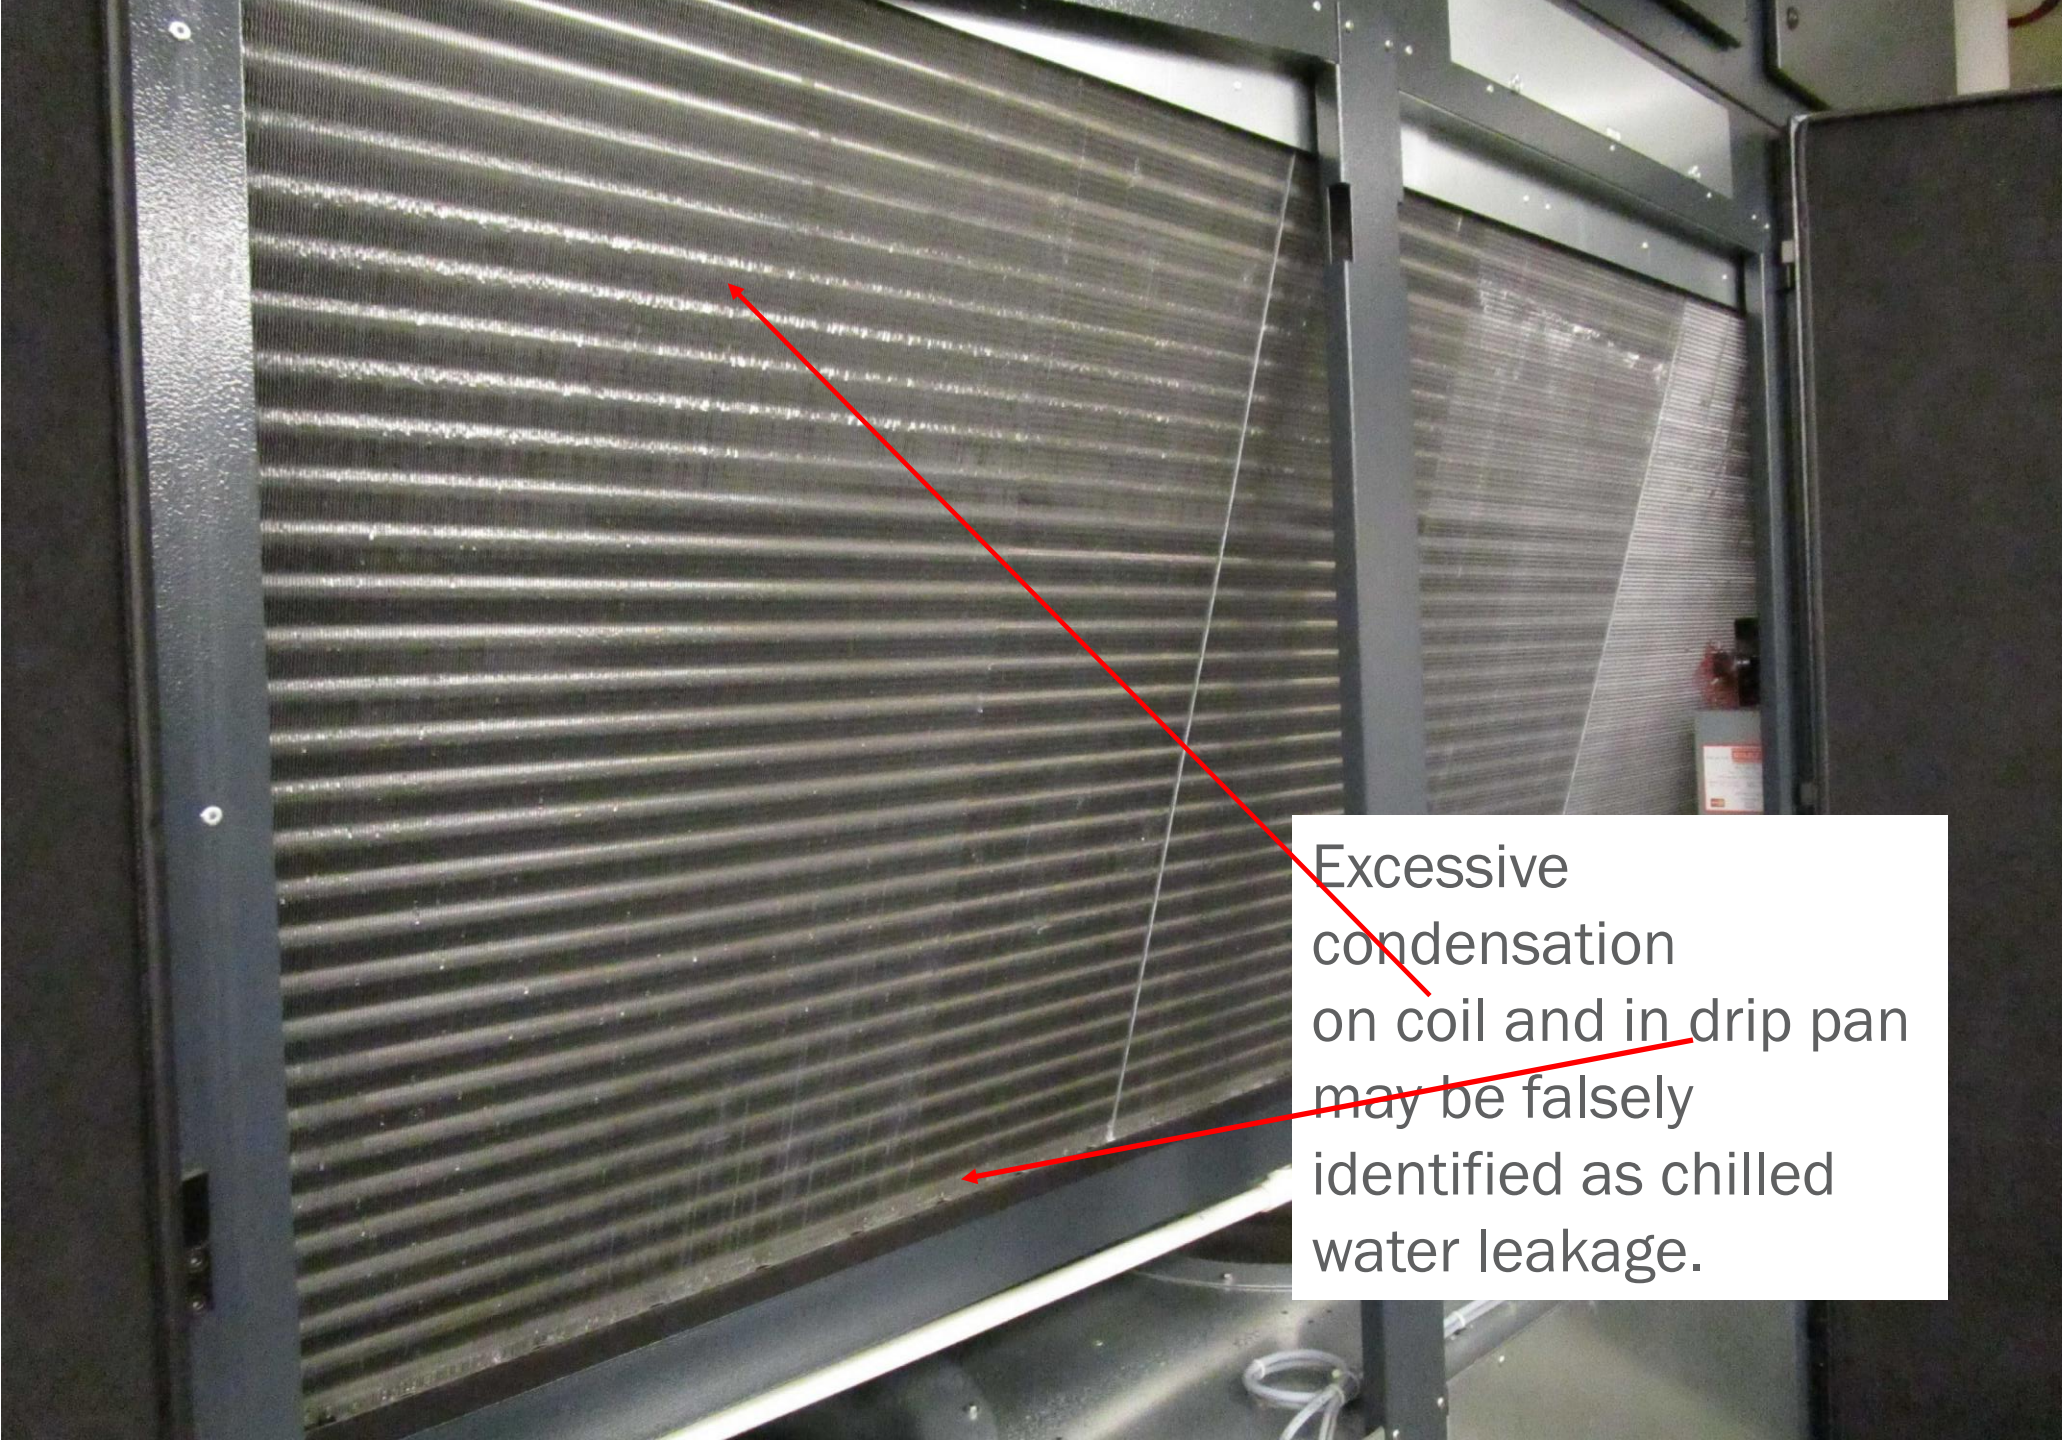
Excessive
condensation
on coil and in drip pan
may be falsely
identified as chilled
water leakage.

Clear condensate
with no water solids.
White zinc corrosion
products and rust
formed due to exposure
of galvanized steel support
to pure water.

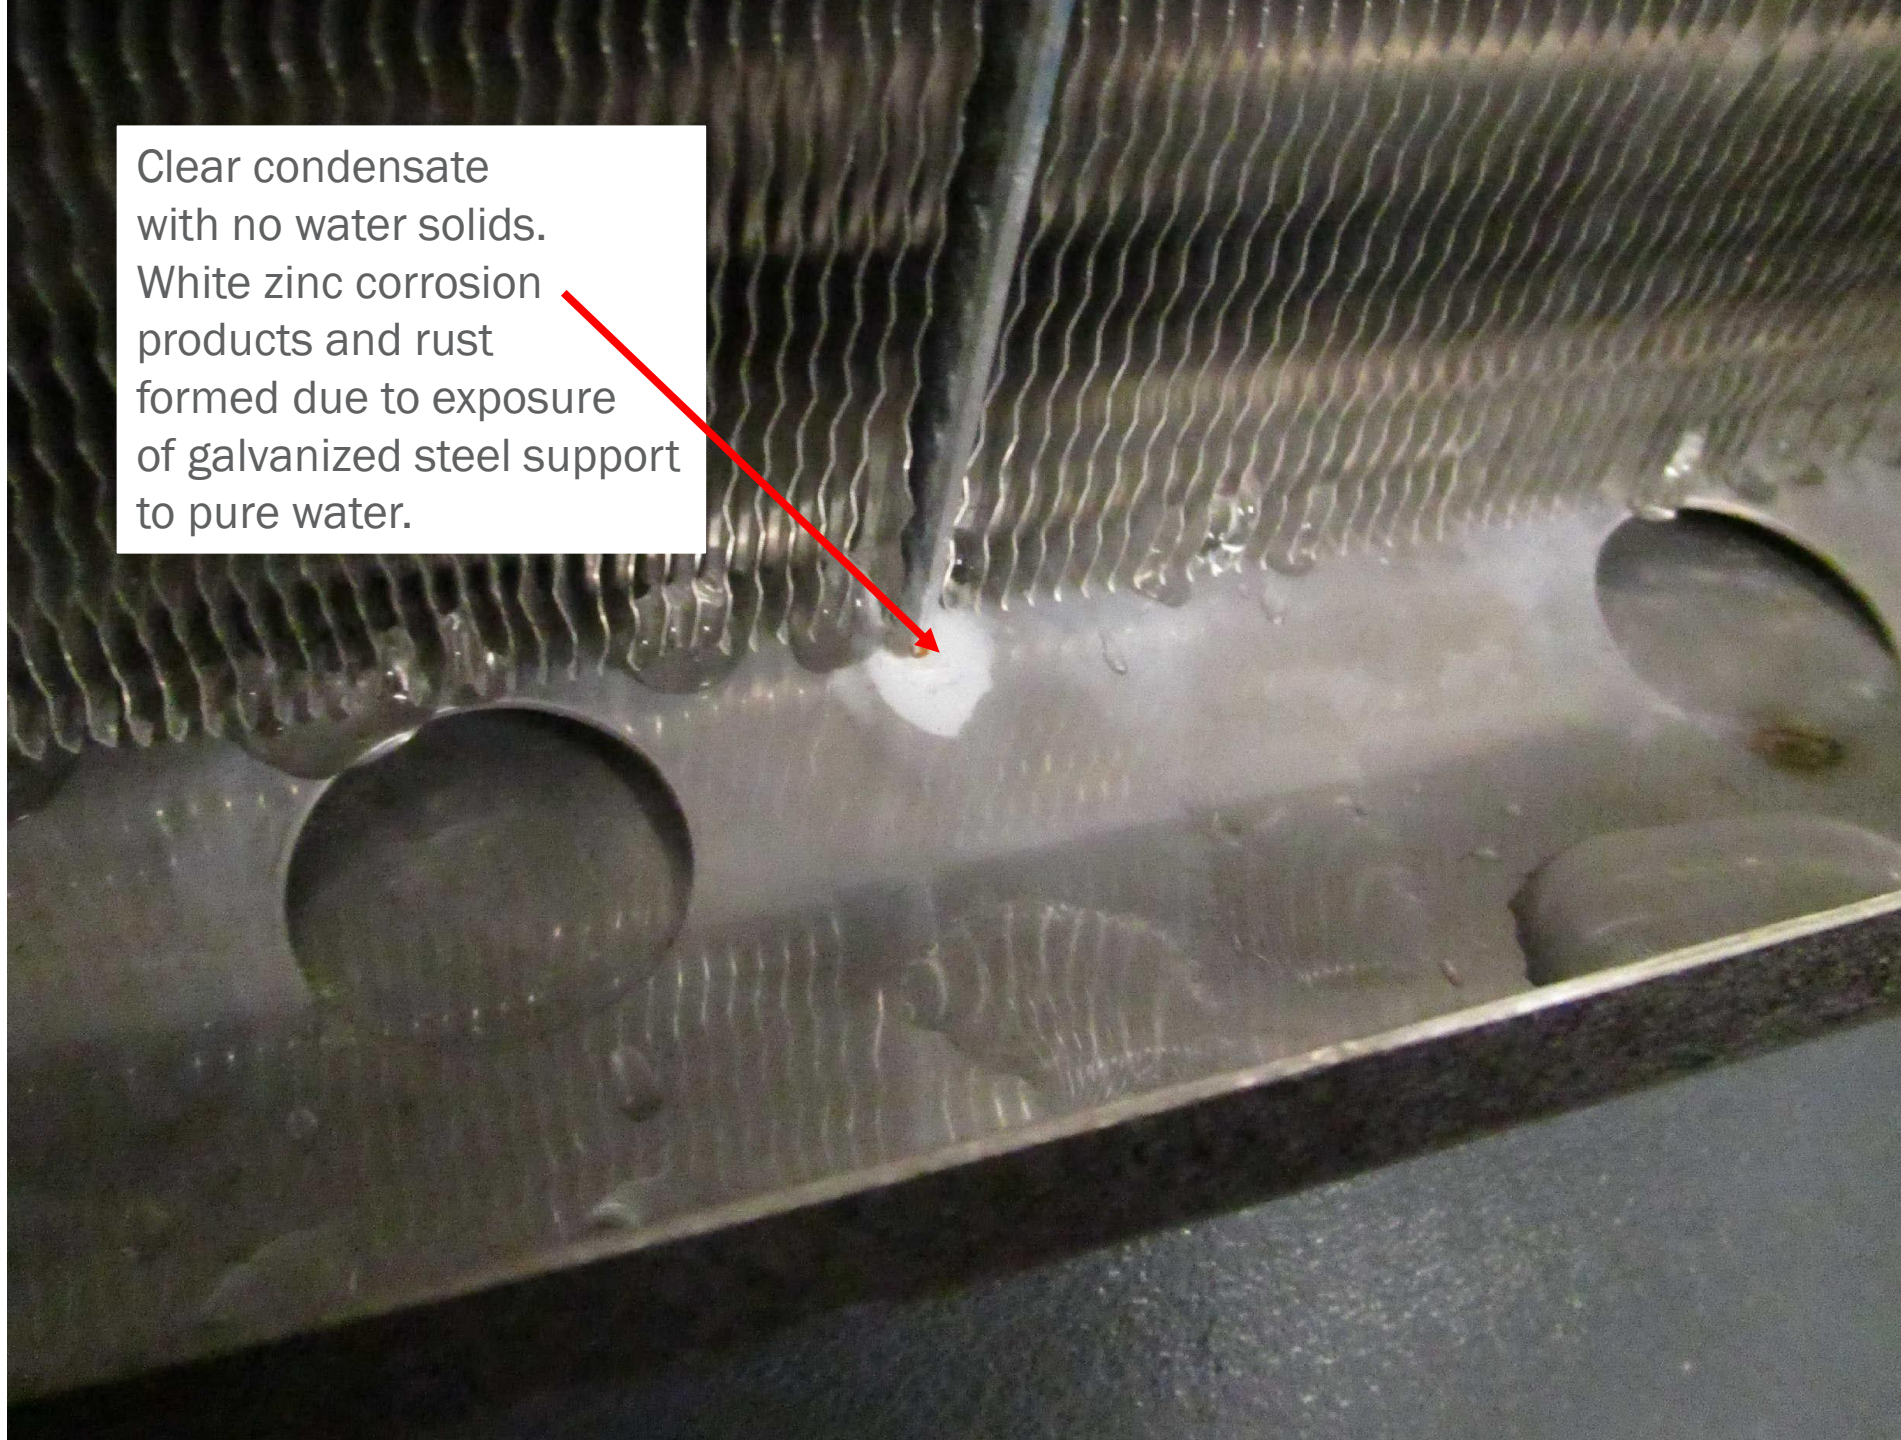
Zinc plating consumed
from galvanized steel
surface exposing steel
which subsequently
rusts

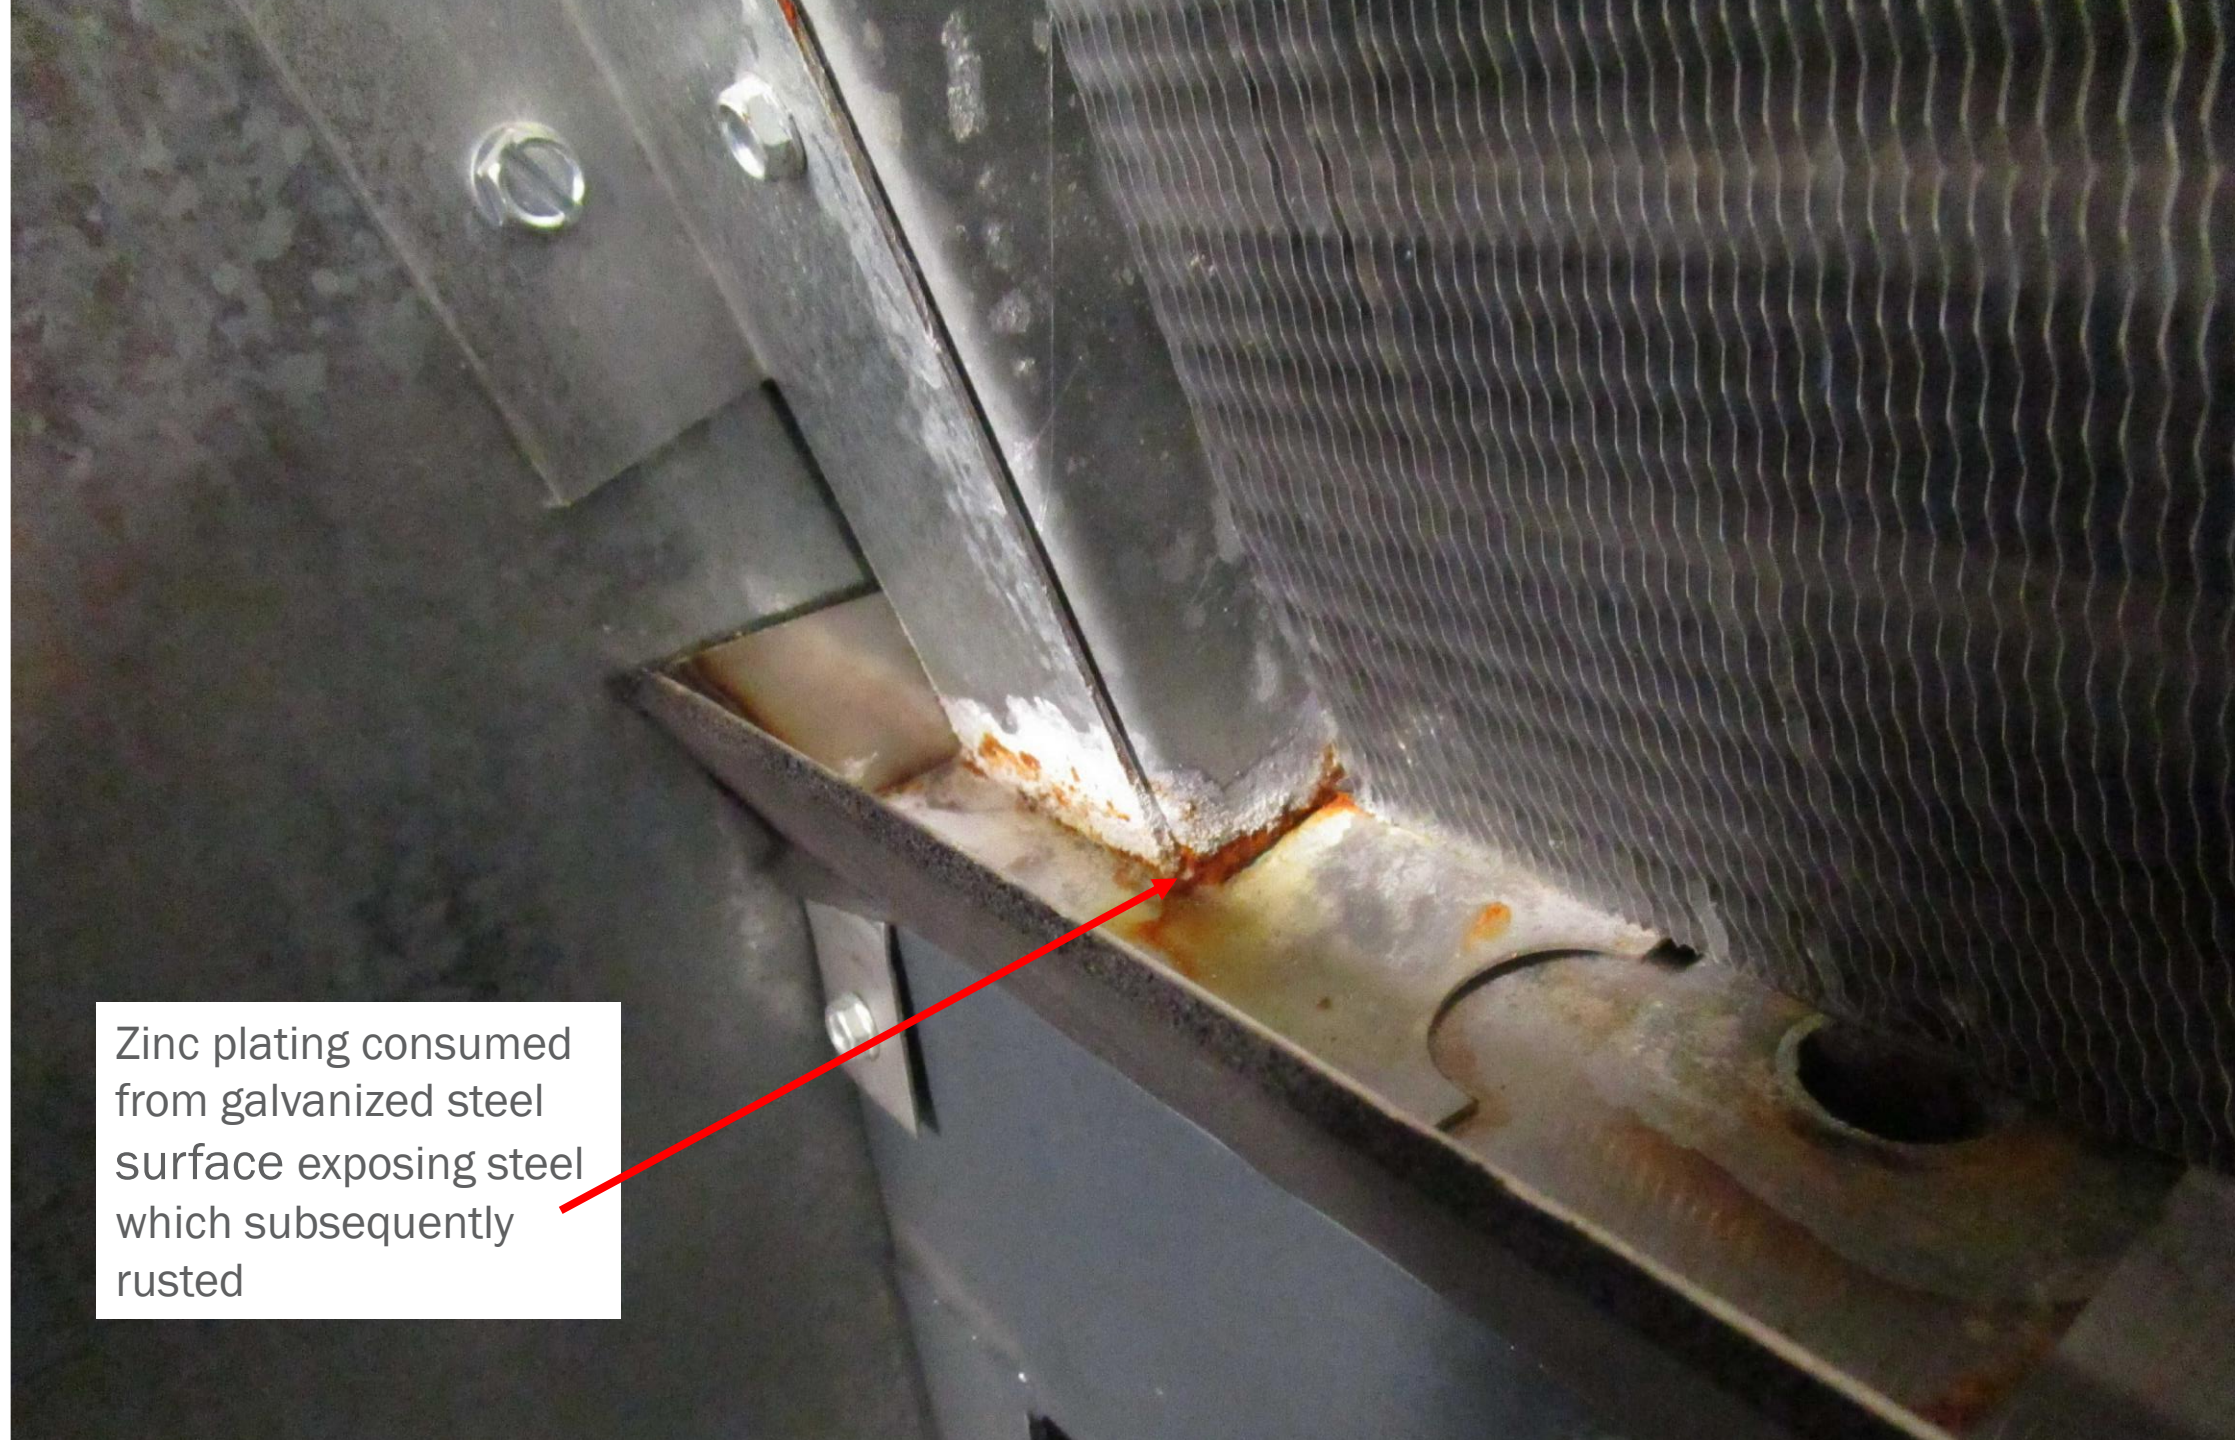
Green patina covering chilled water inlet header and tubes where water vapor condensed from the air. Adjacent outlet header temperature was above the dewpoint, so no condensation occurred there.

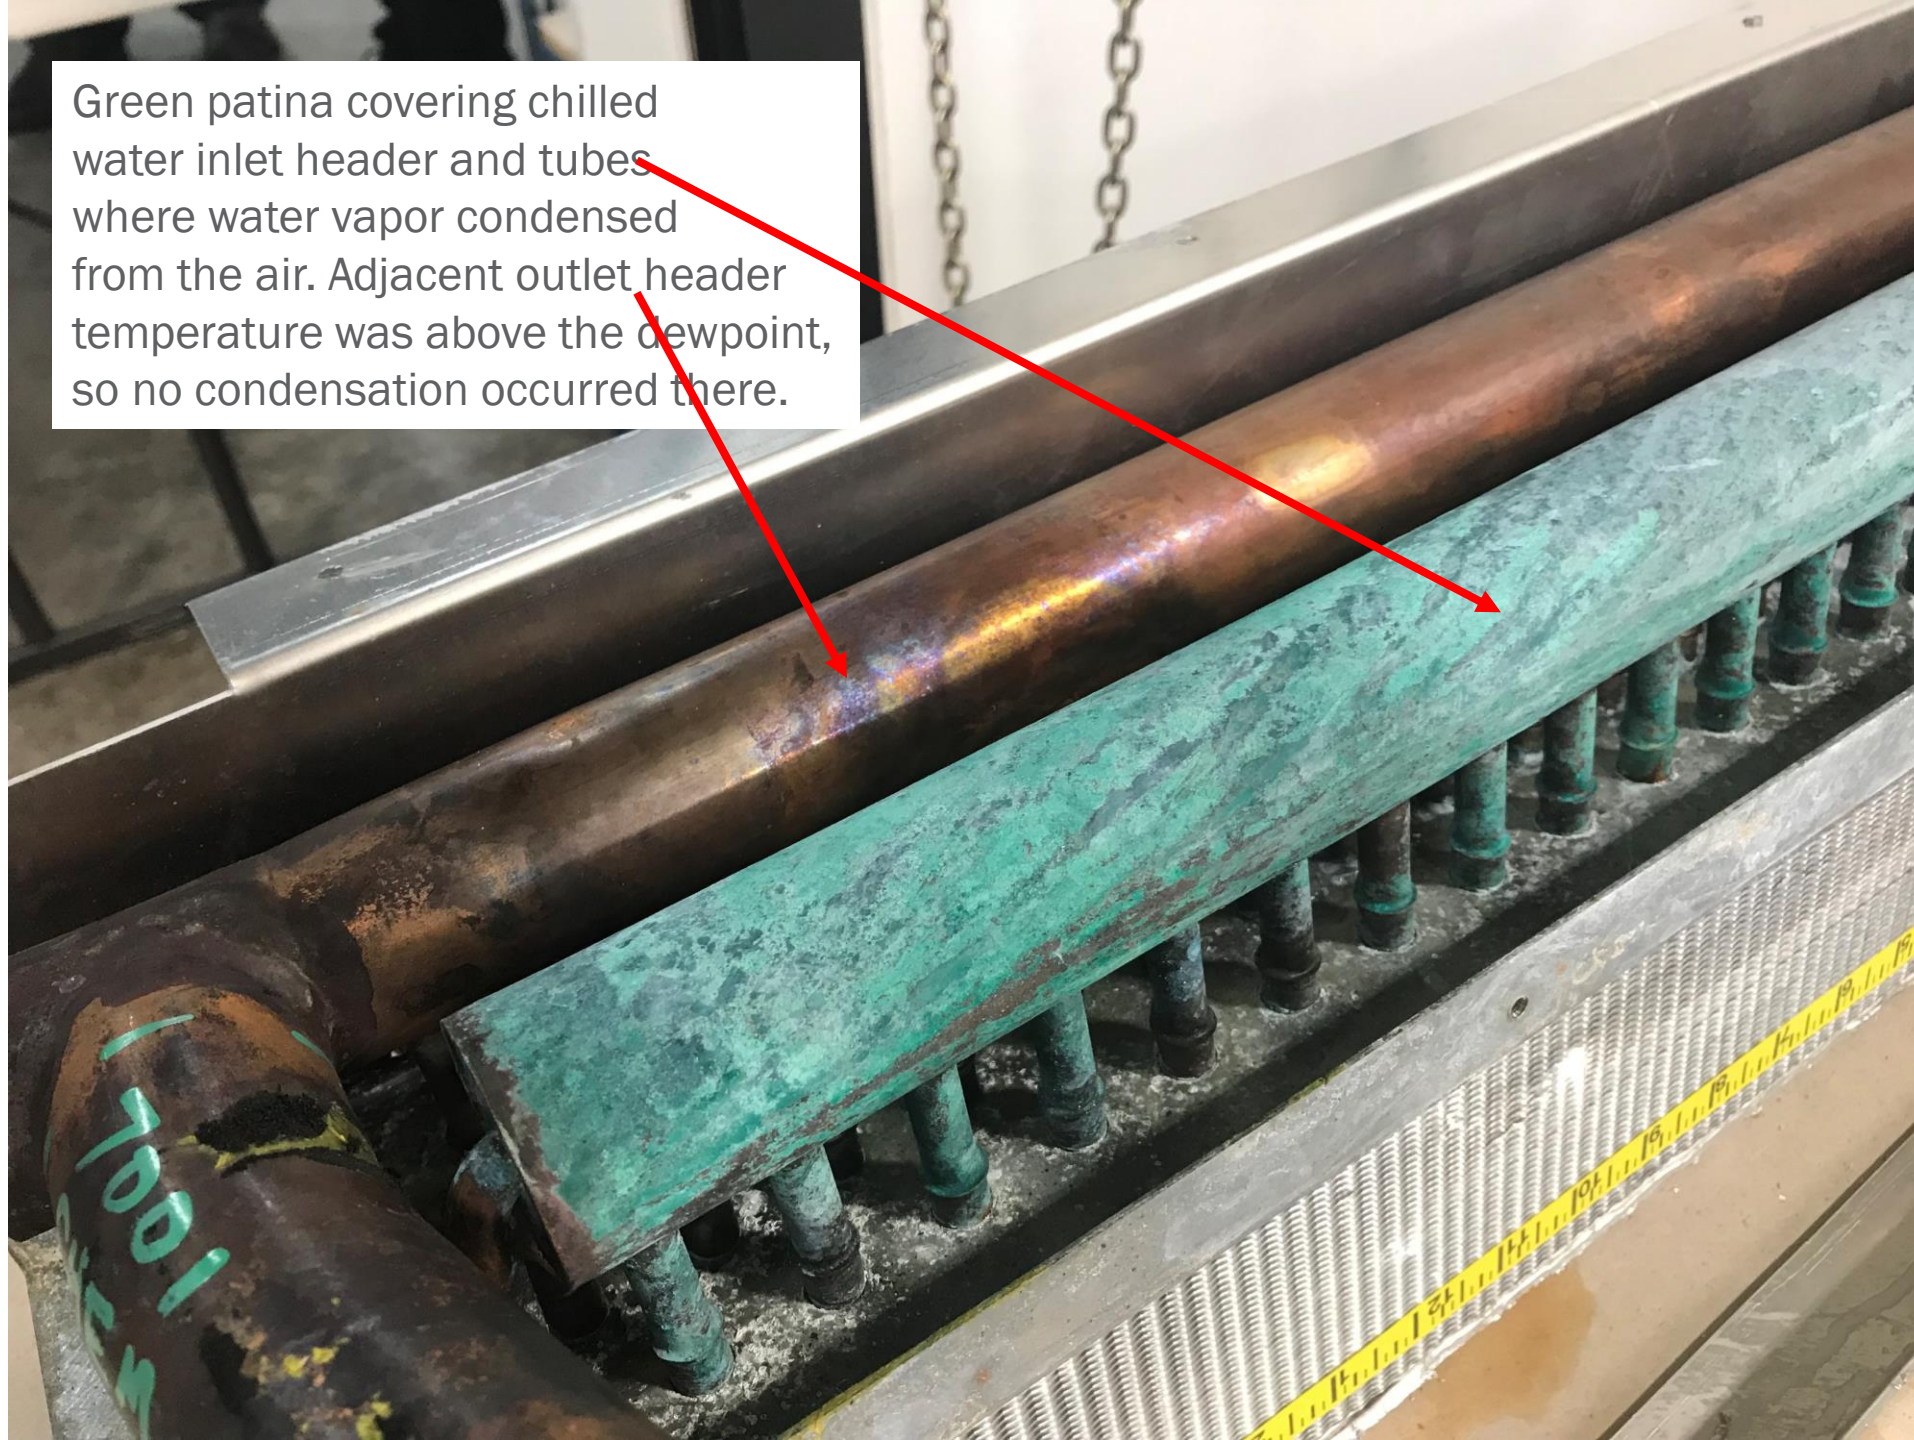
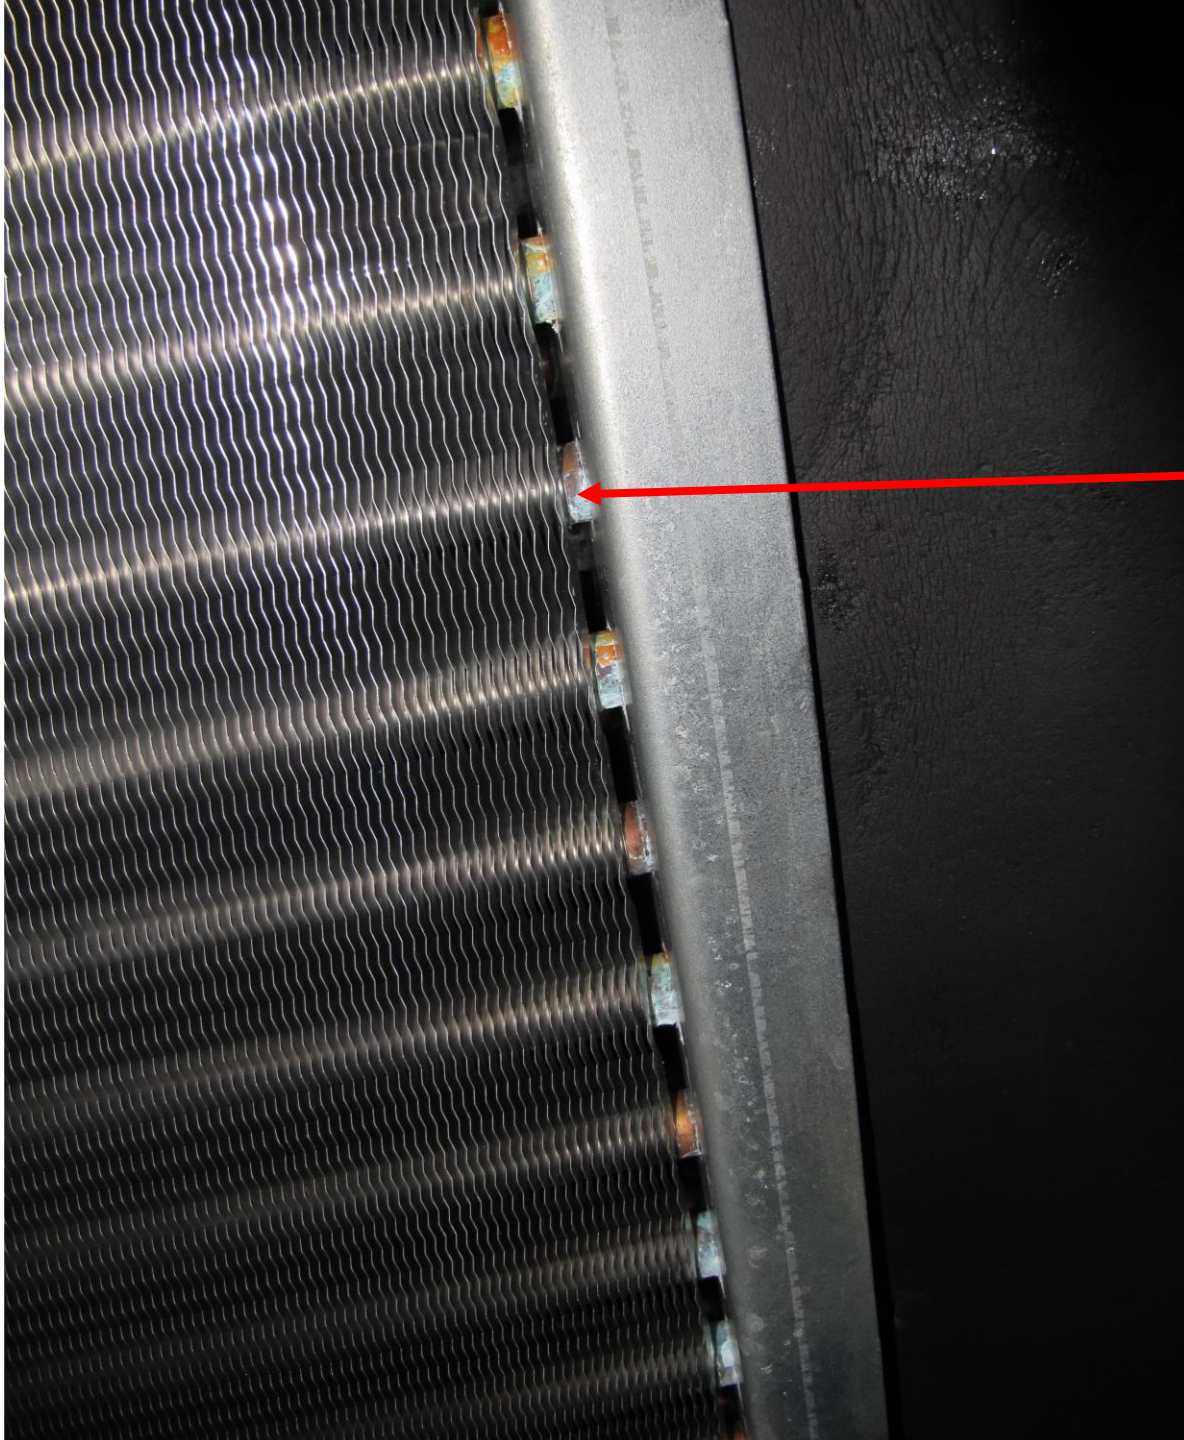
U-bends and/or headers on opposite side of tubesheet. Green patina indicates condensation on coil tubes and superficial atmospheric corrosion.

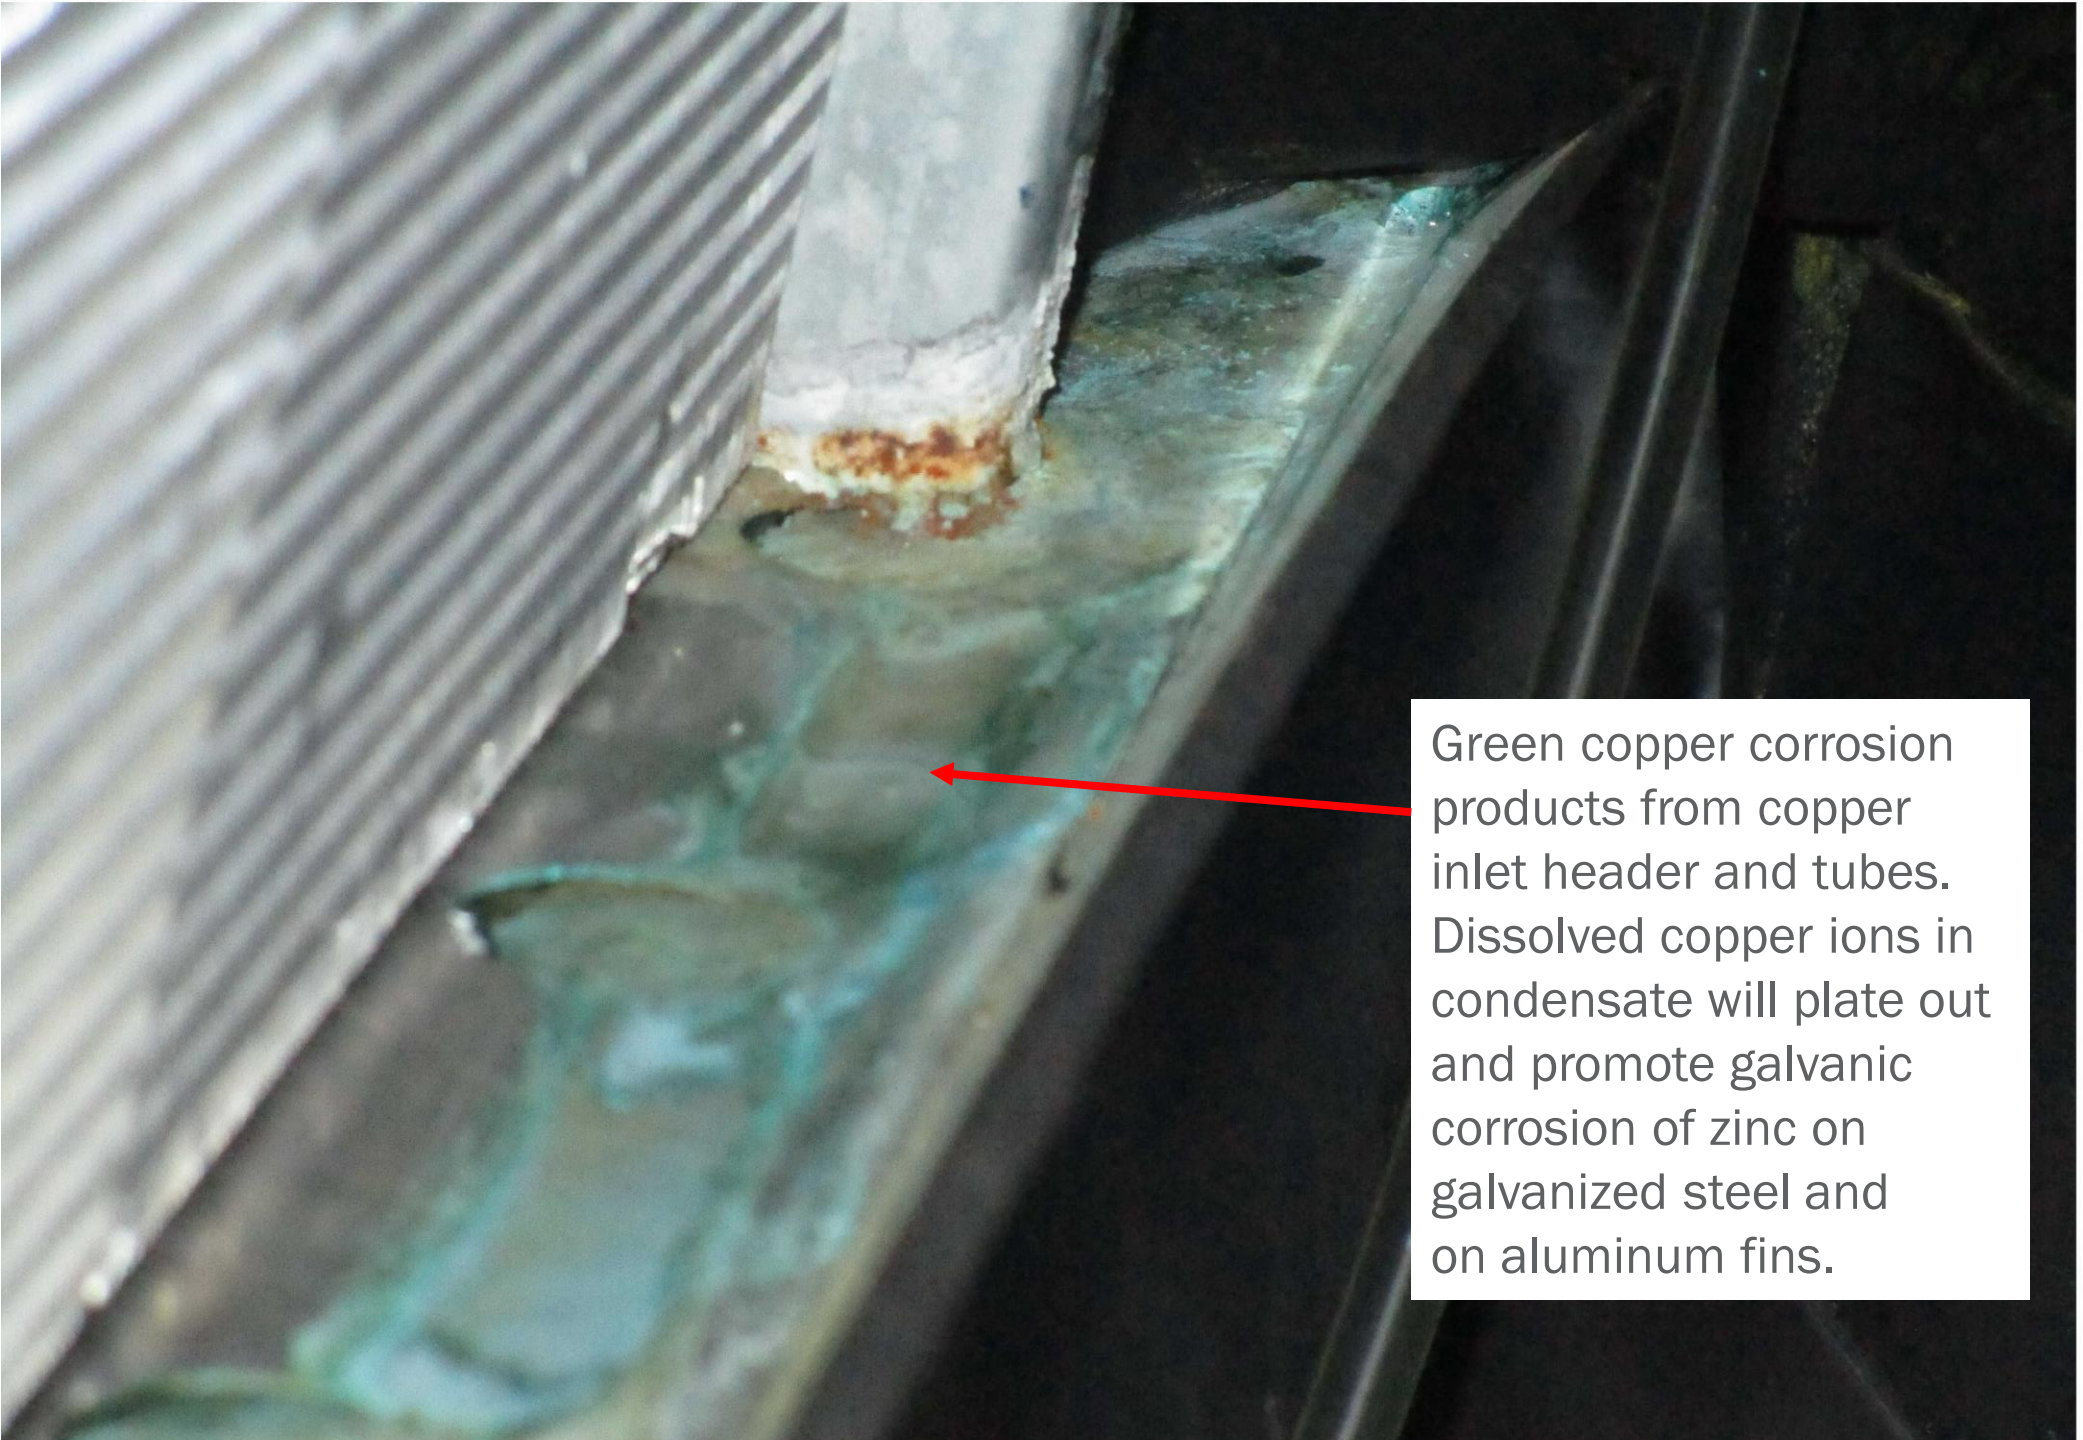
Green copper corrosion products from copper inlet header and tubes. Dissolved copper ions in condensate will plate out and promote galvanic corrosion of zinc on galvanized steel and on aluminum fins.

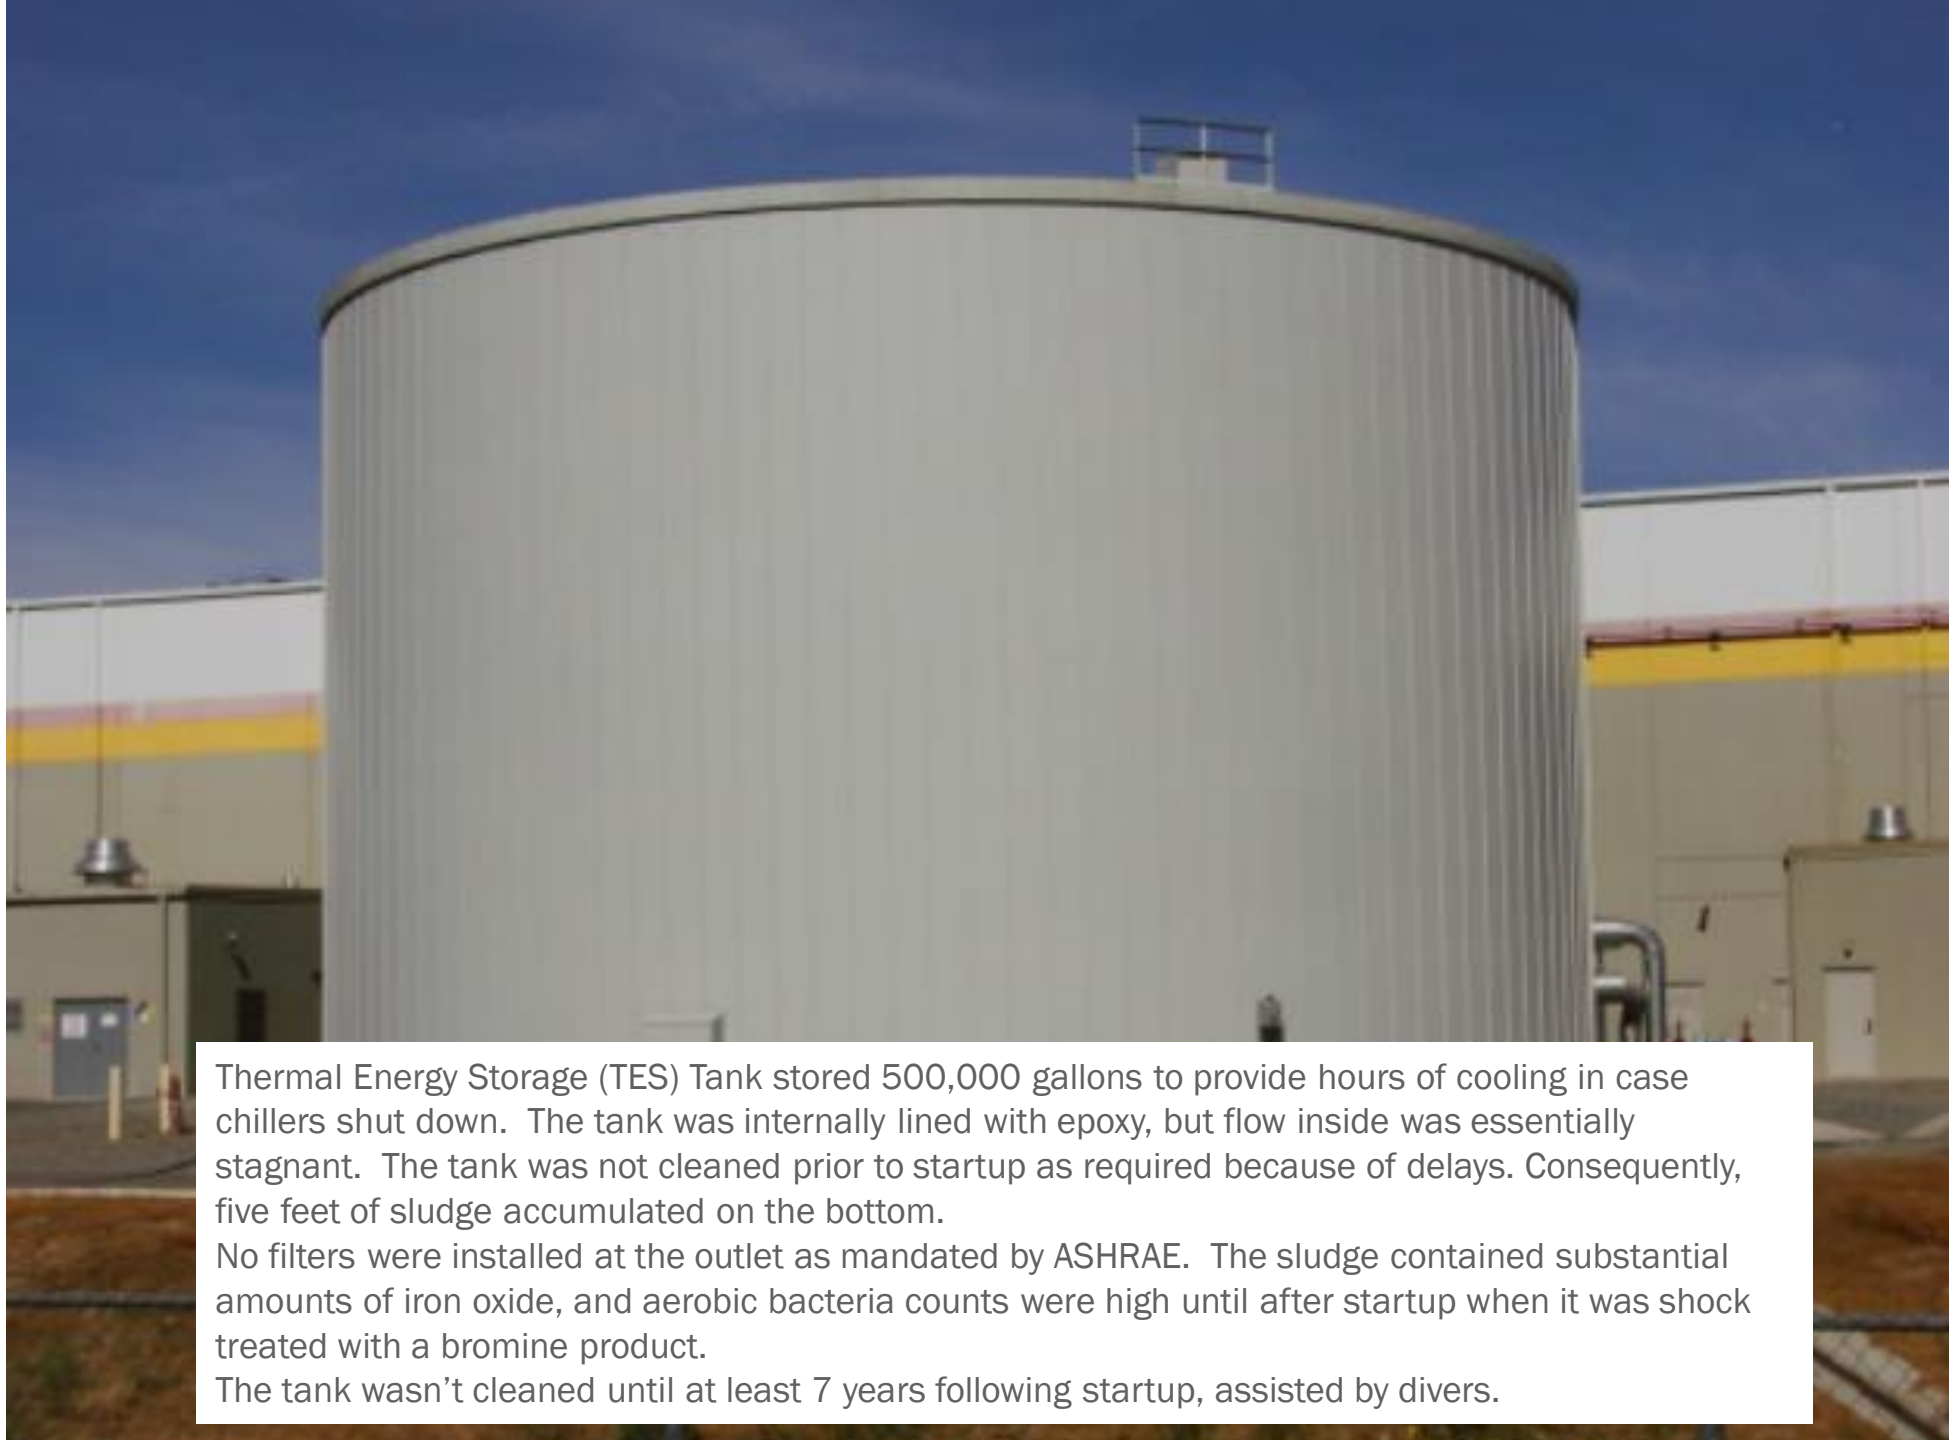
TES Tank before System was Commissioned

Thermal Energy Storage (TES) Tank stored 500,000 gallons to provide hours of cooling in case chillers shut down. The tank was internally lined with epoxy, but flow inside was essentially stagnant. The tank was not cleaned prior to startup as required because of delays. Consequently, five feet of sludge accumulated on the bottom.

No filters were installed at the outlet as mandated by ASHRAE. The sludge contained substantial amounts of iron oxide, and aerobic bacteria counts were high until after startup when it was shock treated with a bromine product.

The tank wasn't cleaned until at least 7 years following startup, assisted by divers.

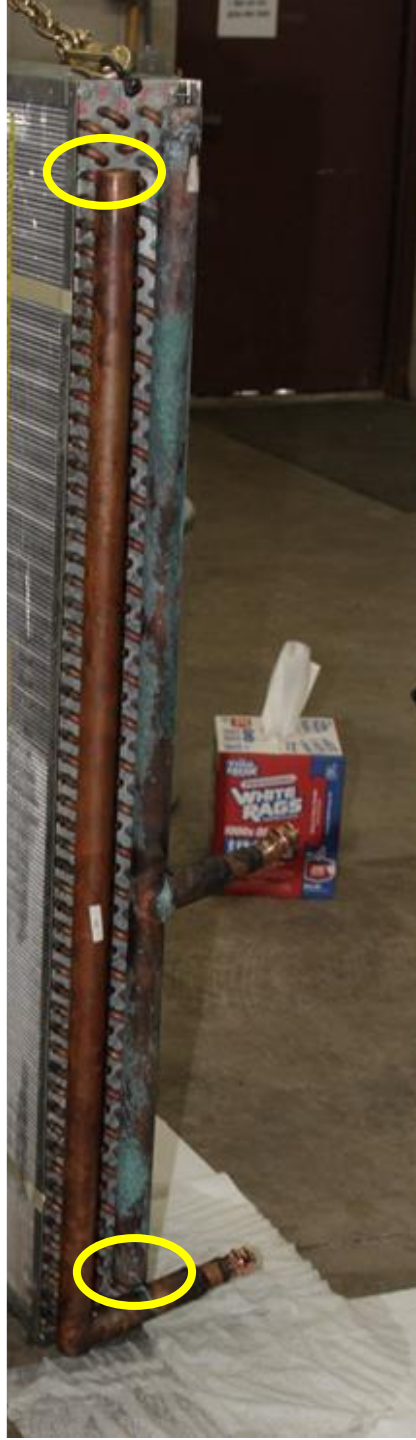
One of the coils failed a pressurized air leak test at two locations

- Leaks at end-most tubes connecting unsupported headers to coil tubes.
