Data Center Cooling System Failure

CRAH – Computer Room Air Handler Coils

Jim Dillon, Dorothy Collins and Philip Yu

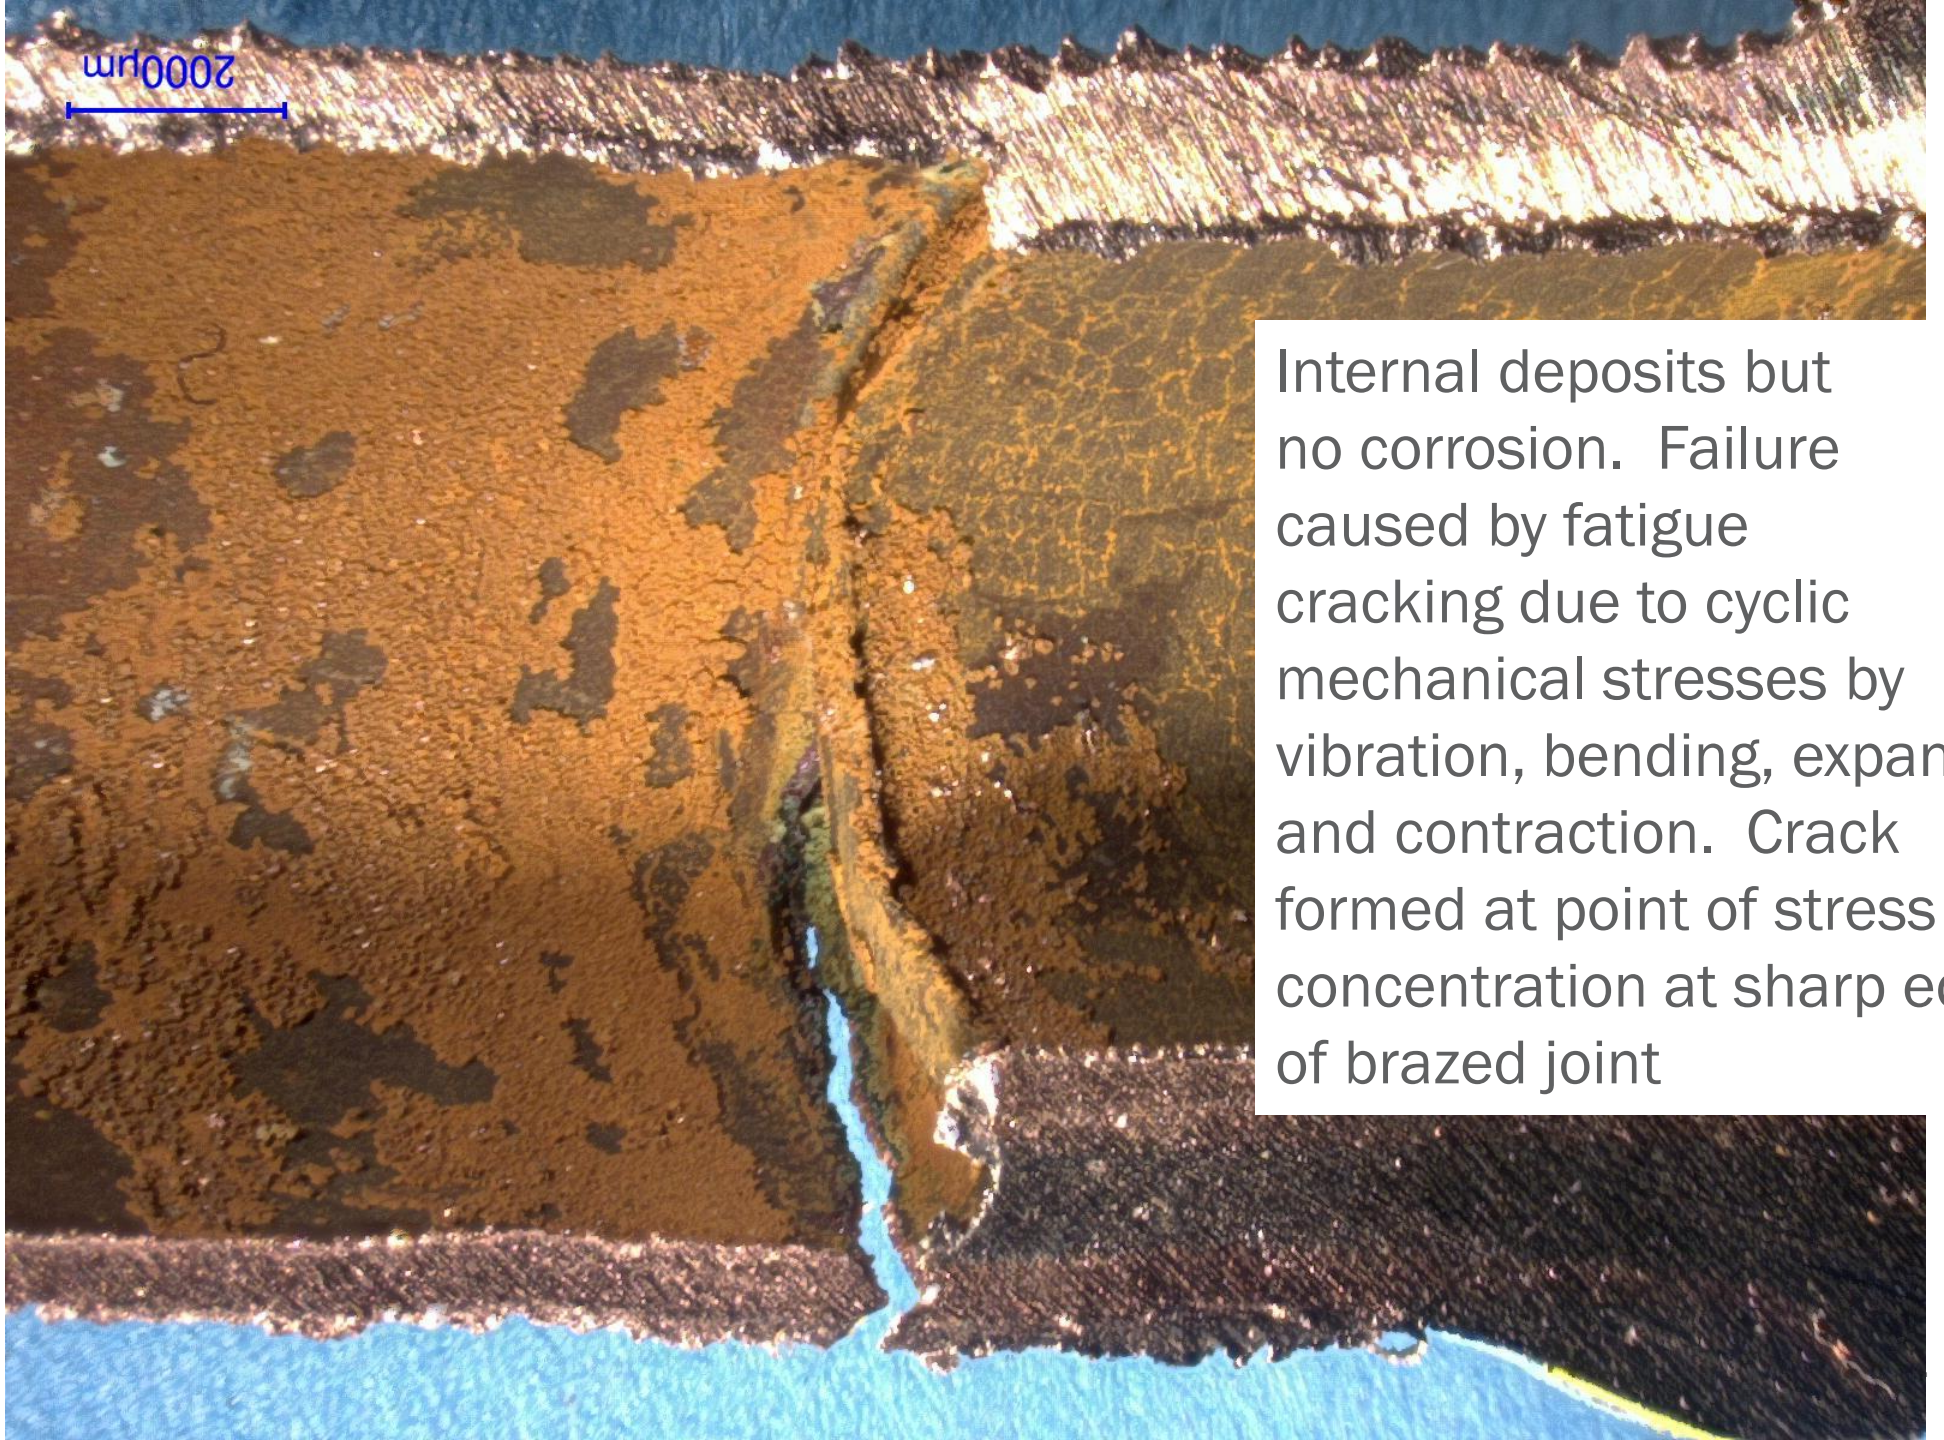
Internal deposits but no corrosion. Failure caused by fatigue cracking due to cyclic mechanical stresses by vibration, bending, expansion and contraction. Crack formed at point of stress concentration at sharp edge of brazed joint

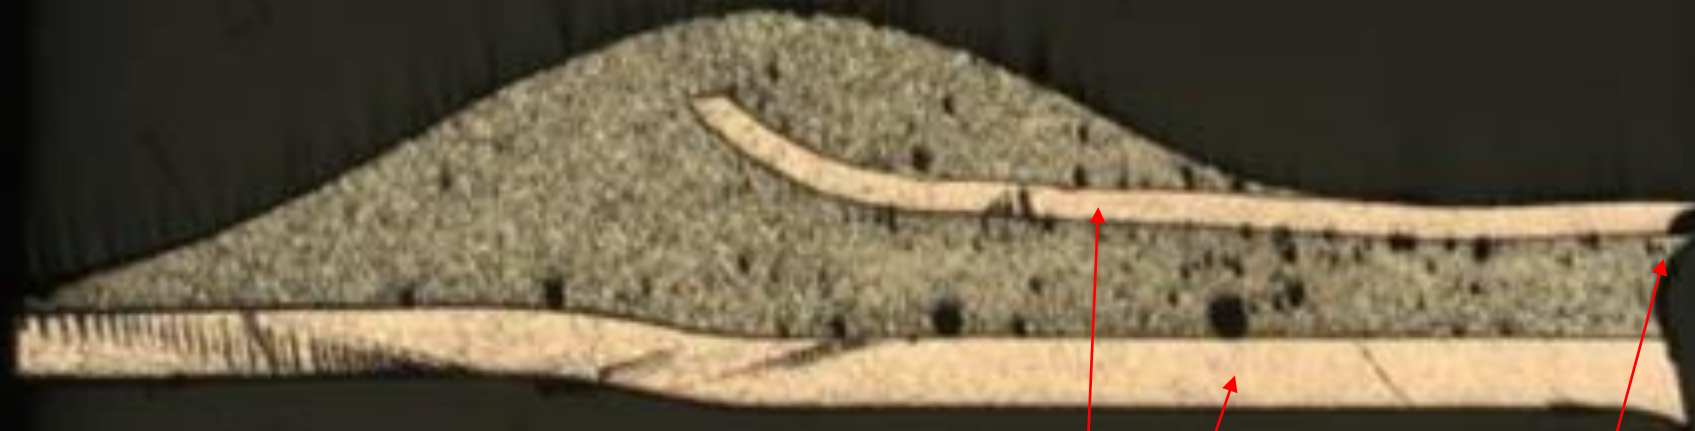
- Fracture at end of tube at interface of brazed joint.
- Tube thickness is about 0.012"
- Inlet tube is about 0.024" thick.

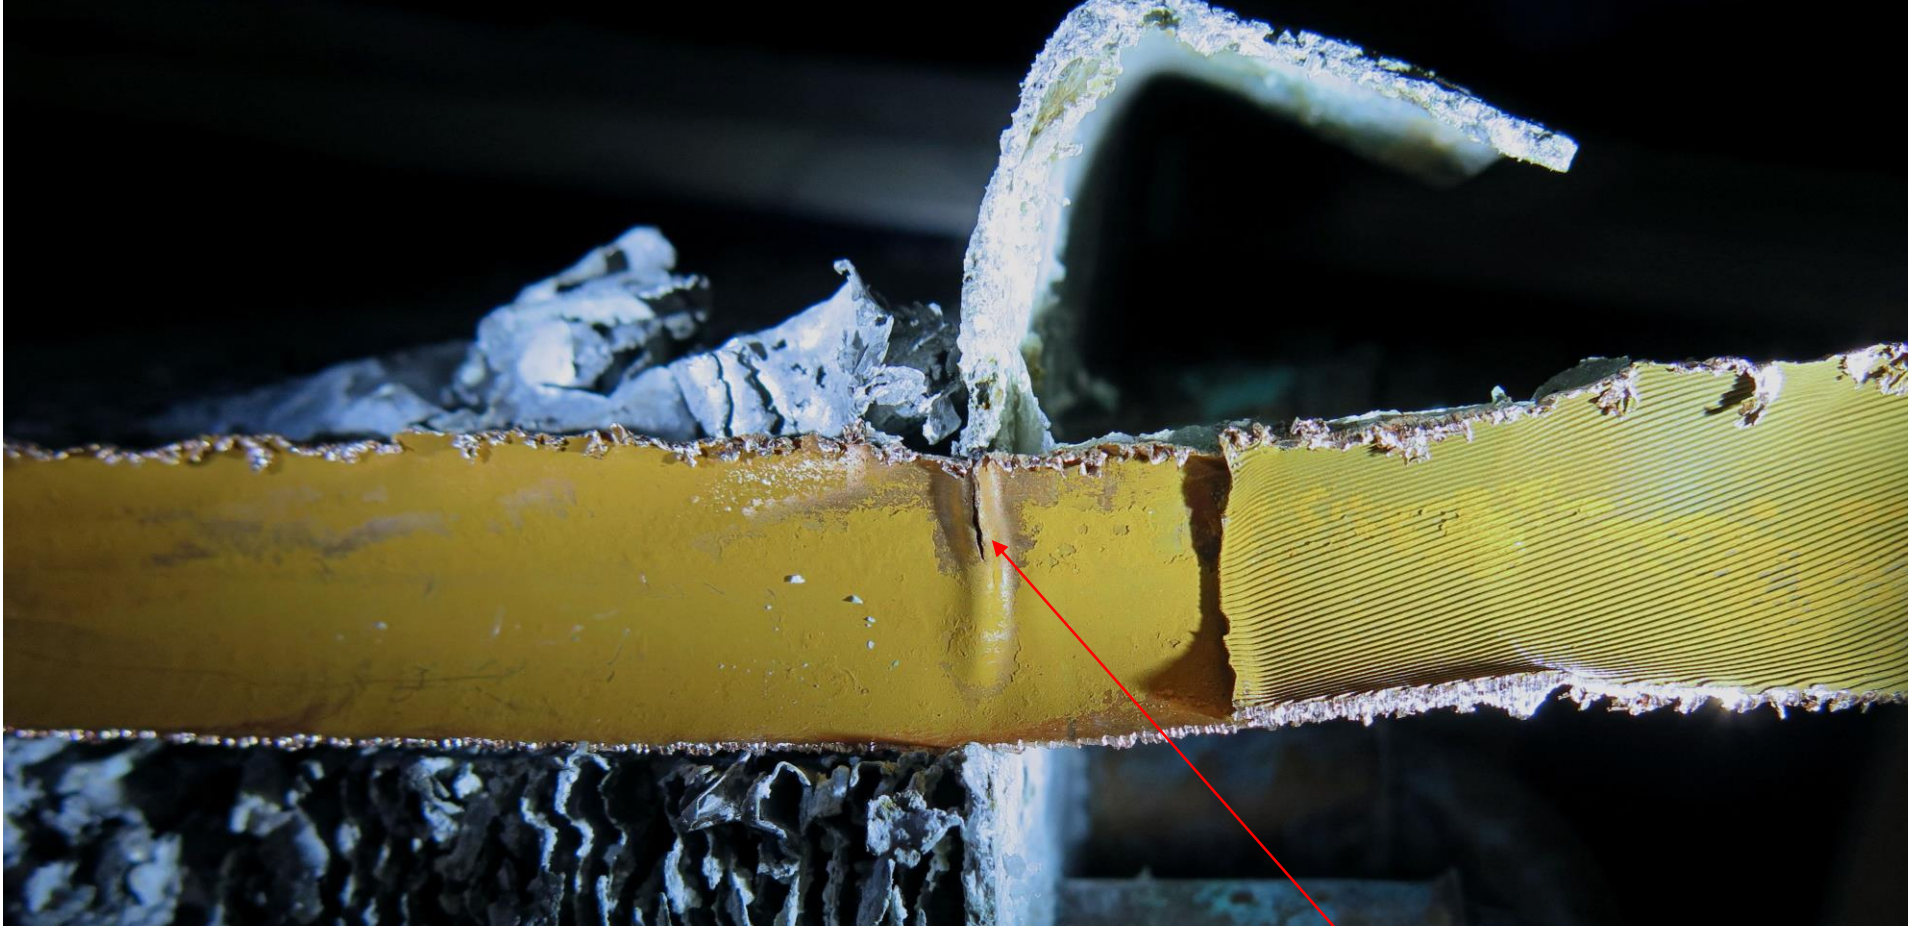
Through-crack at
galvanized steel header
contact point. Fatigue
crack at point of rigid
restraint. No internal
surface corrosion.

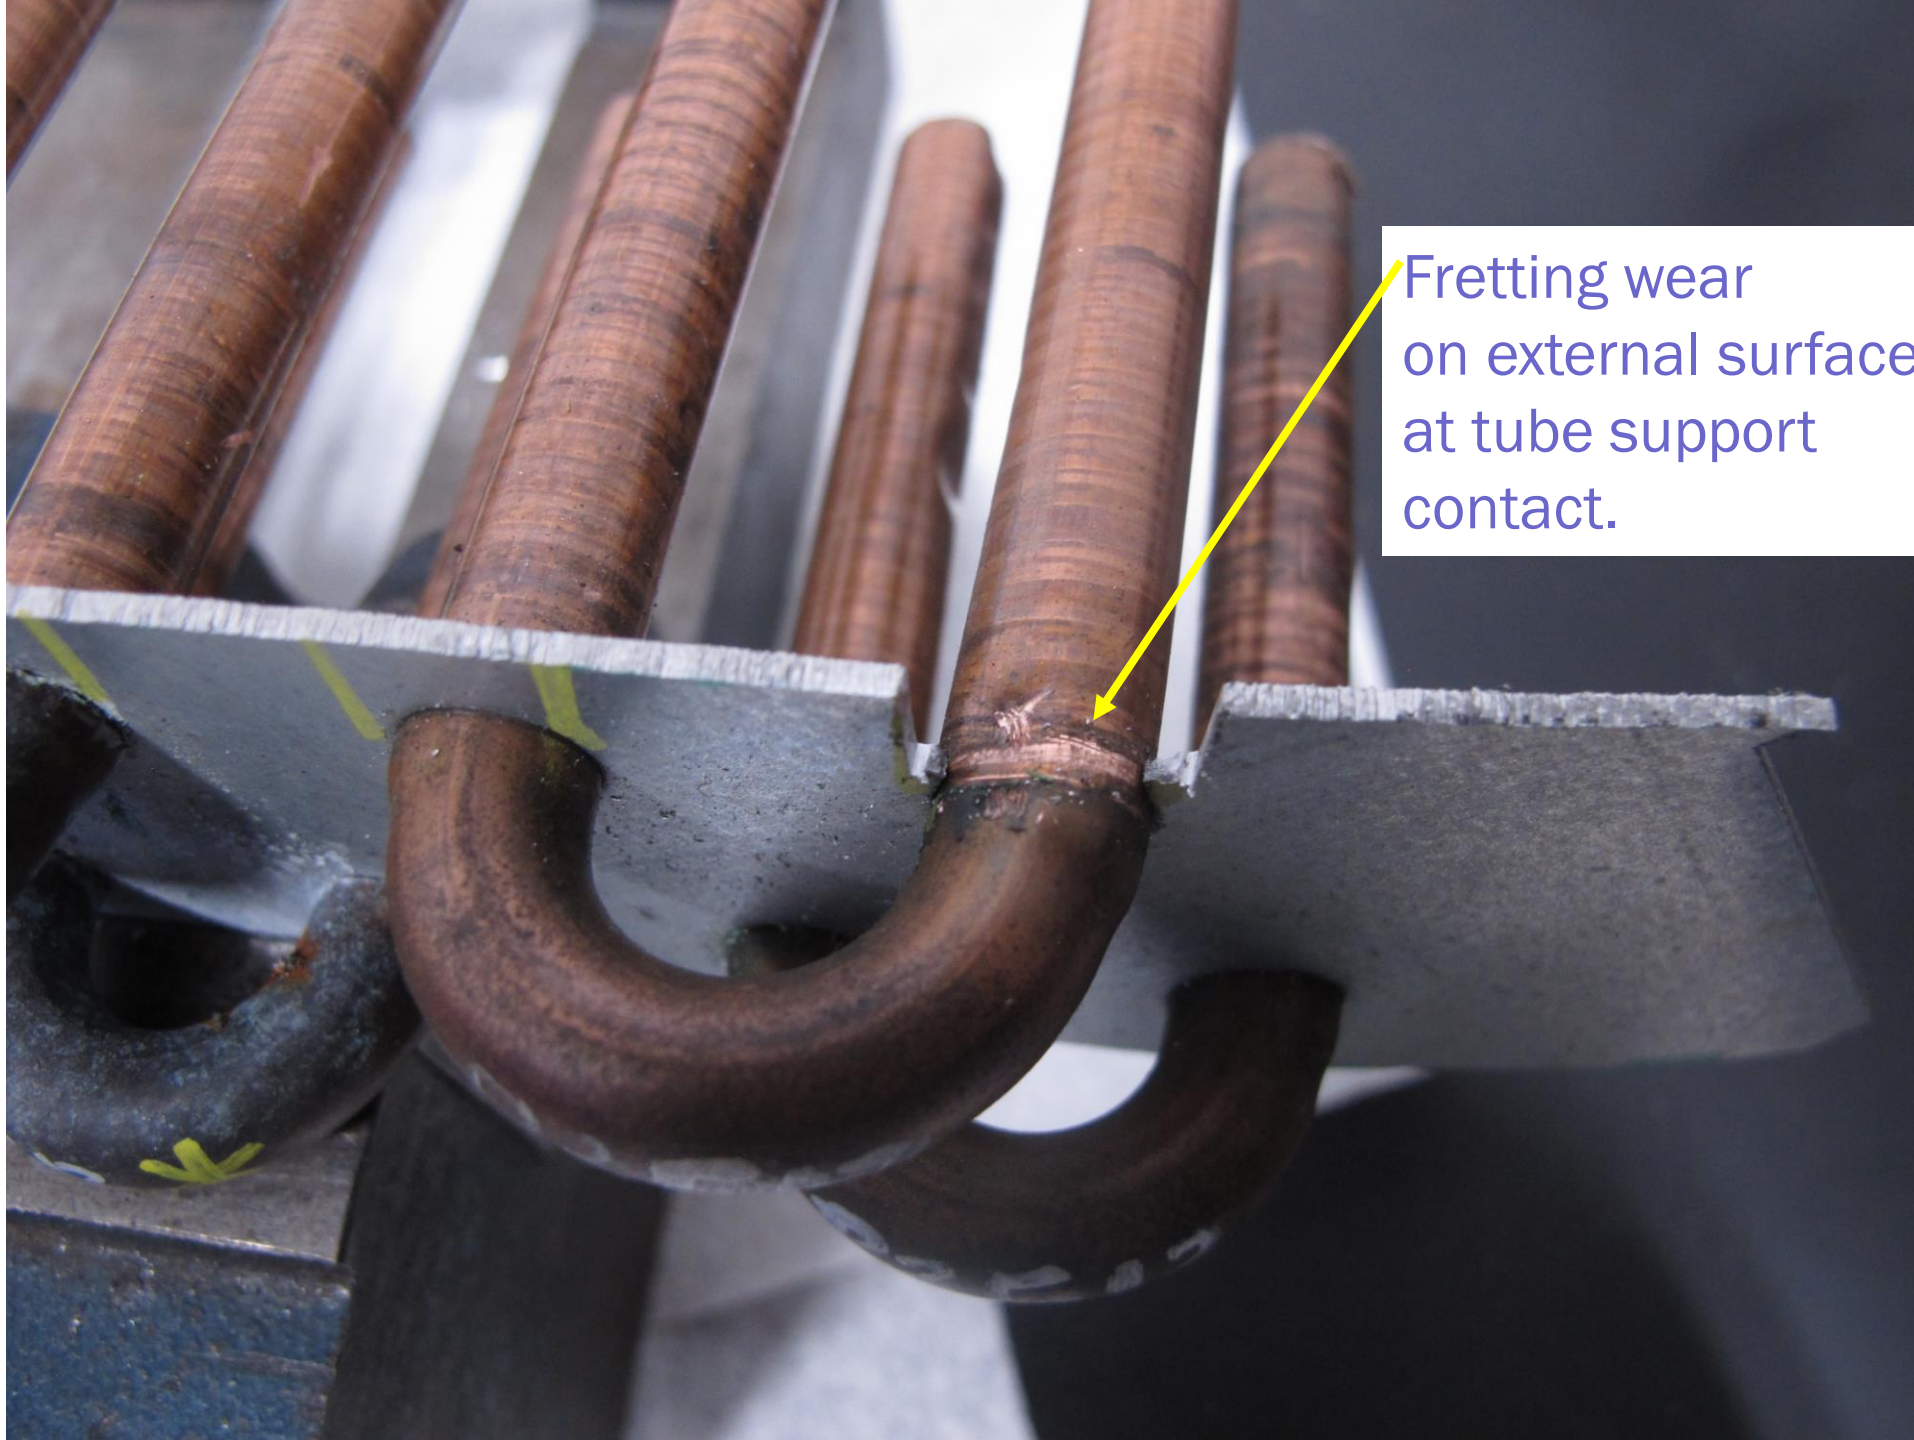
Fretting wear
on external surface
at tube support
contact.

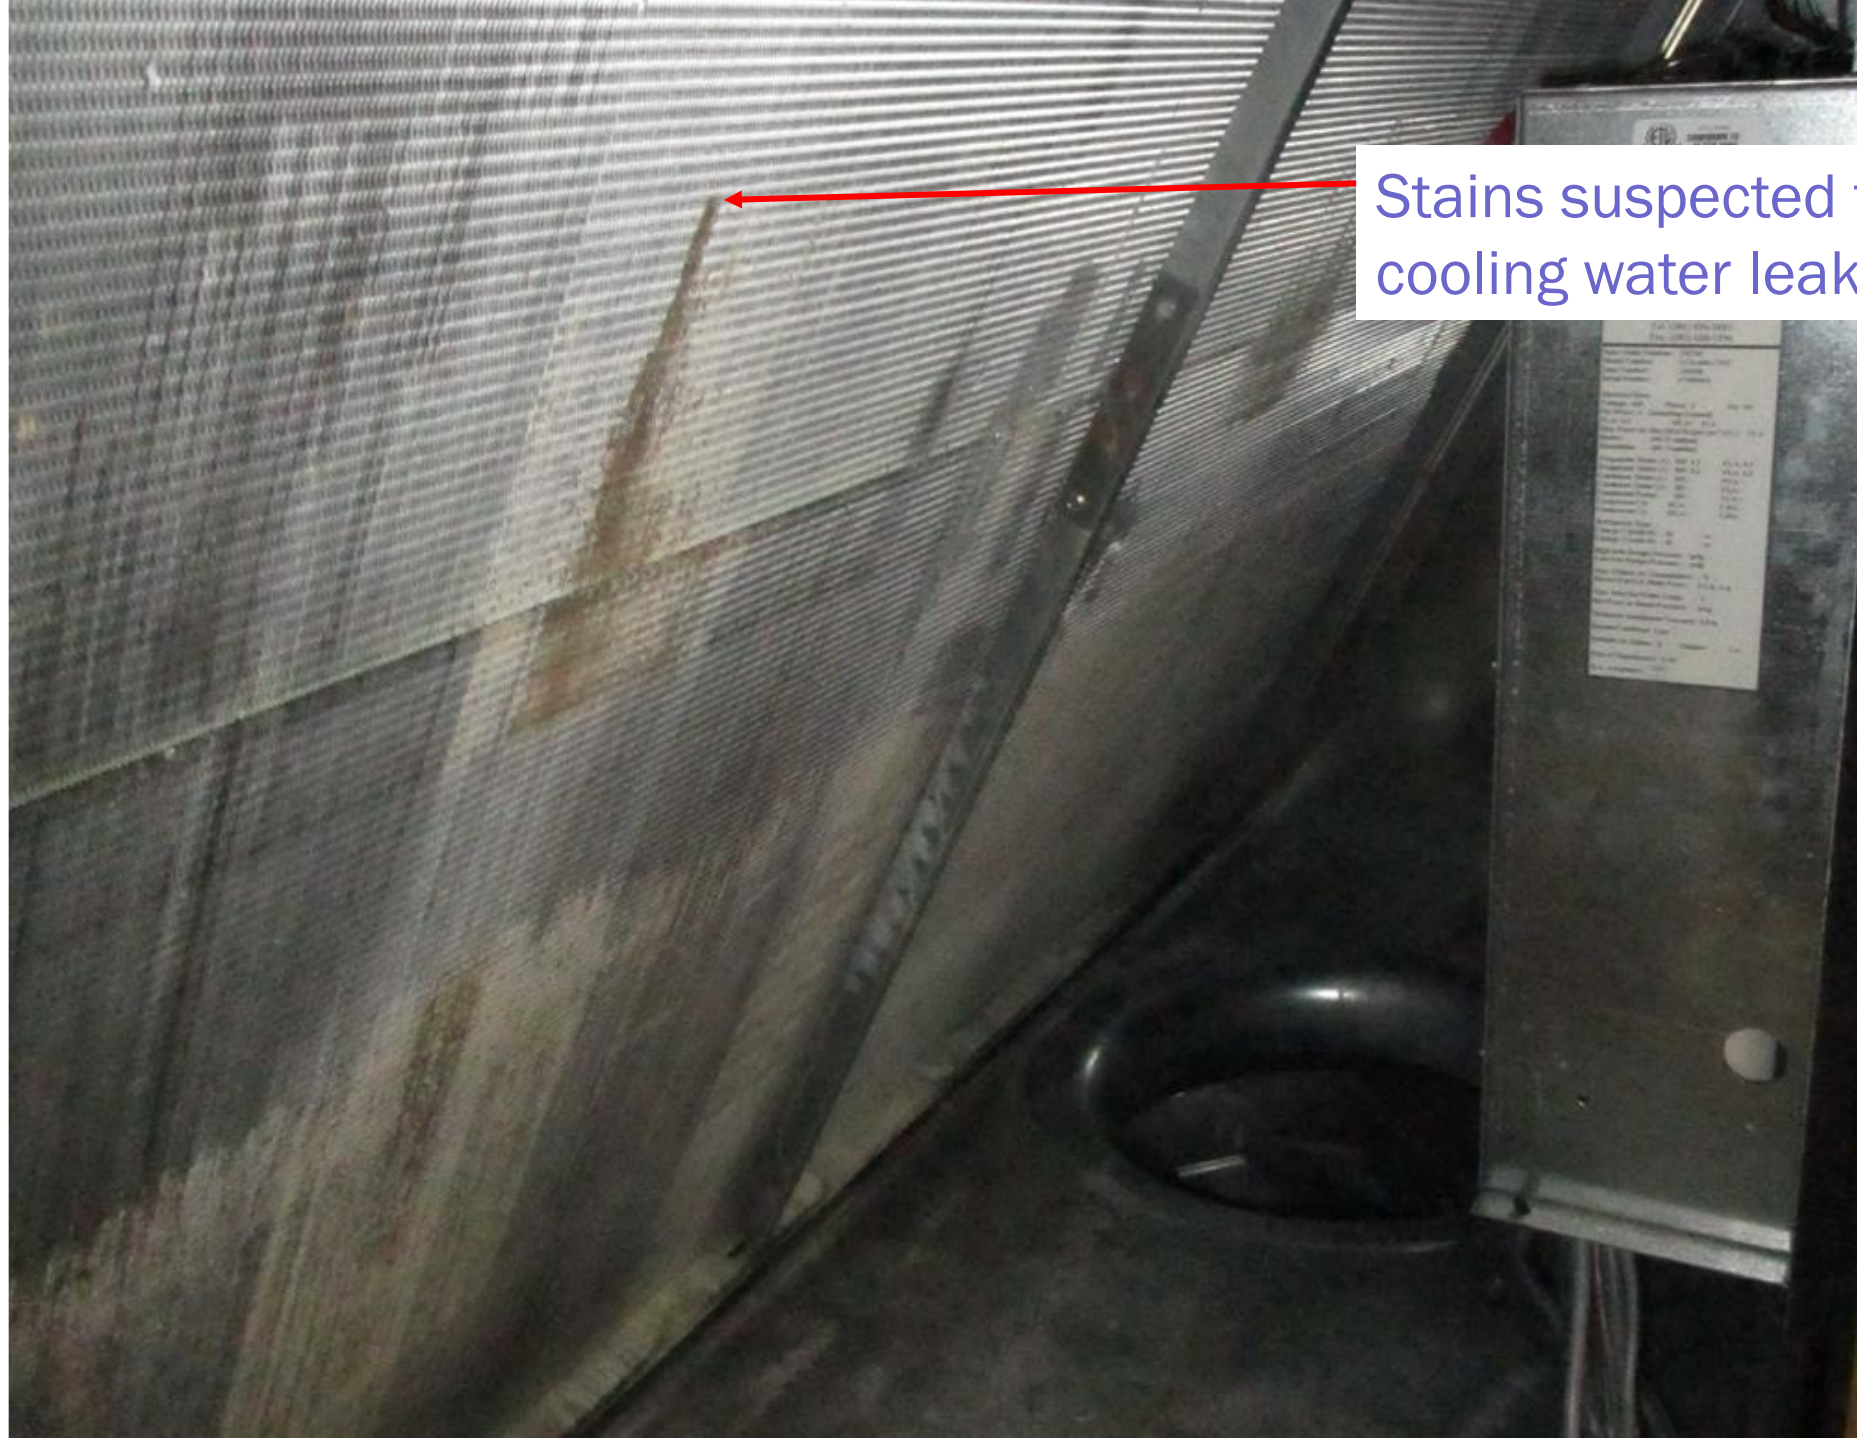
Stains suspected to be
cooling water leak sites.

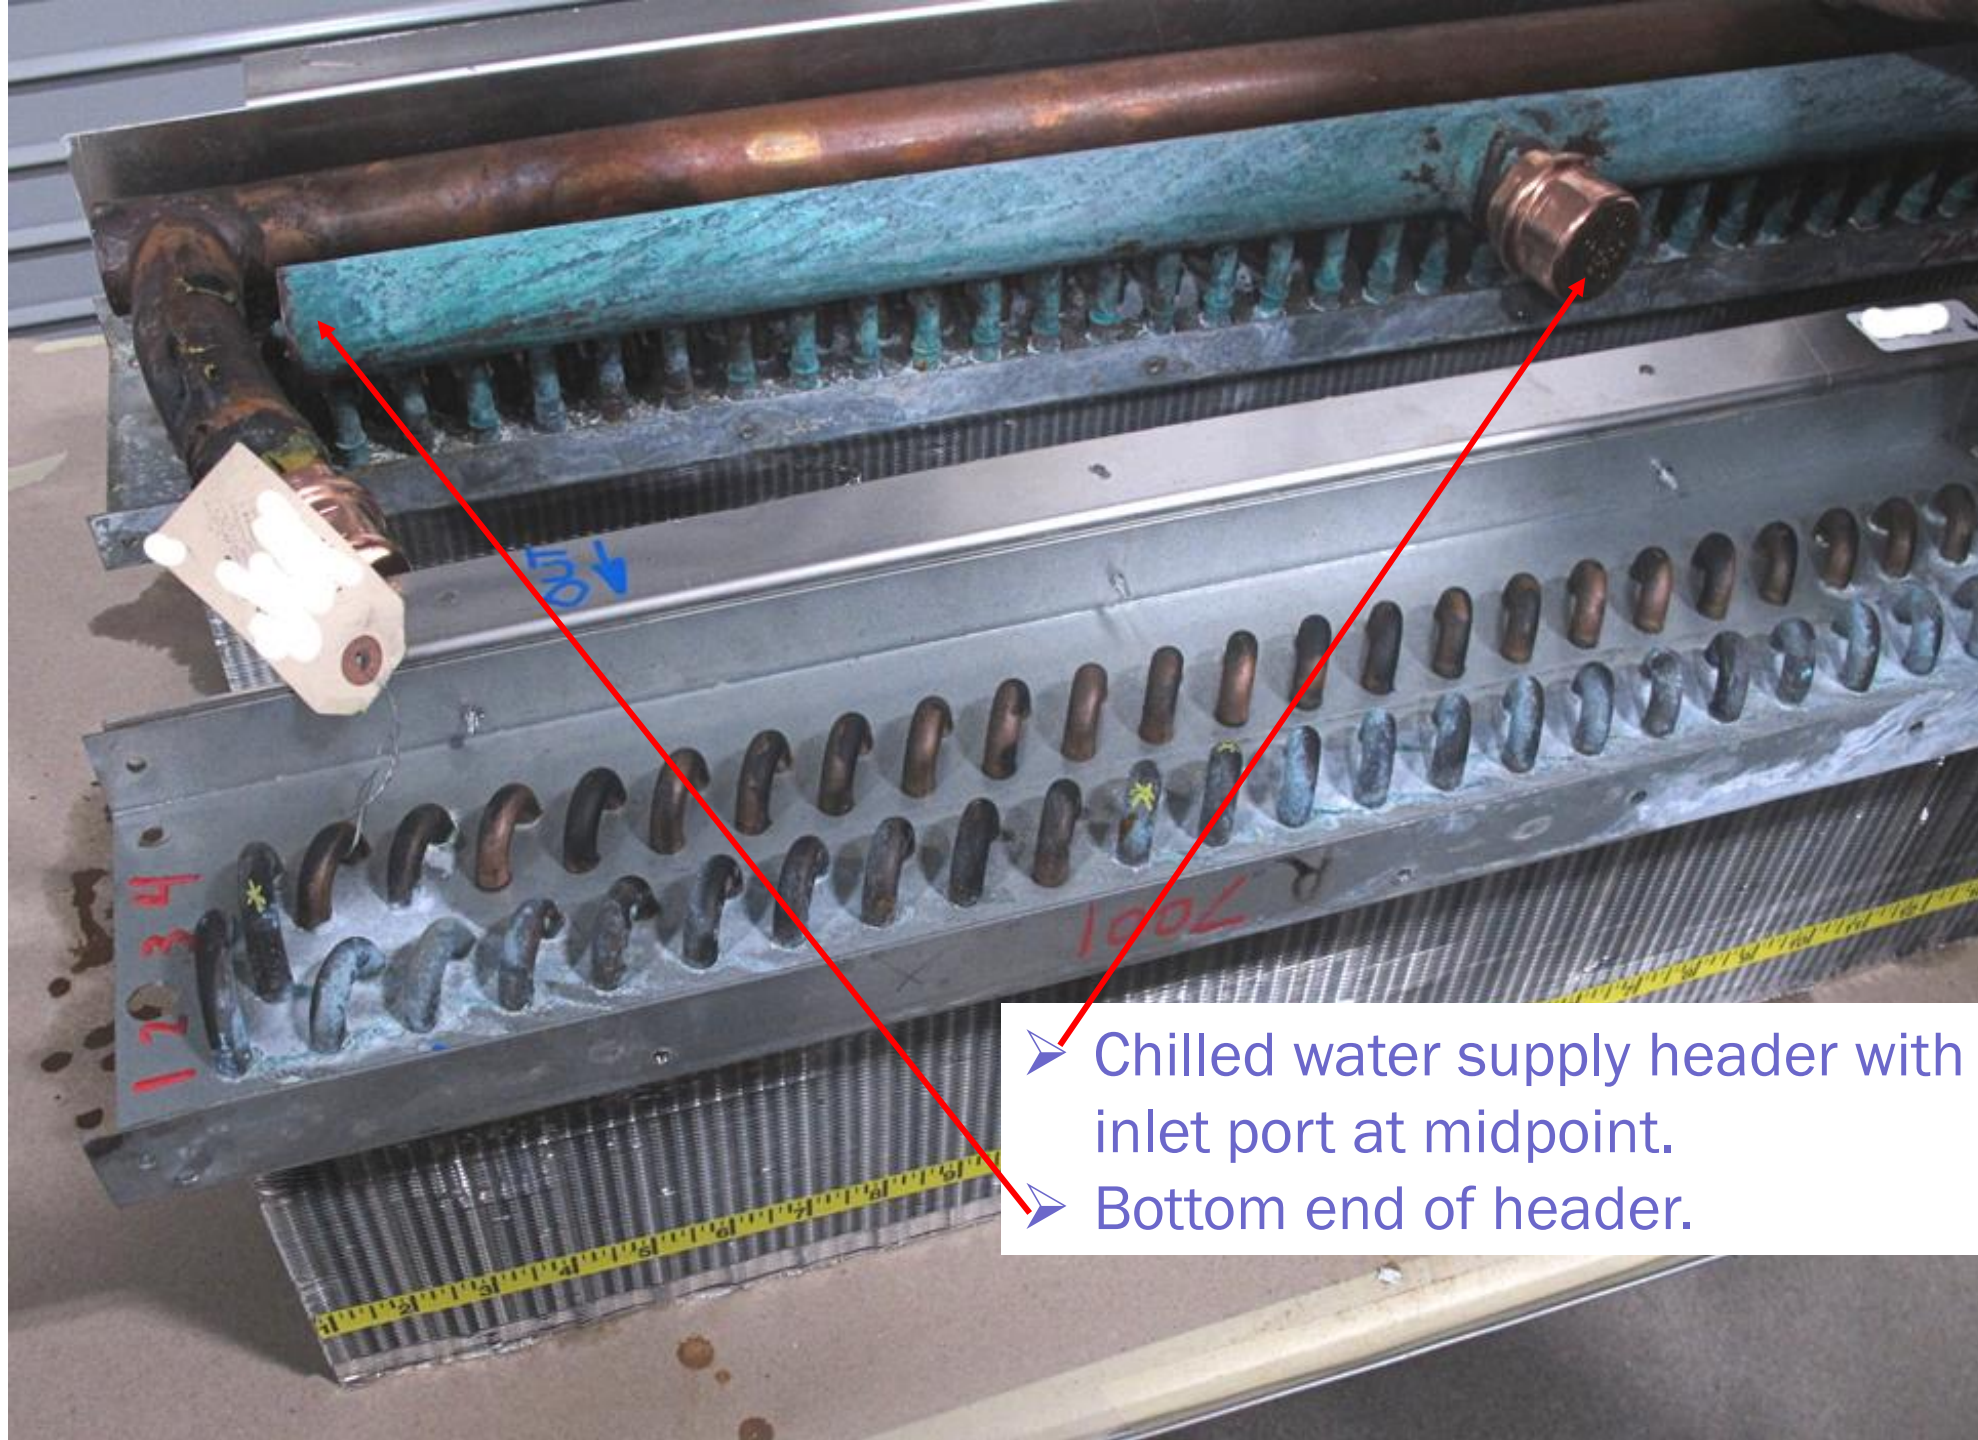
- Chilled water supply header with inlet port at midpoint.
- Bottom end of header.

Buildup of iron oxide chips and heavy suspended deposits that settled at bottom end of Inlet header. Large chips could not pass through small diameter tube ends, blocking cooling water flow. No strainers or filters upstream of CRAH coils.

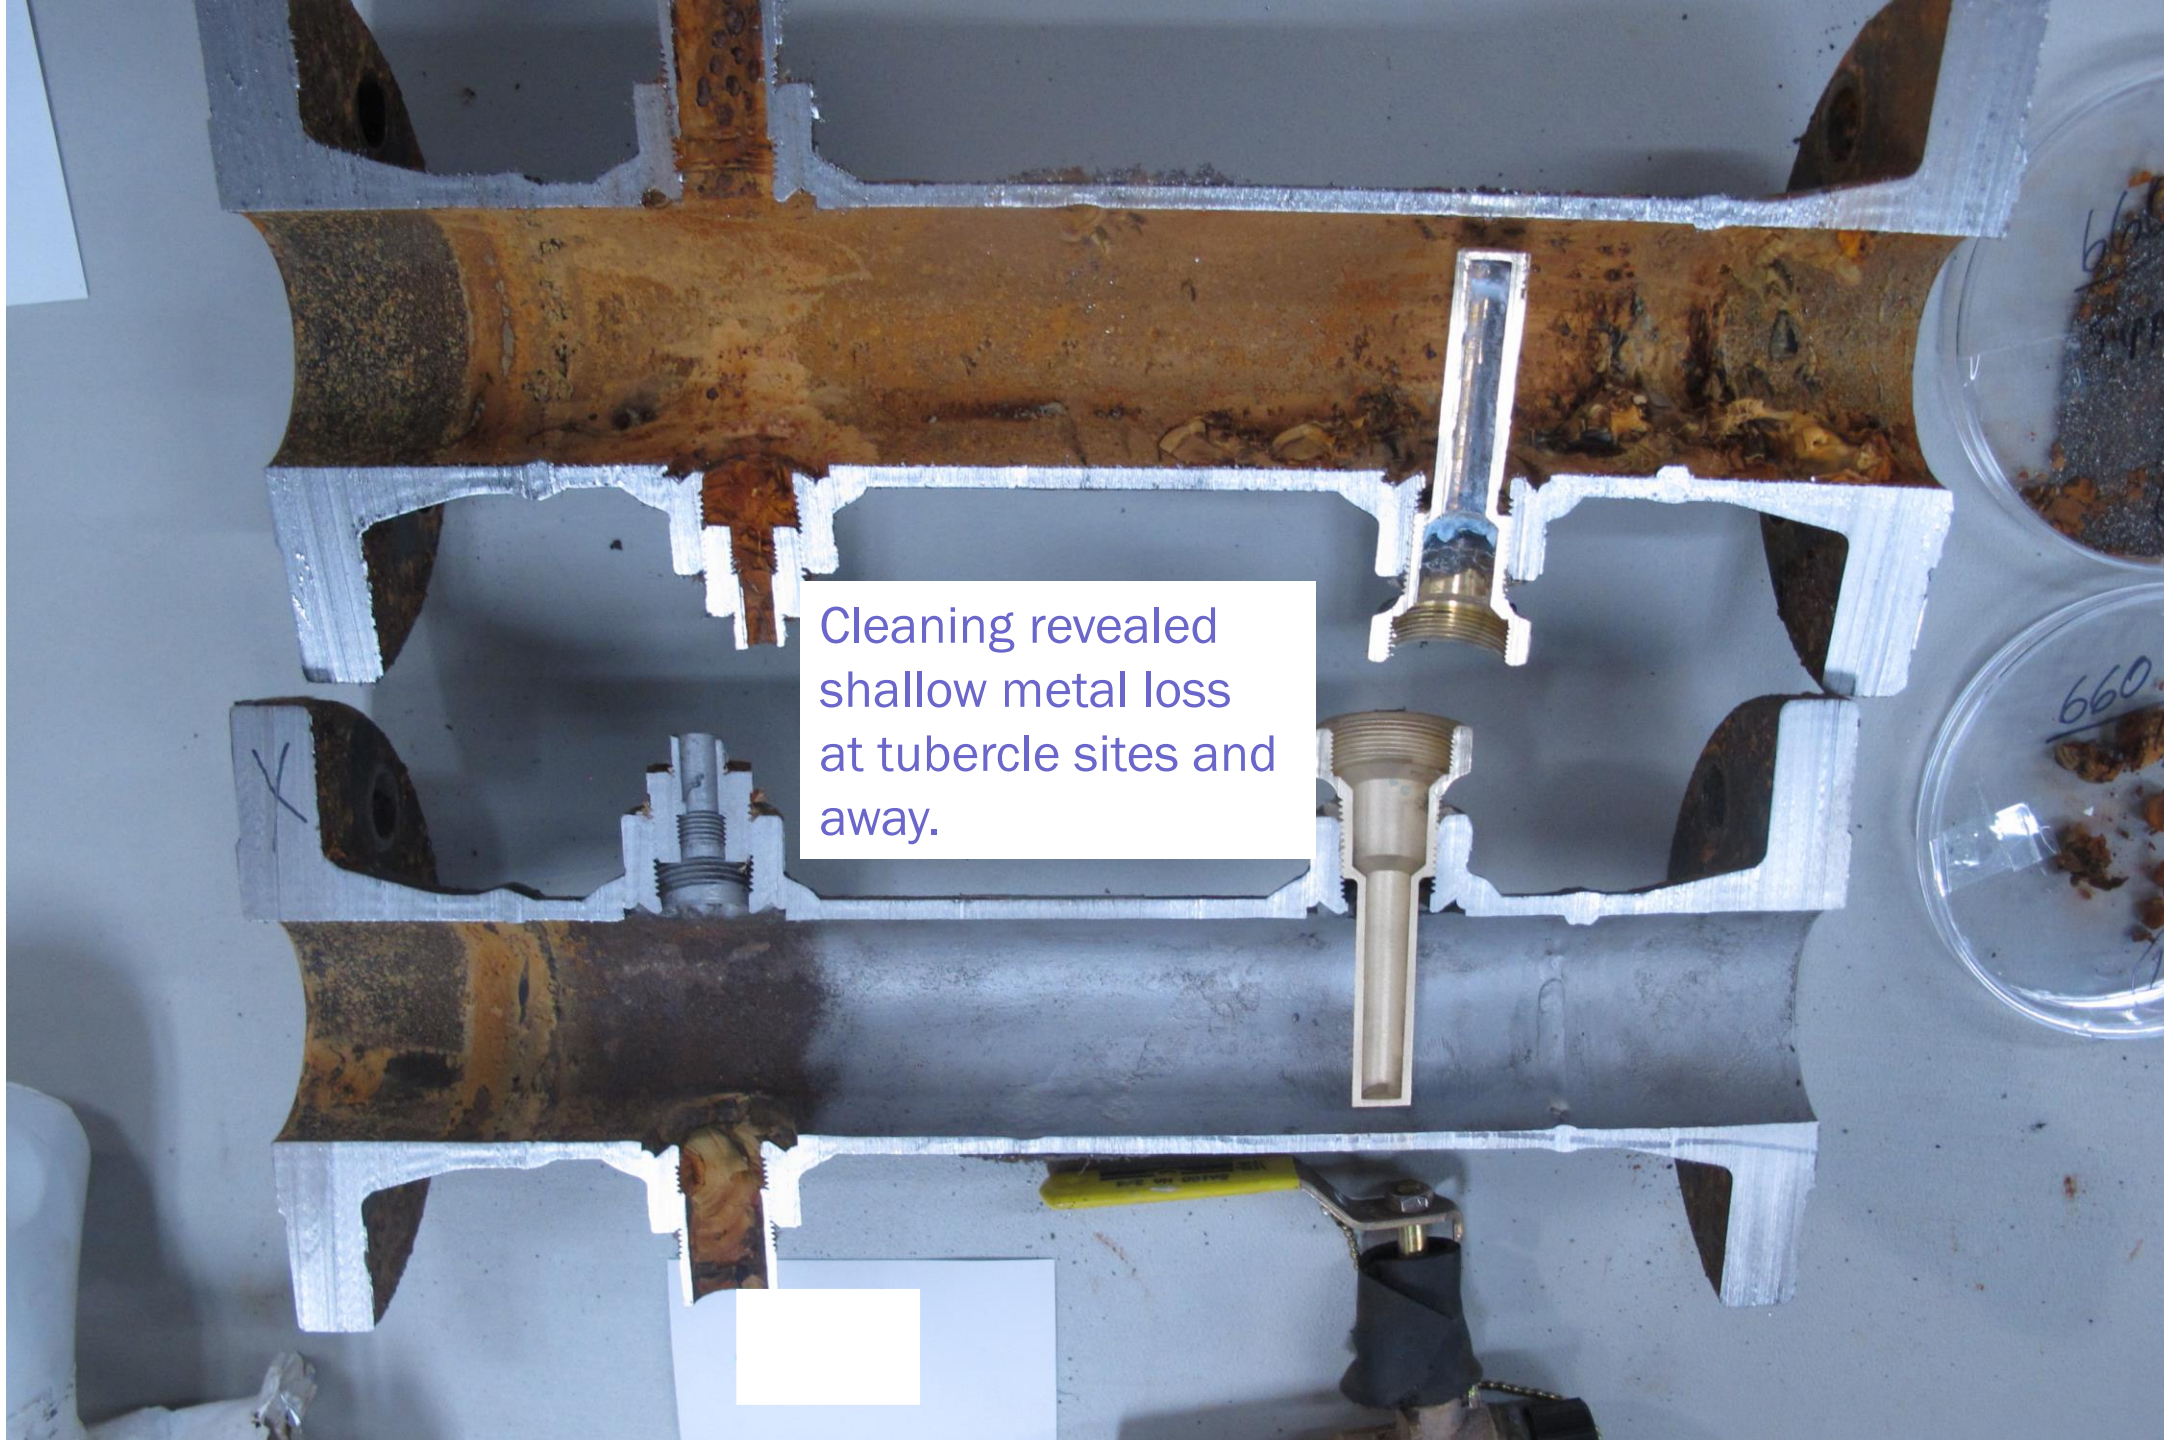
Cleaning revealed
shallow metal loss
at tubercle sites and
away.

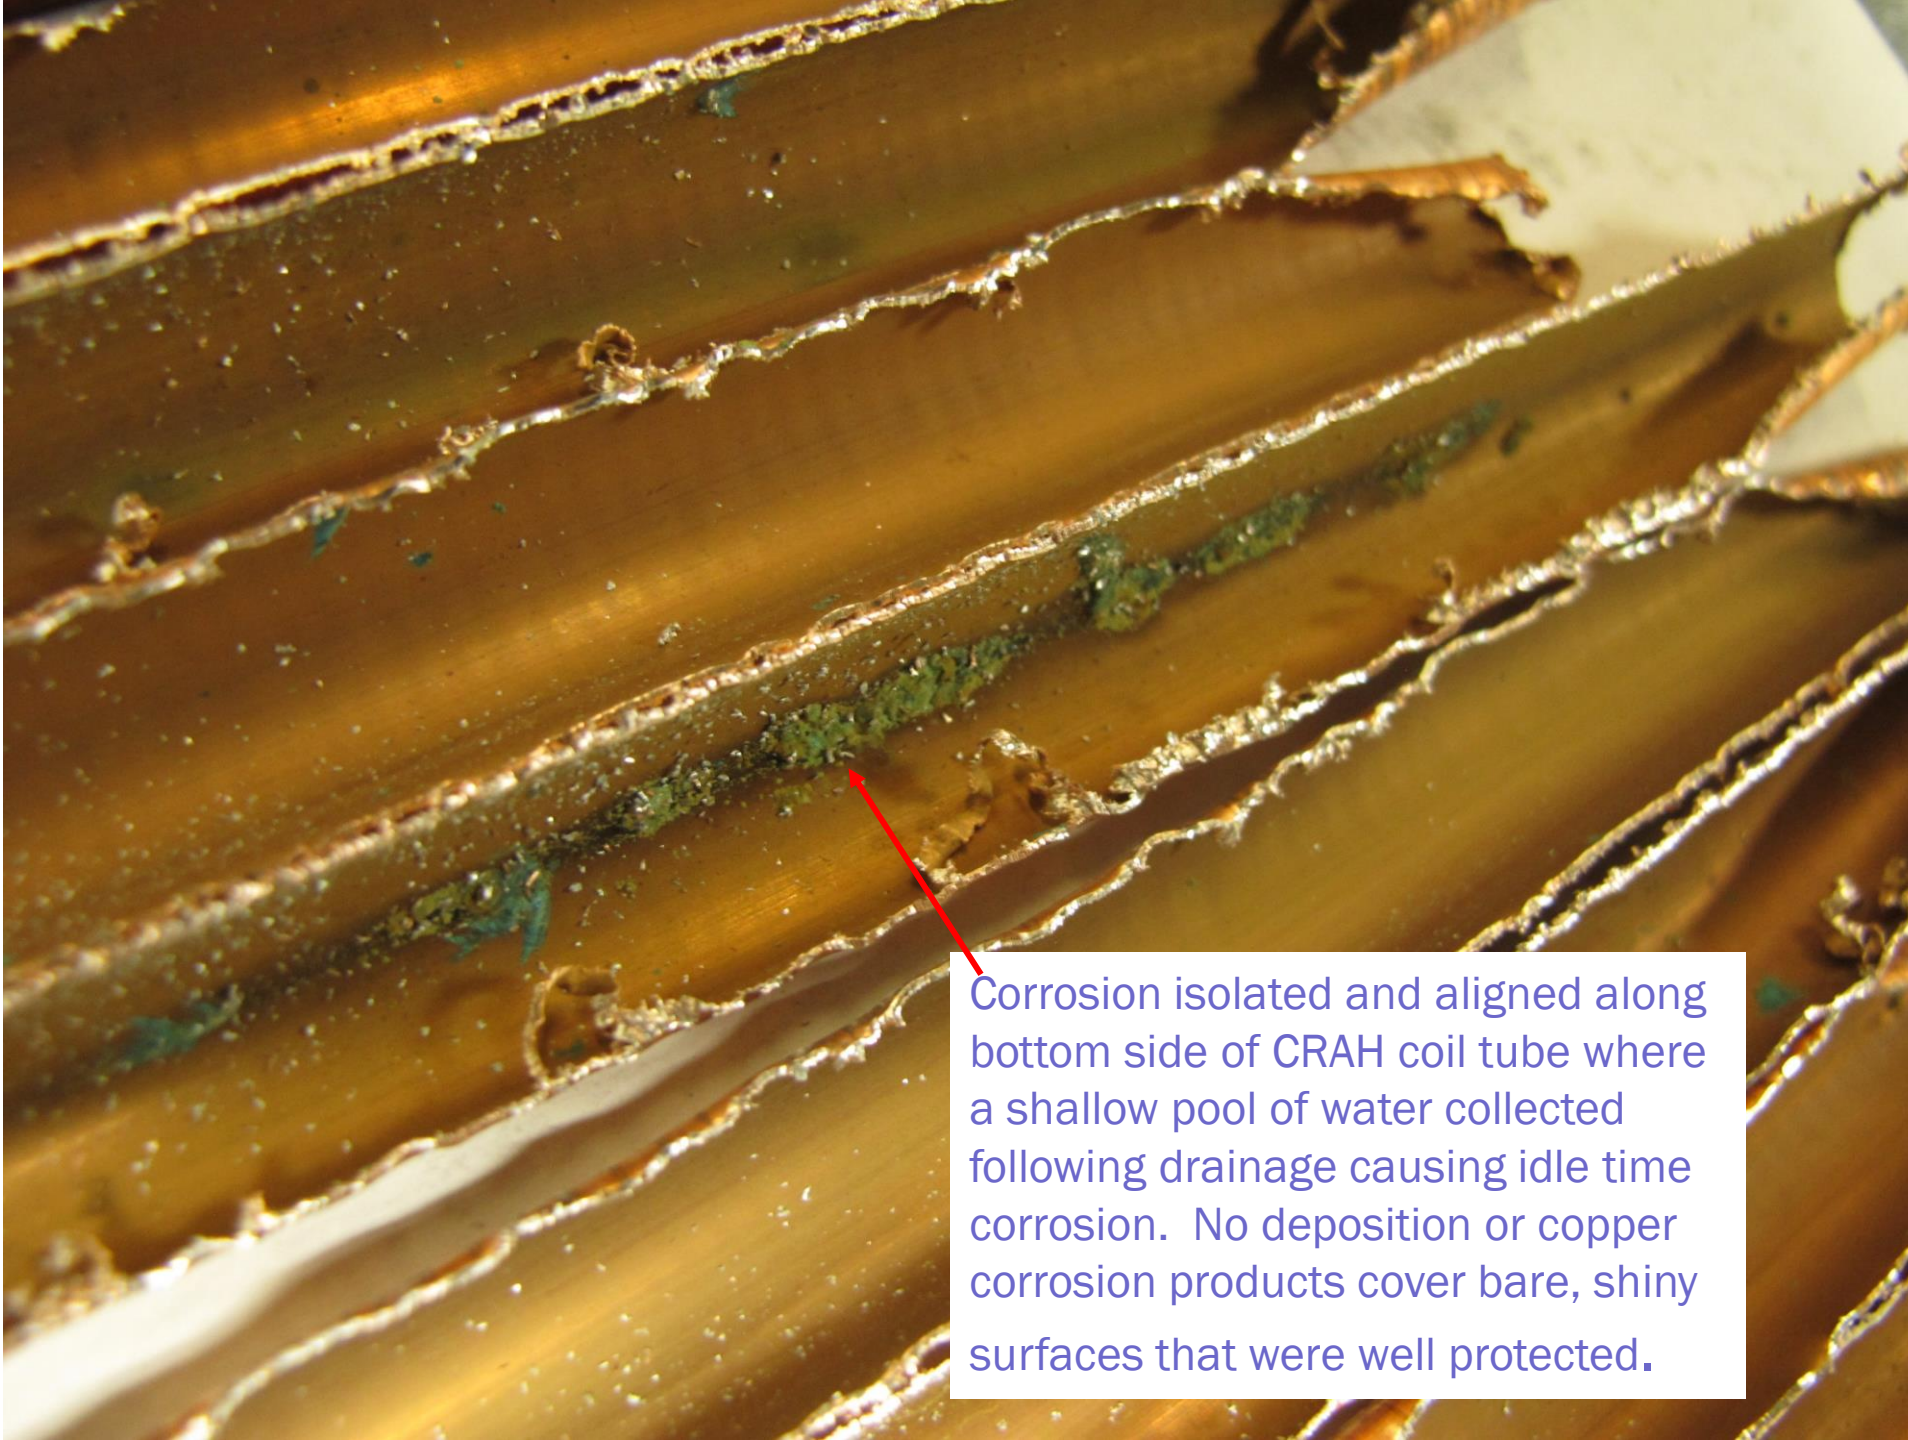
Corrosion isolated and aligned along bottom side of CRAH coil tube where a shallow pool of water collected following drainage causing idle time corrosion. No deposition or copper corrosion products cover bare, shiny surfaces that were well protected.

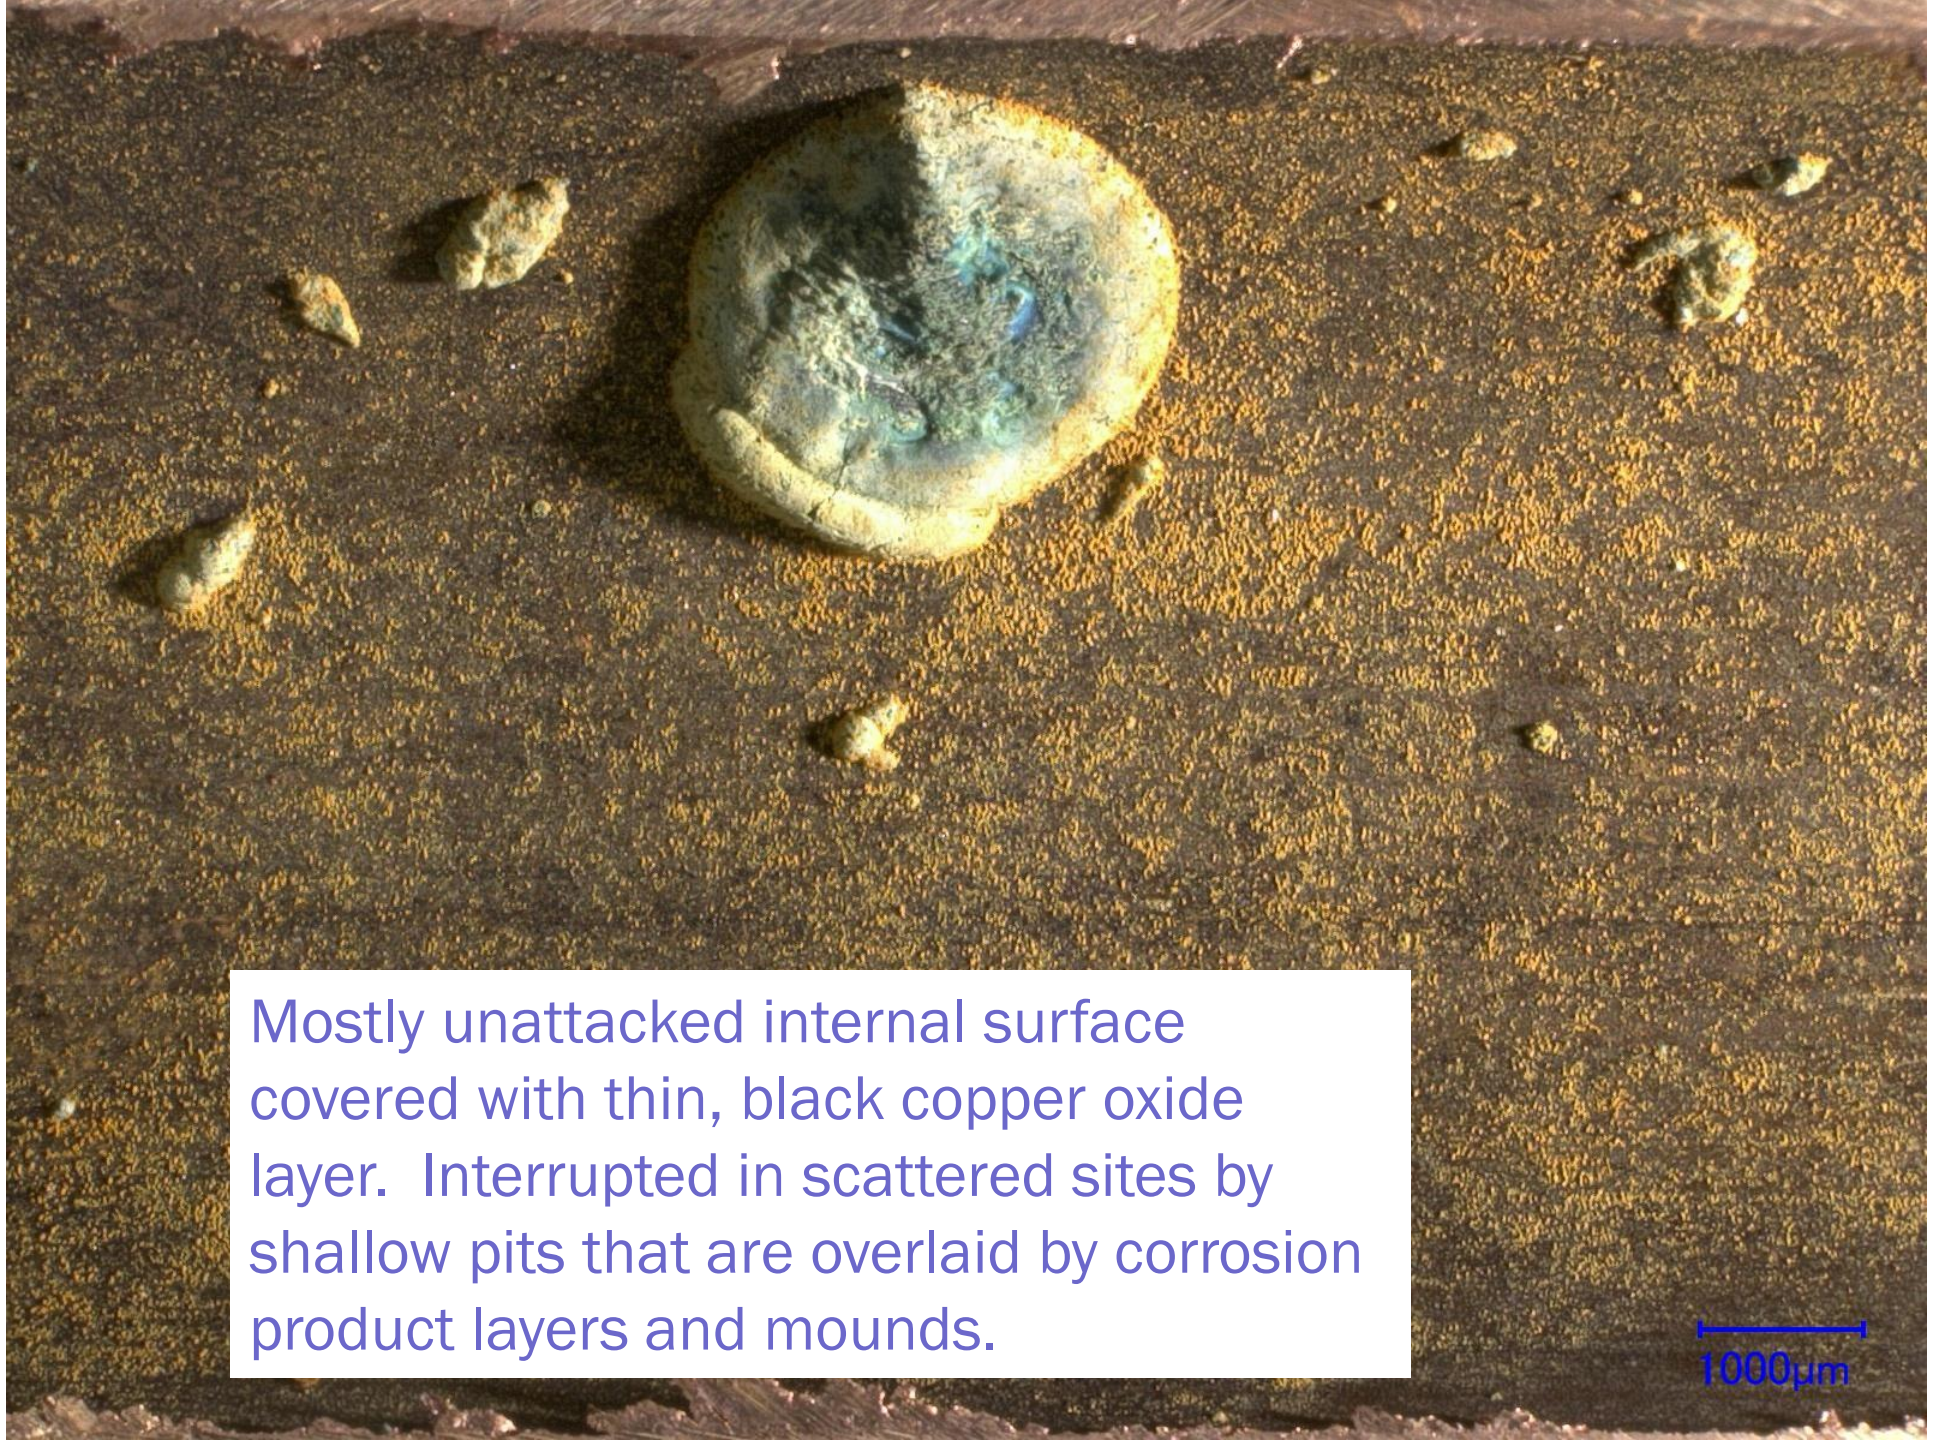
Mostly unattacked internal surface covered with thin, black copper oxide layer. Interrupted in scattered sites by shallow pits that are overlaid by corrosion product layers and mounds.
