Data Center Cooling System Failure

CRAH – Computer Room Air Handler Coils

Jim Dillon, Dorothy Collins and Philip Yu

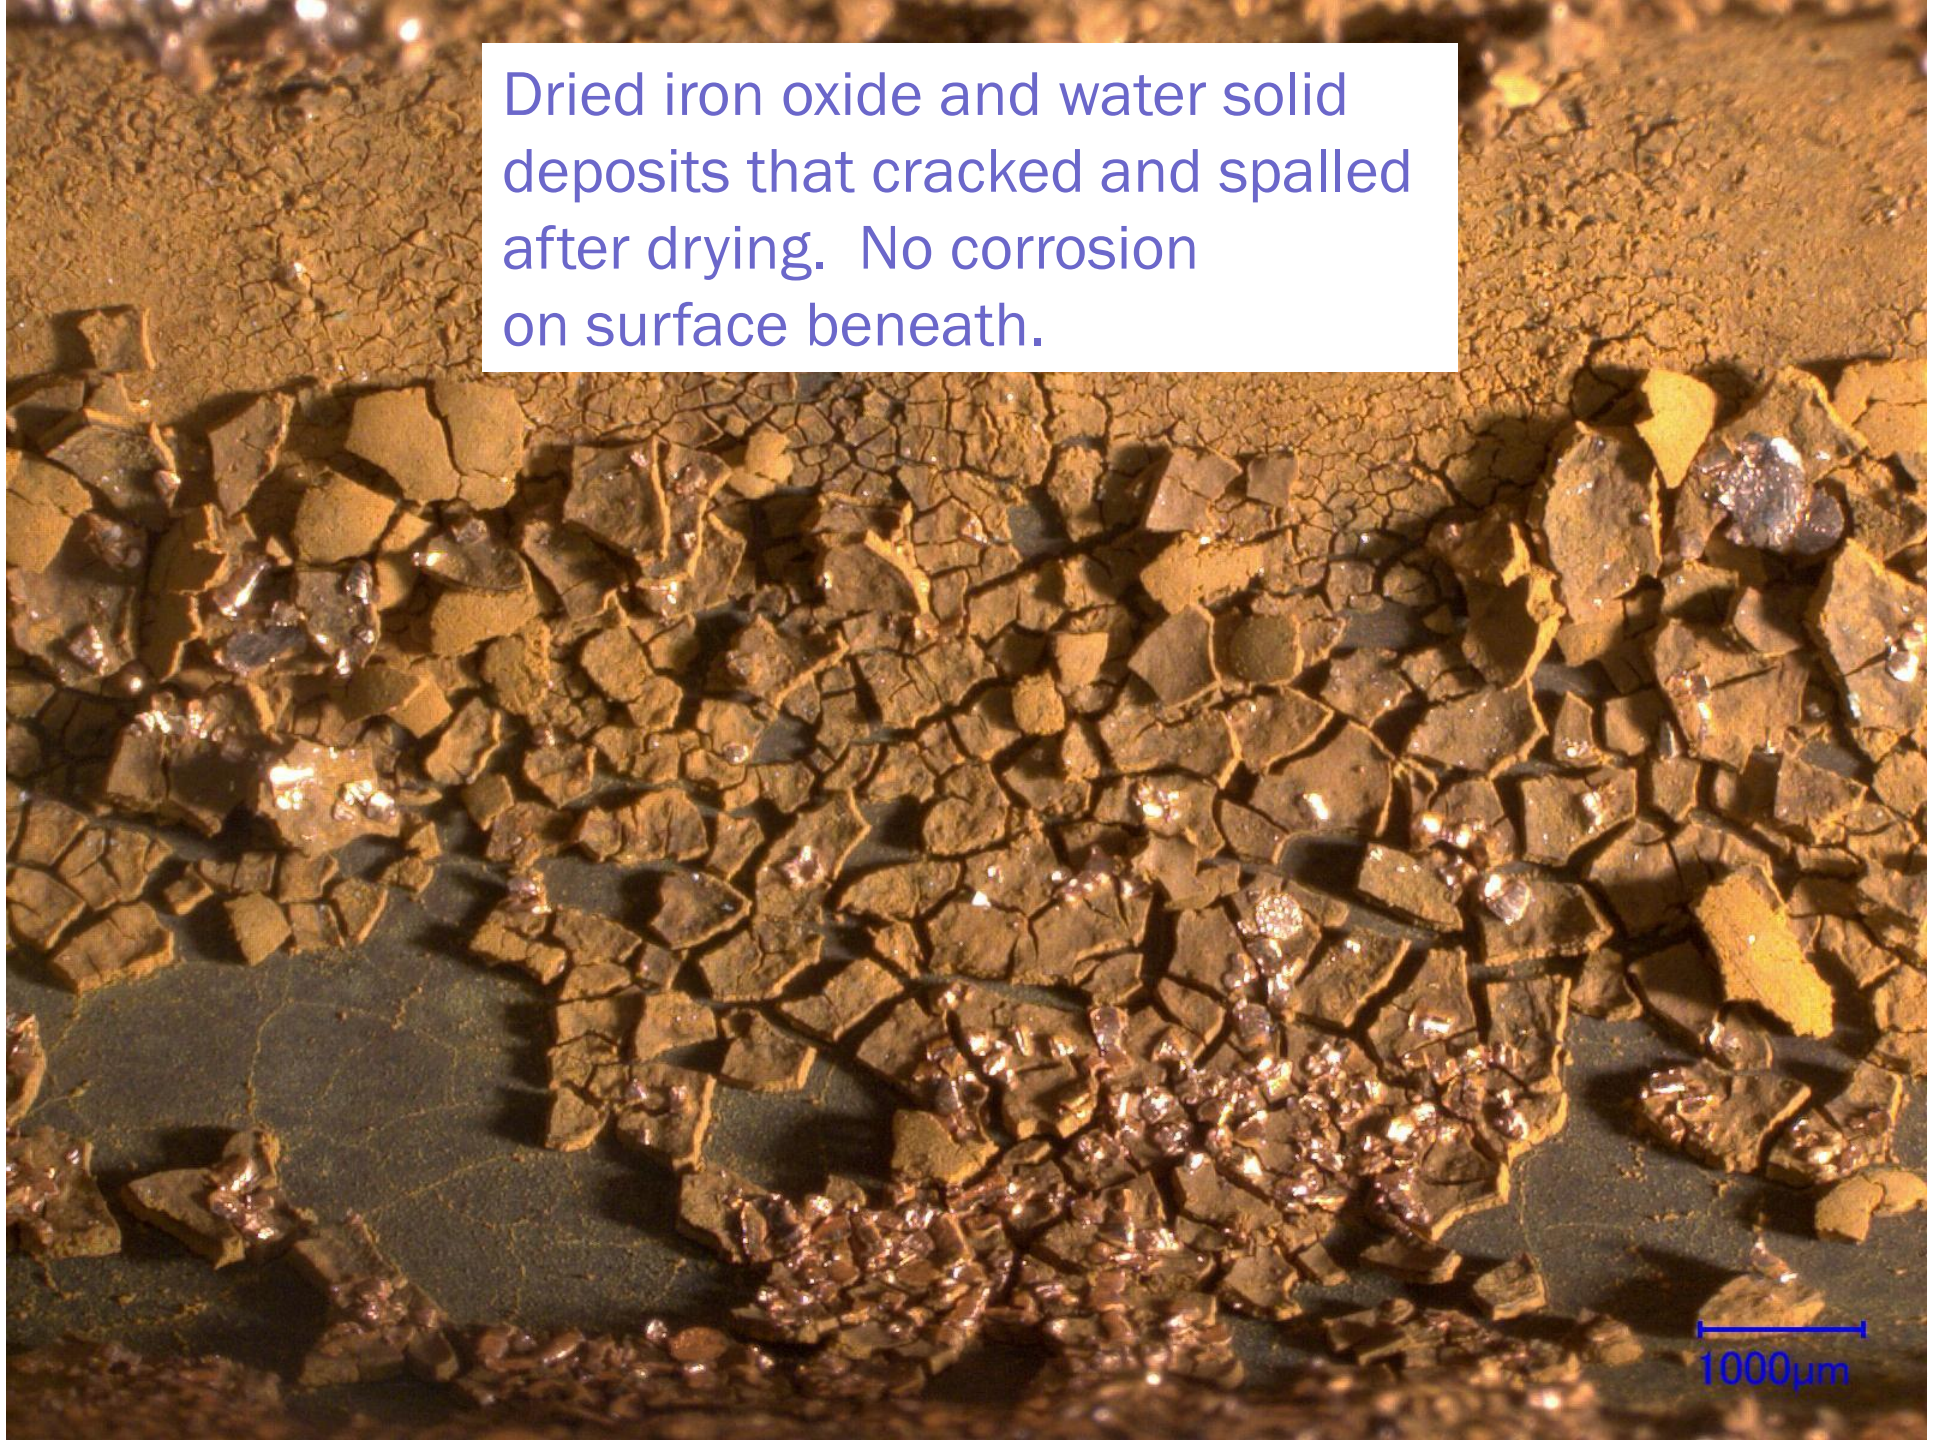
Dried iron oxide and water solid deposits that cracked and spalled after drying. No corrosion on surface beneath.

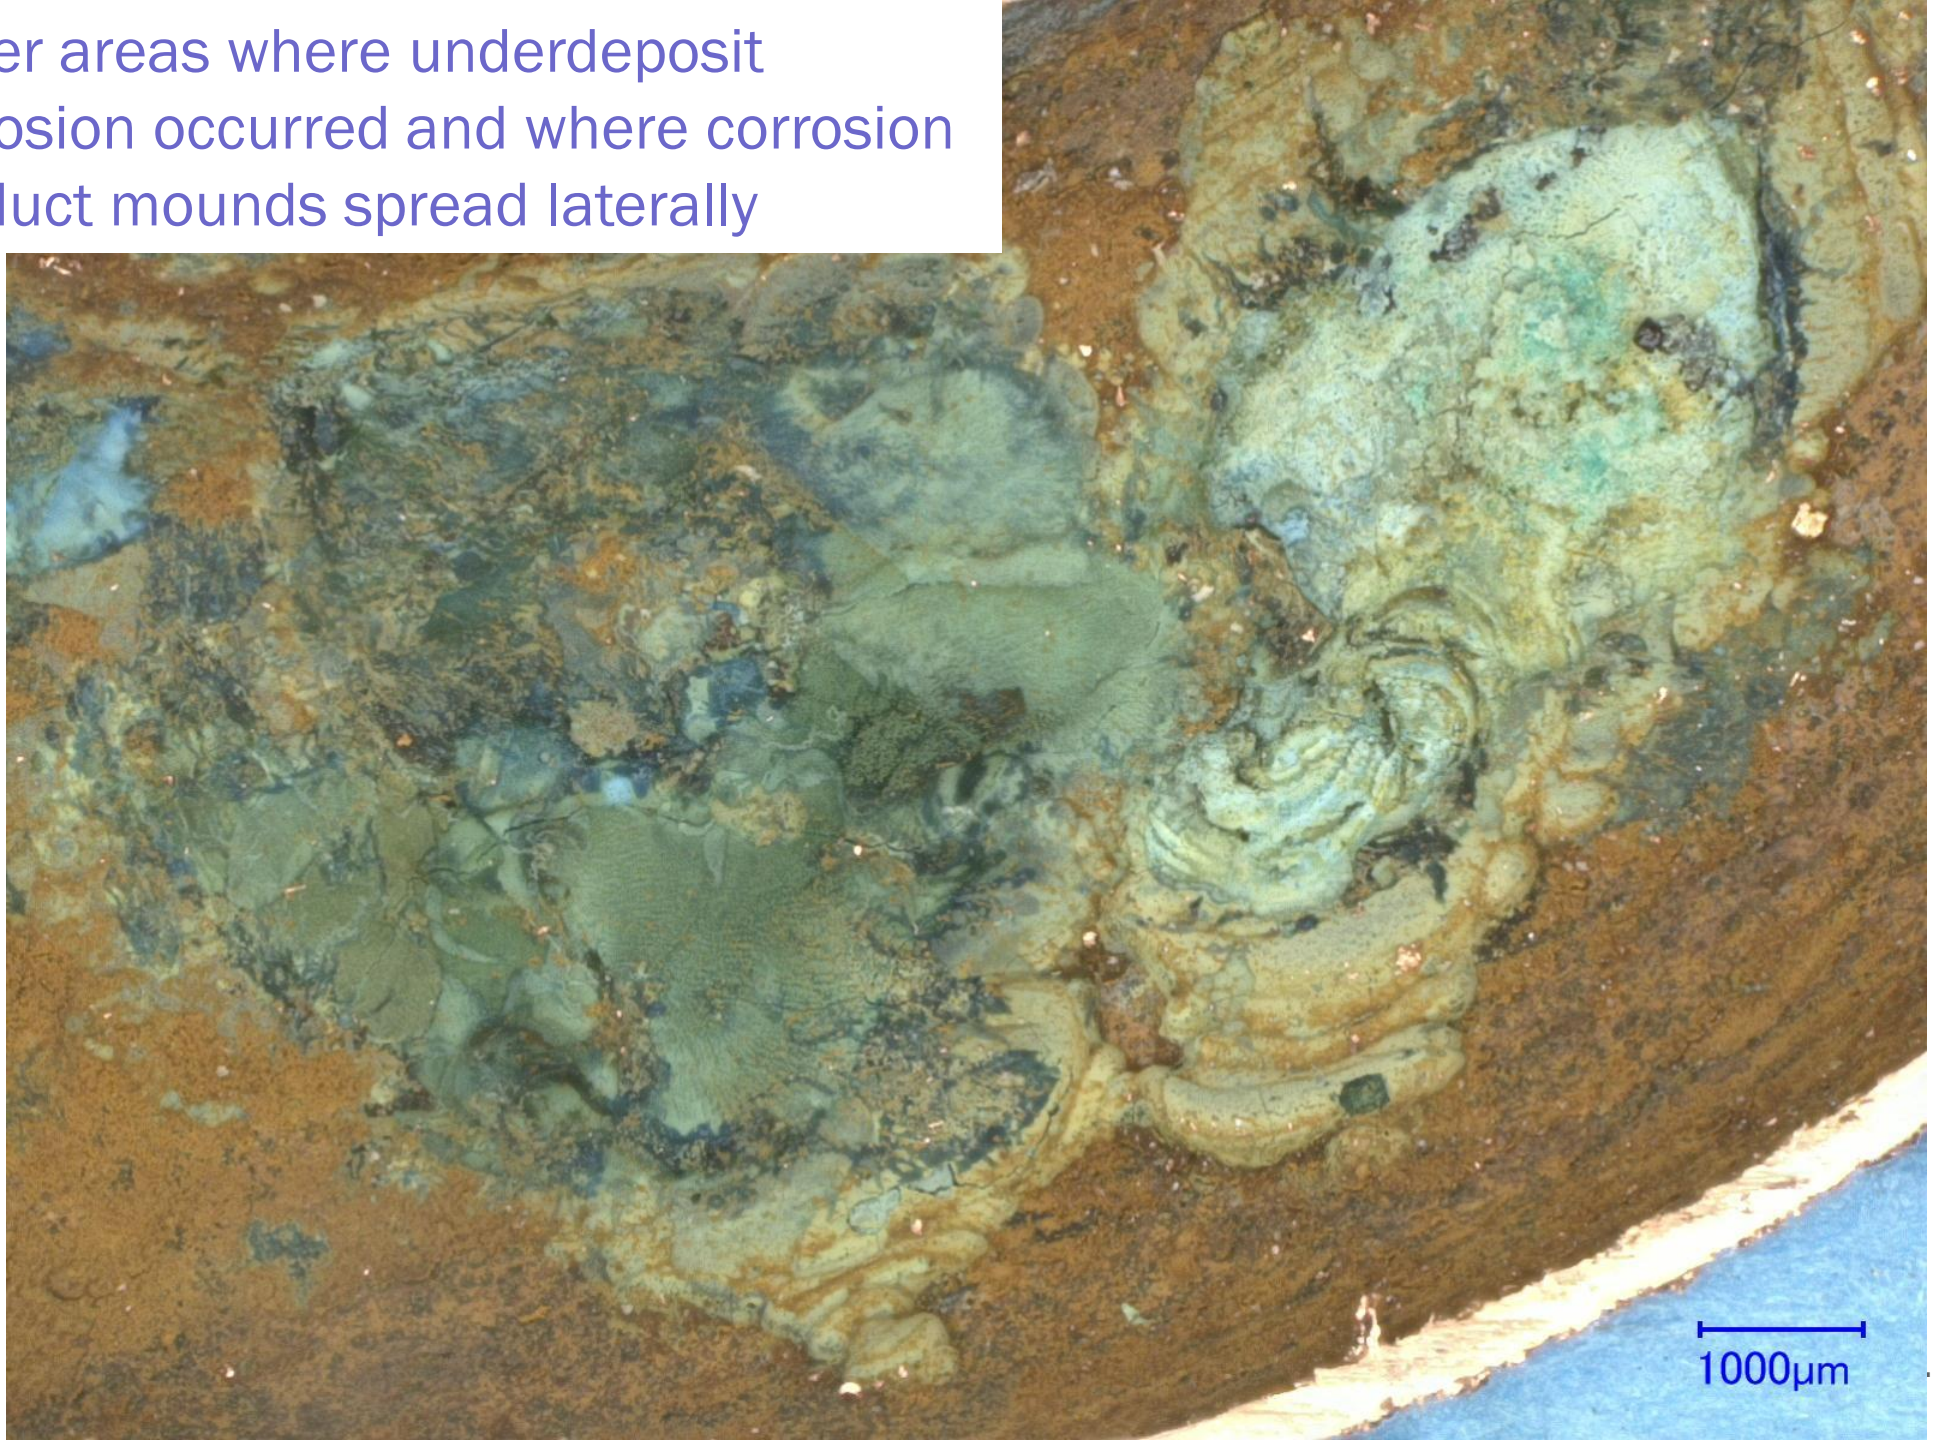
Wider areas where underdeposit corrosion occurred and where corrosion product mounds spread laterally

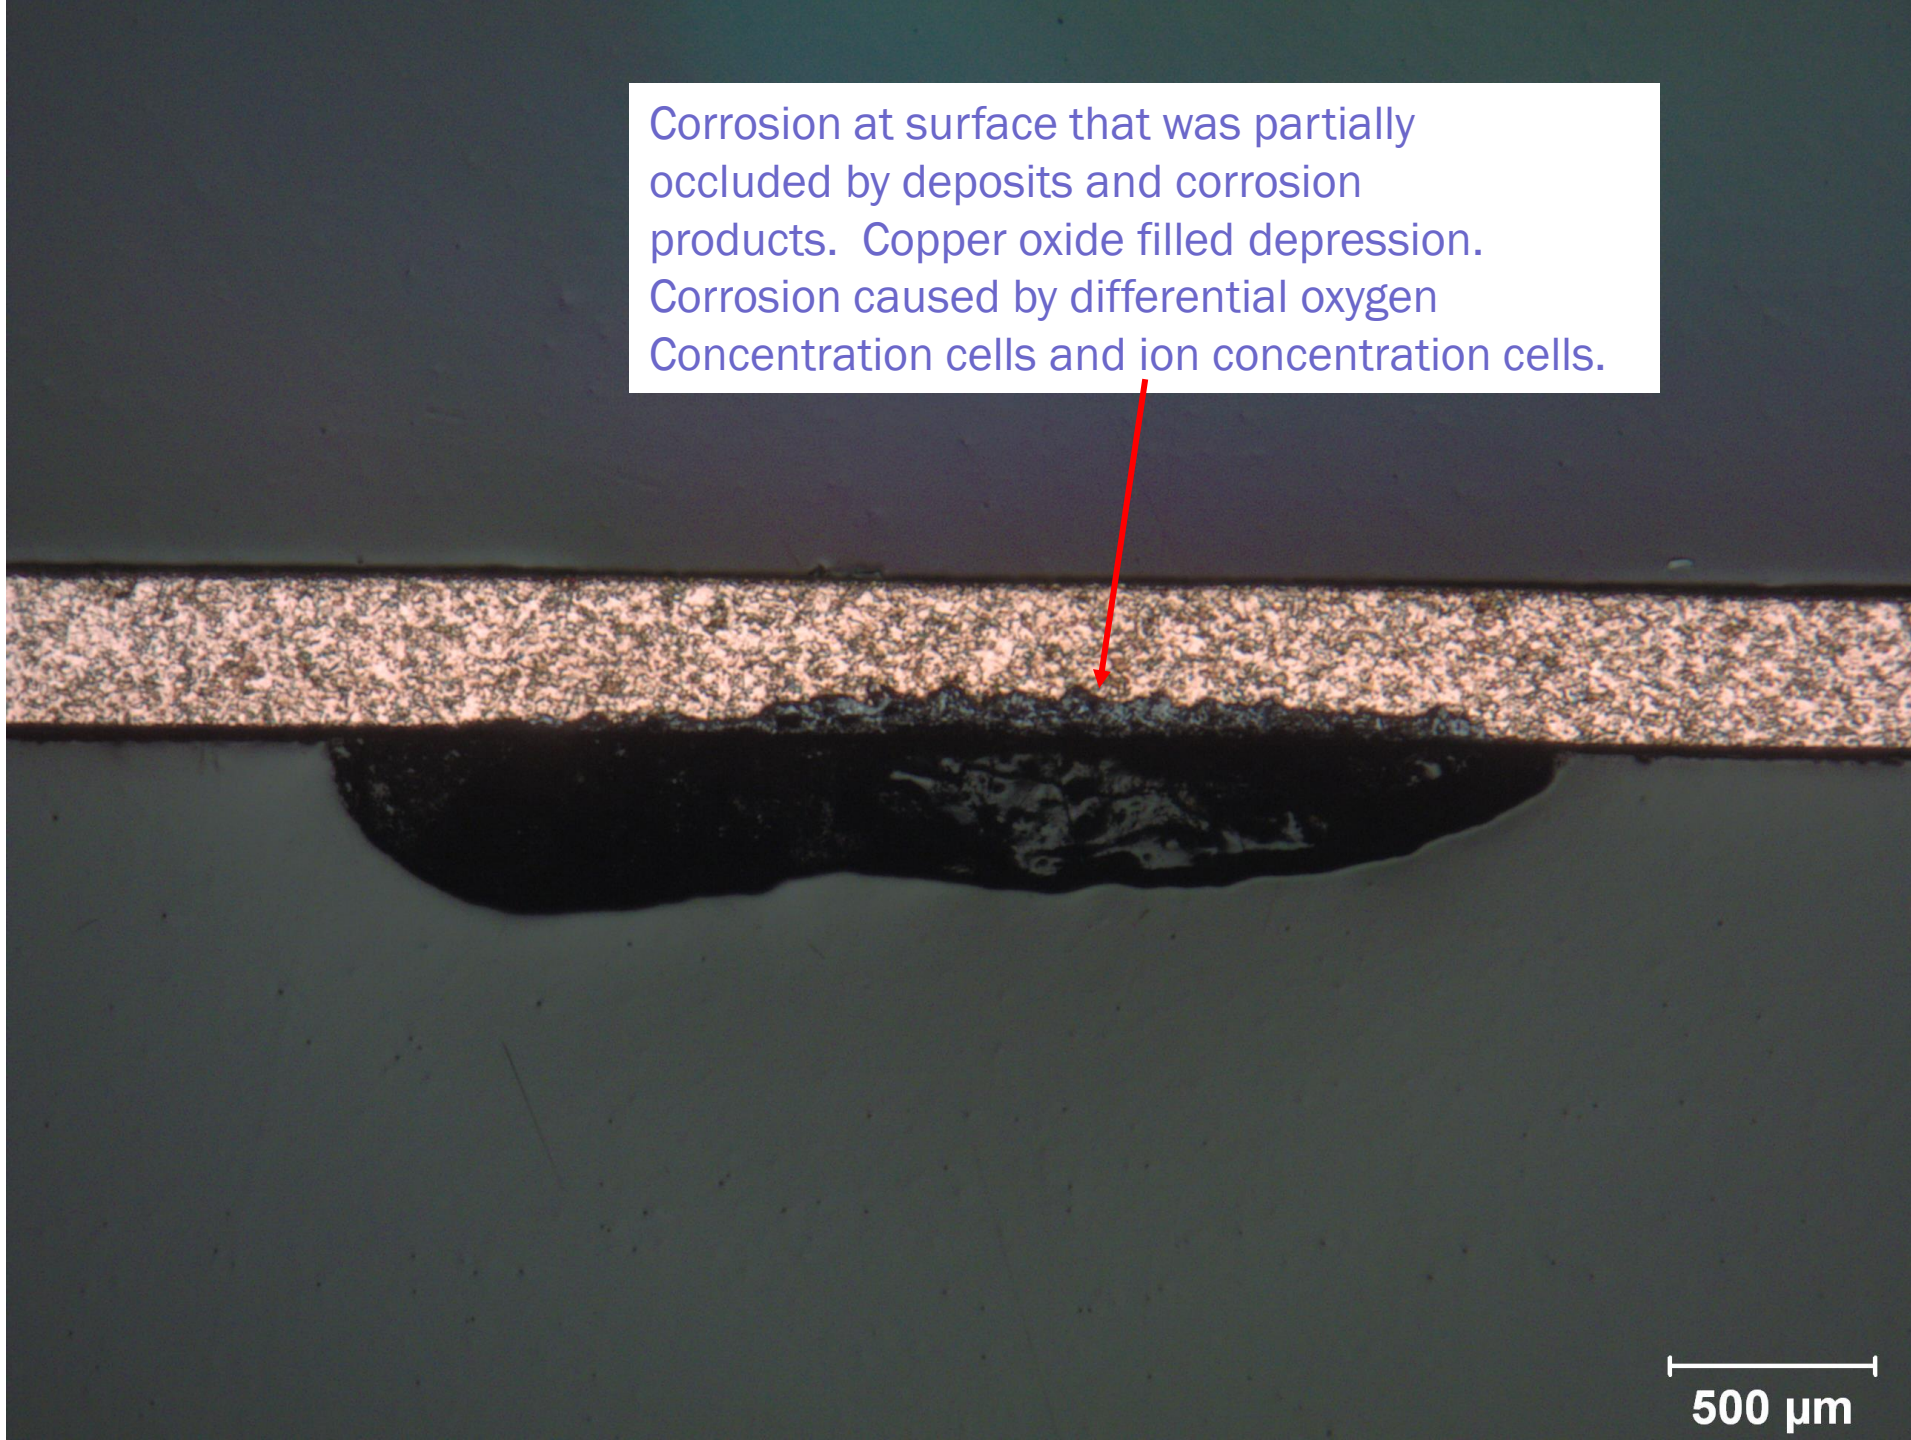
Corrosion at surface that was partially
occluded by deposits and corrosion
products. Copper oxide filled depression.
Corrosion caused by differential oxygen
Concentration cells and ion concentration cells.

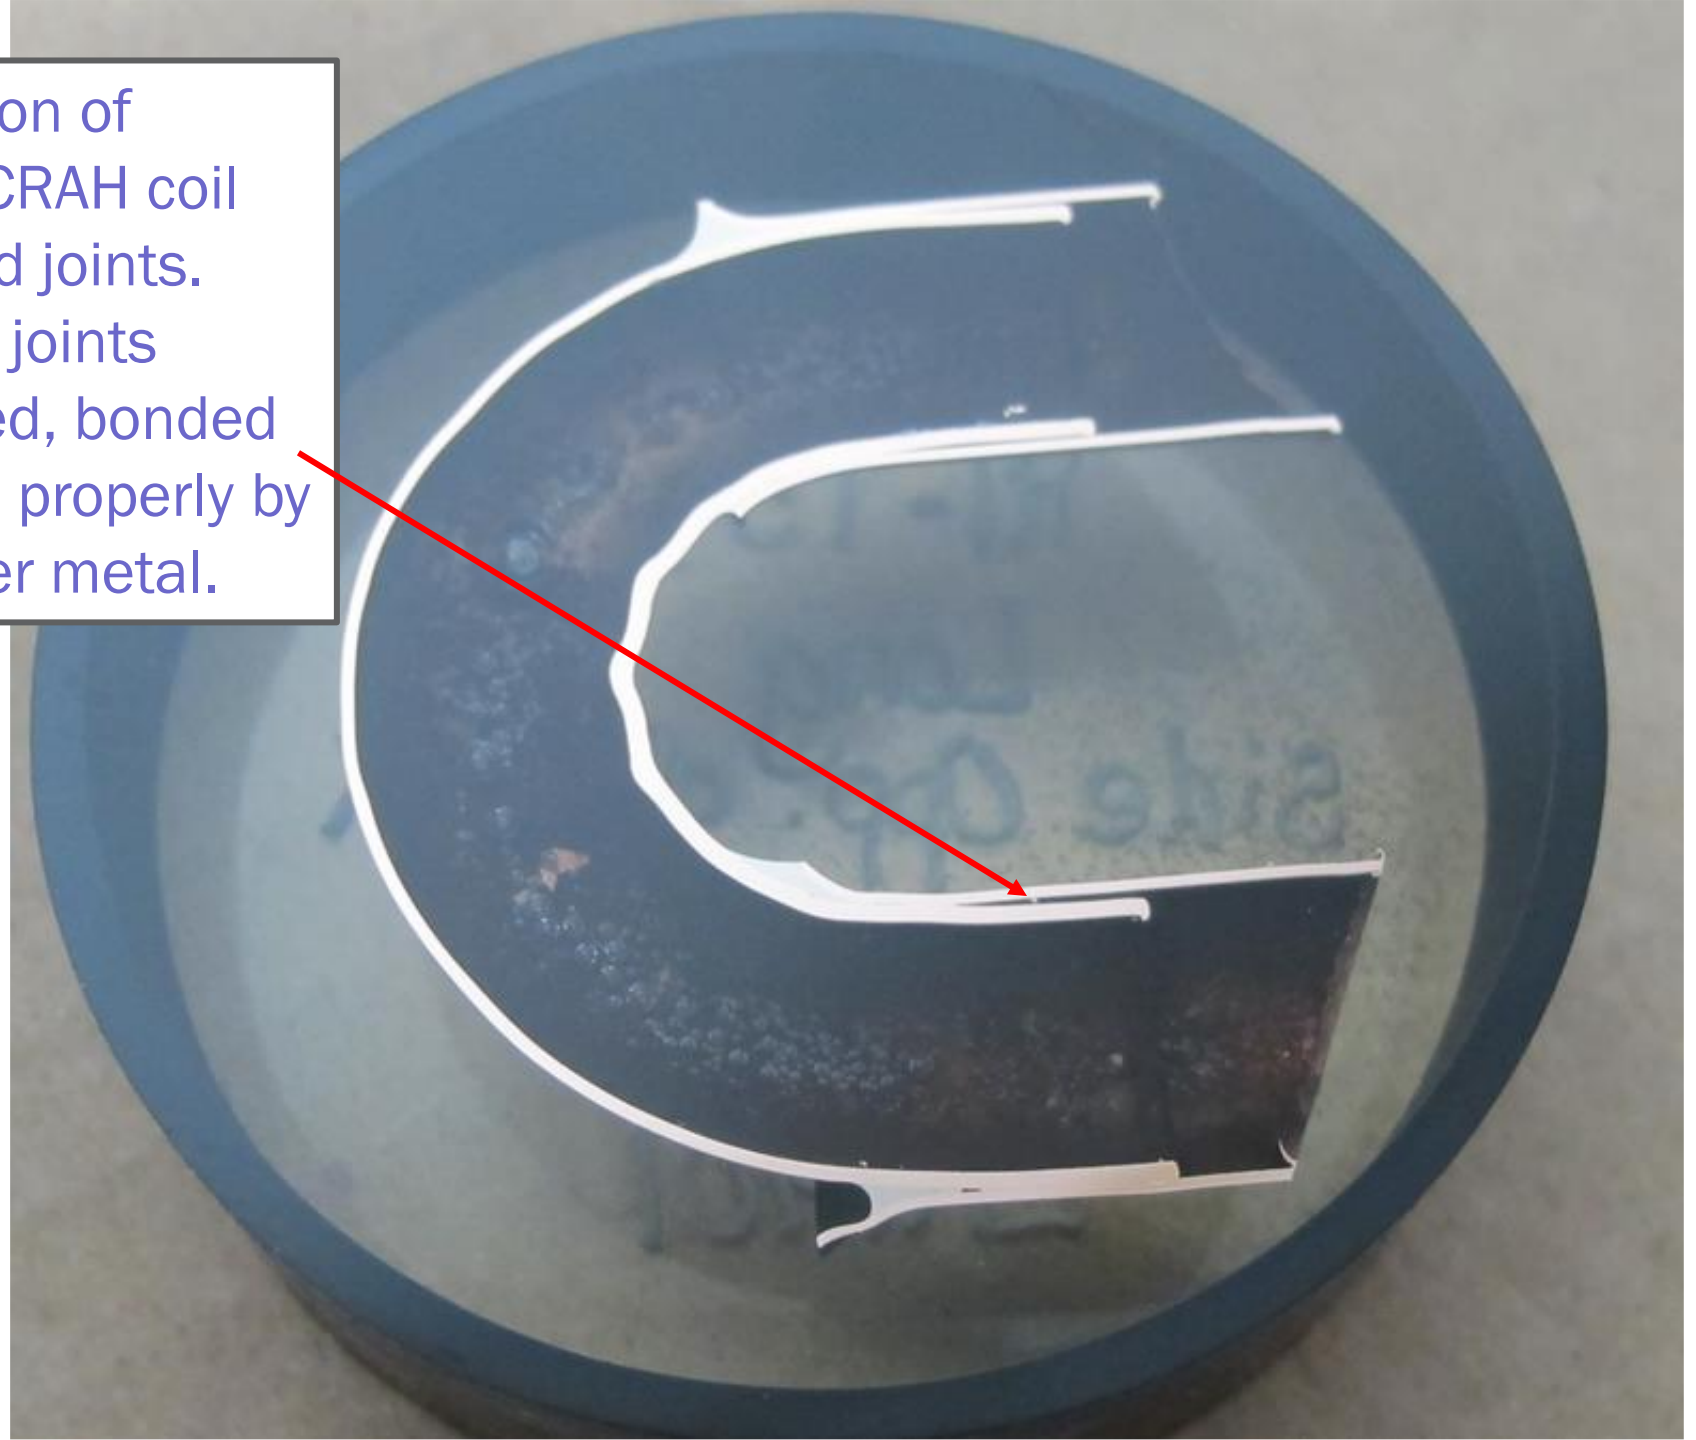
Cross-section of
U-bend to CRAH coil
tube brazed joints.
Portions of joints
are not filled, bonded
and sealed properly by
brazing filler metal.

Ideal gap width for brazed joints is 0.001-0.003" to promote wicking of molten filler metal into joint. The gaps here are greater at about 0.010", which promoted porosity.

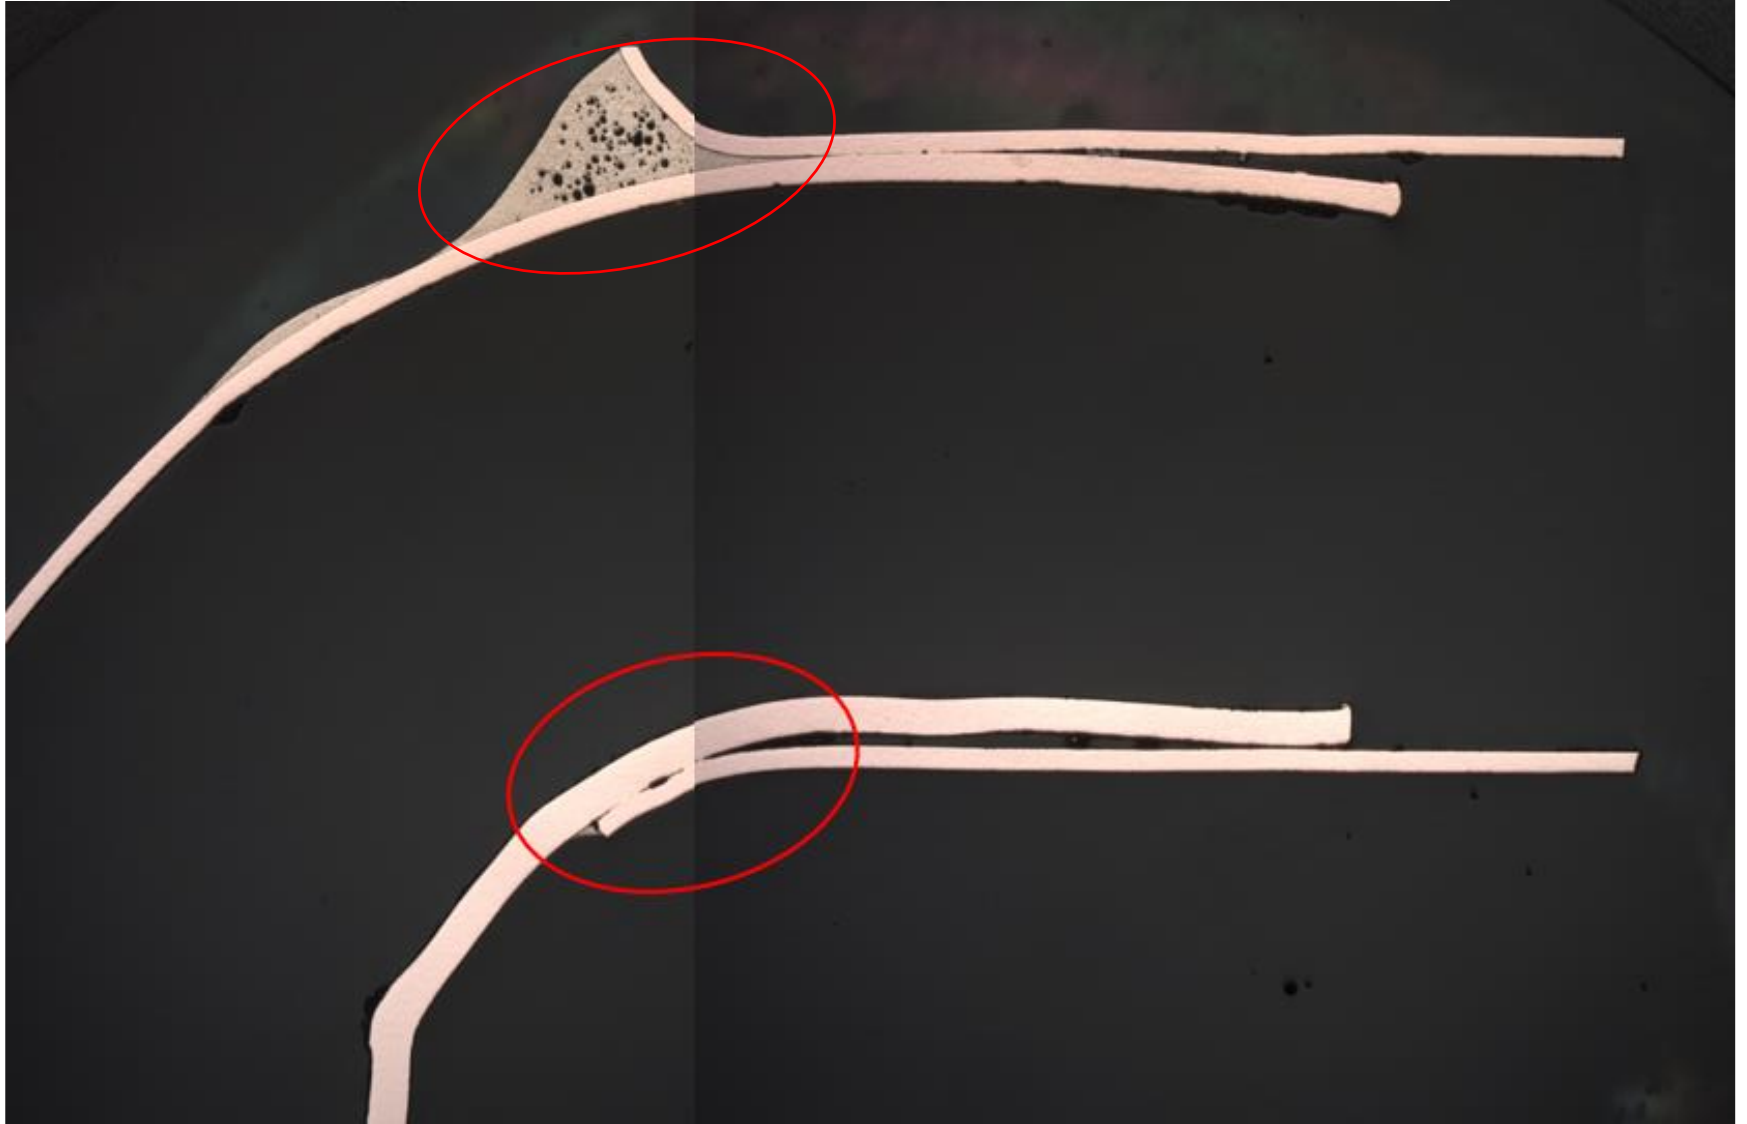
Misaligned Tight Joint

Brazing metal did not penetrate and seal the joint. Braze metal only sealed joint outside of the gap in circled locations.

Poor fitup weakened the joint. The bend should be installed deeper into the tube end and be filled with braze metal.

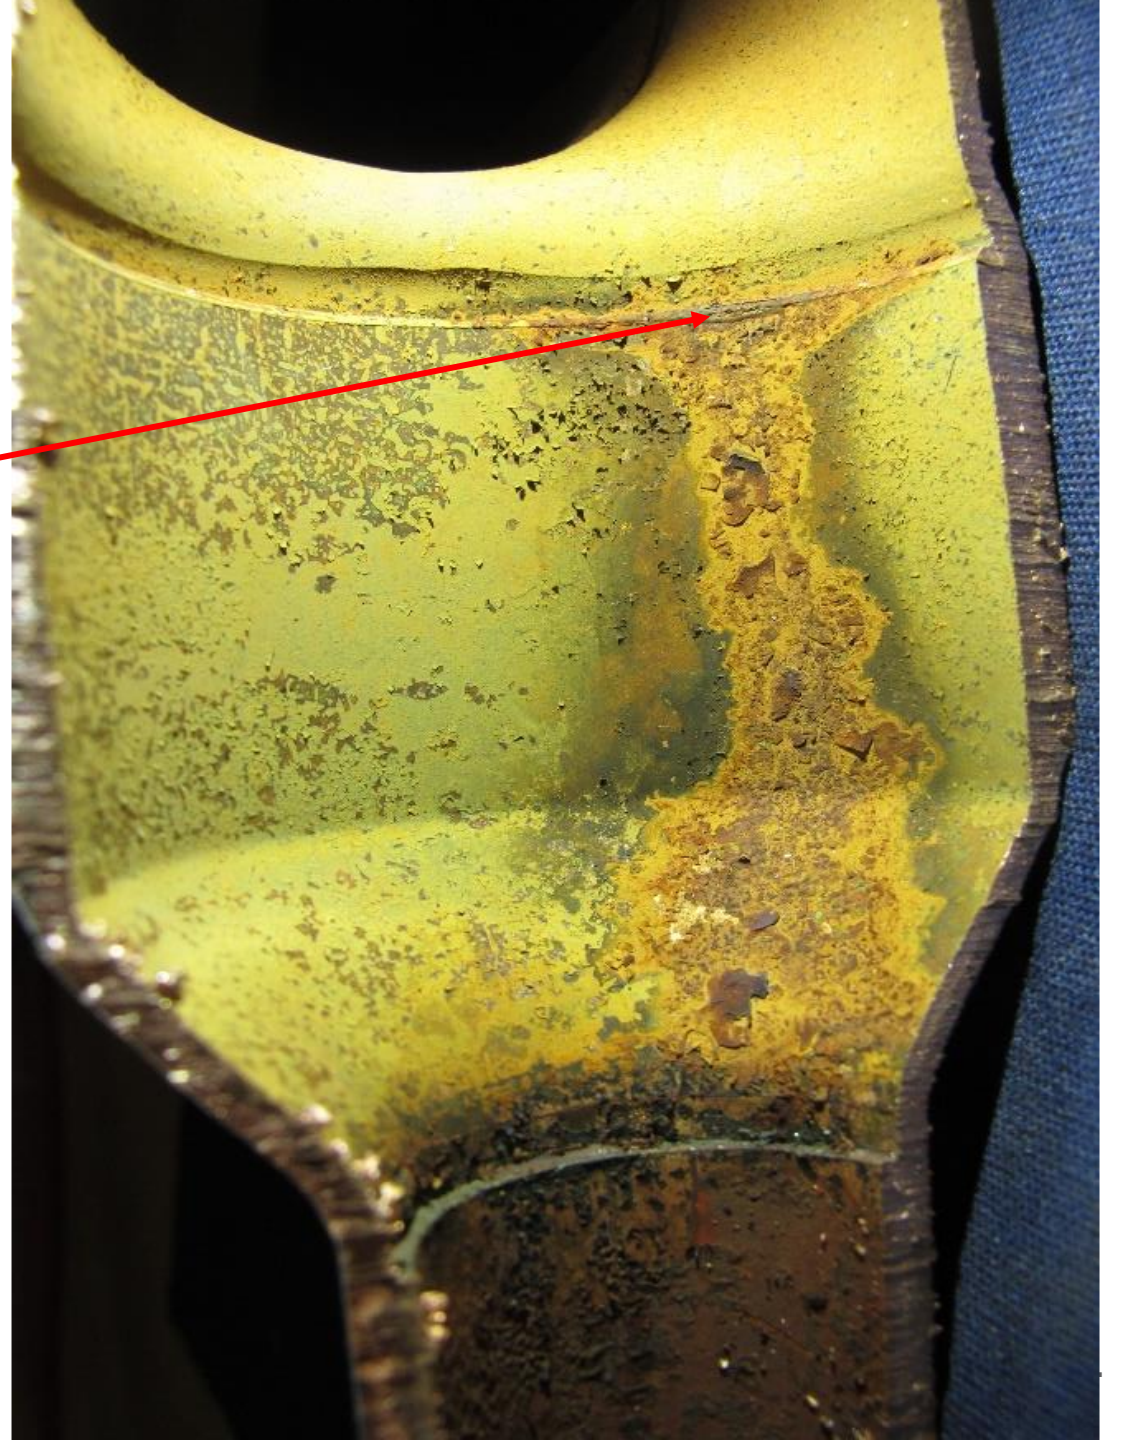
- Vertically oriented brazed header joint where zinc chloride flux dripped downward from joint and corroded surfaces below.
- The header was not flushed immediately following brazing to remove residual corrosive flux.

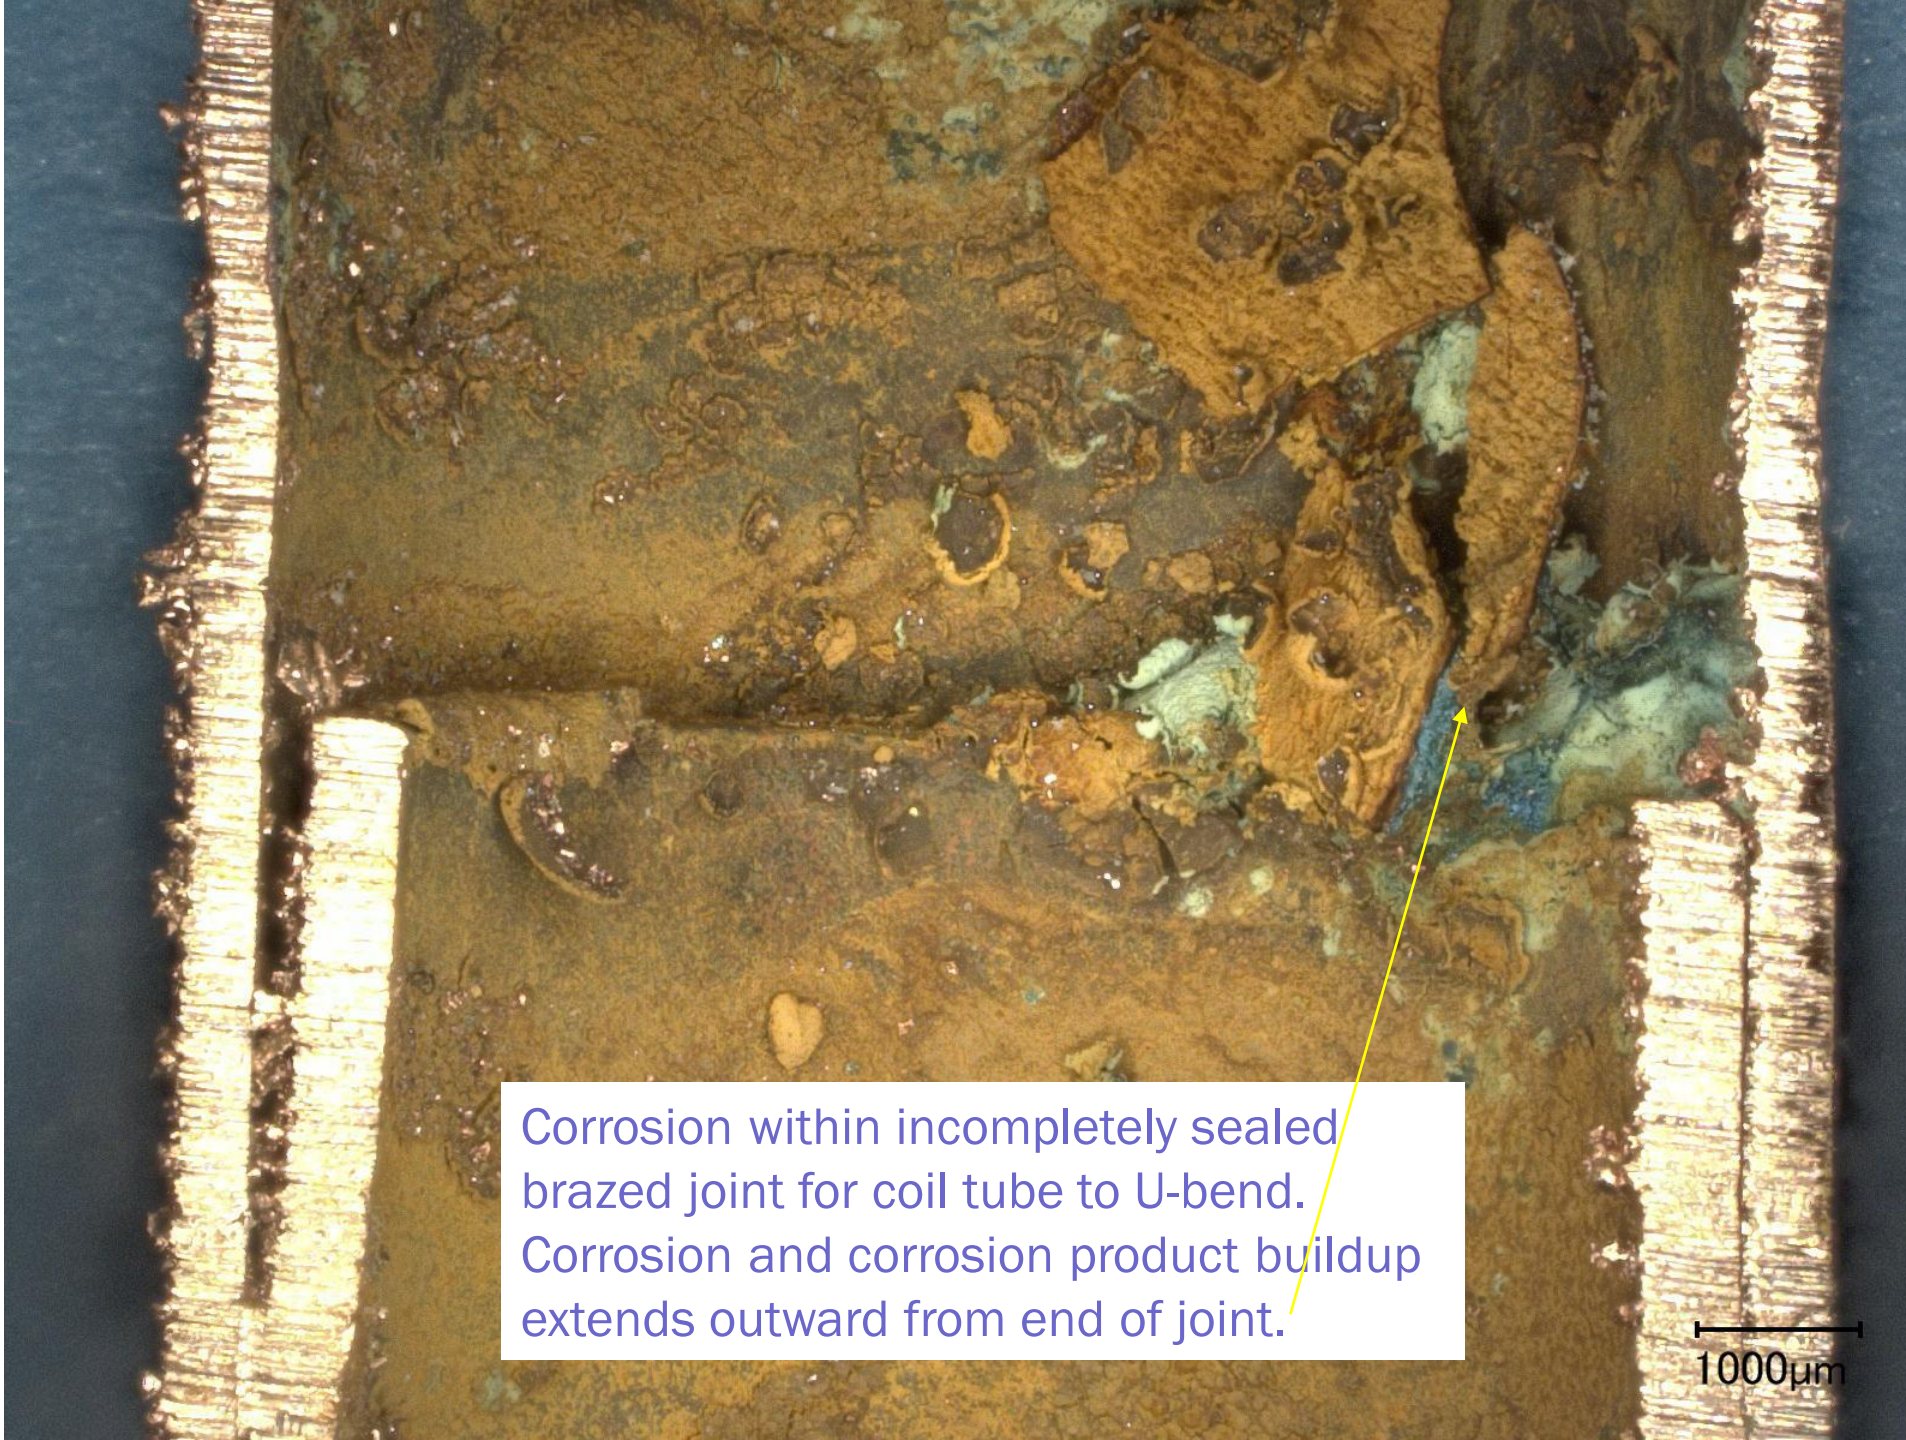
Corrosion within incompletely sealed
brazed joint for coil tube to U-bend.
Corrosion and corrosion product buildup
extends outward from end of joint.

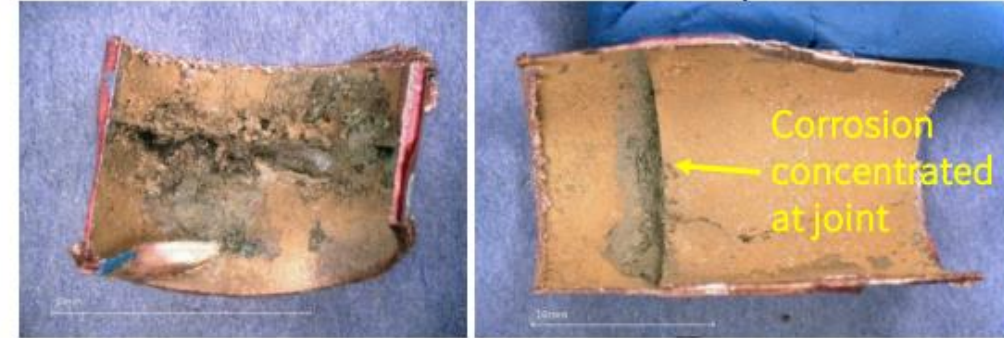
Corrosion on Interior of Pipe

- The accelerated corrosion in the unit analyzed was likely caused by crevices at the straight pipe / U-bend connections in conjunction with the presence of corrosive species in the environment.

- This conclusion was based on the following factors:
 - On the interior of the pipes, the corrosion was concentrated around the straight pipe / U-bend connections.

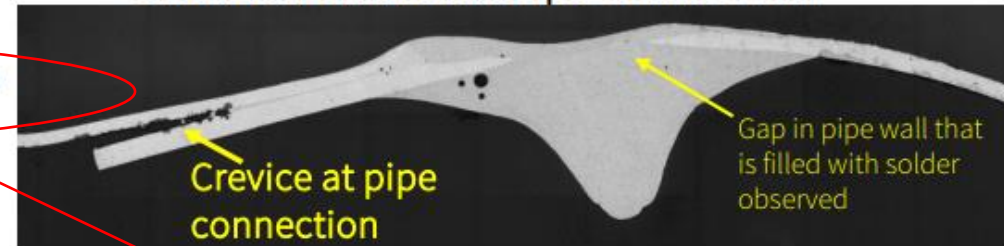
Observed Crevice at Pipe Connection

- Crevices were observed at these connections.
 - Chlorine and sulfur detected by EDS around the crevices suggests that corrosive ions in the chilled water migrated into the crevices.

- Crevices can form at the pipe connections due to solder not filling the overlap region. A lack of solder fill may result from:
 - Insufficient or incomplete solder

- Pipe diameter gap being too large or too small
 - Pipe overlap region being too long

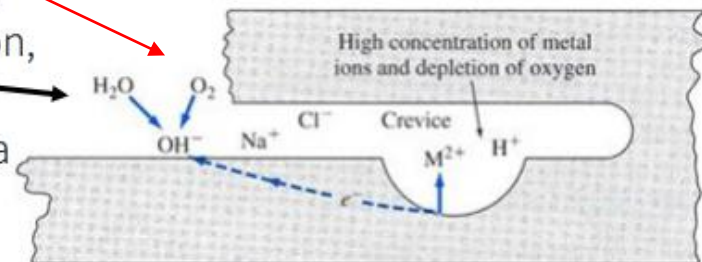
Crevices cause local stagnation, reduced inhibitor, and a buildup of ion species.

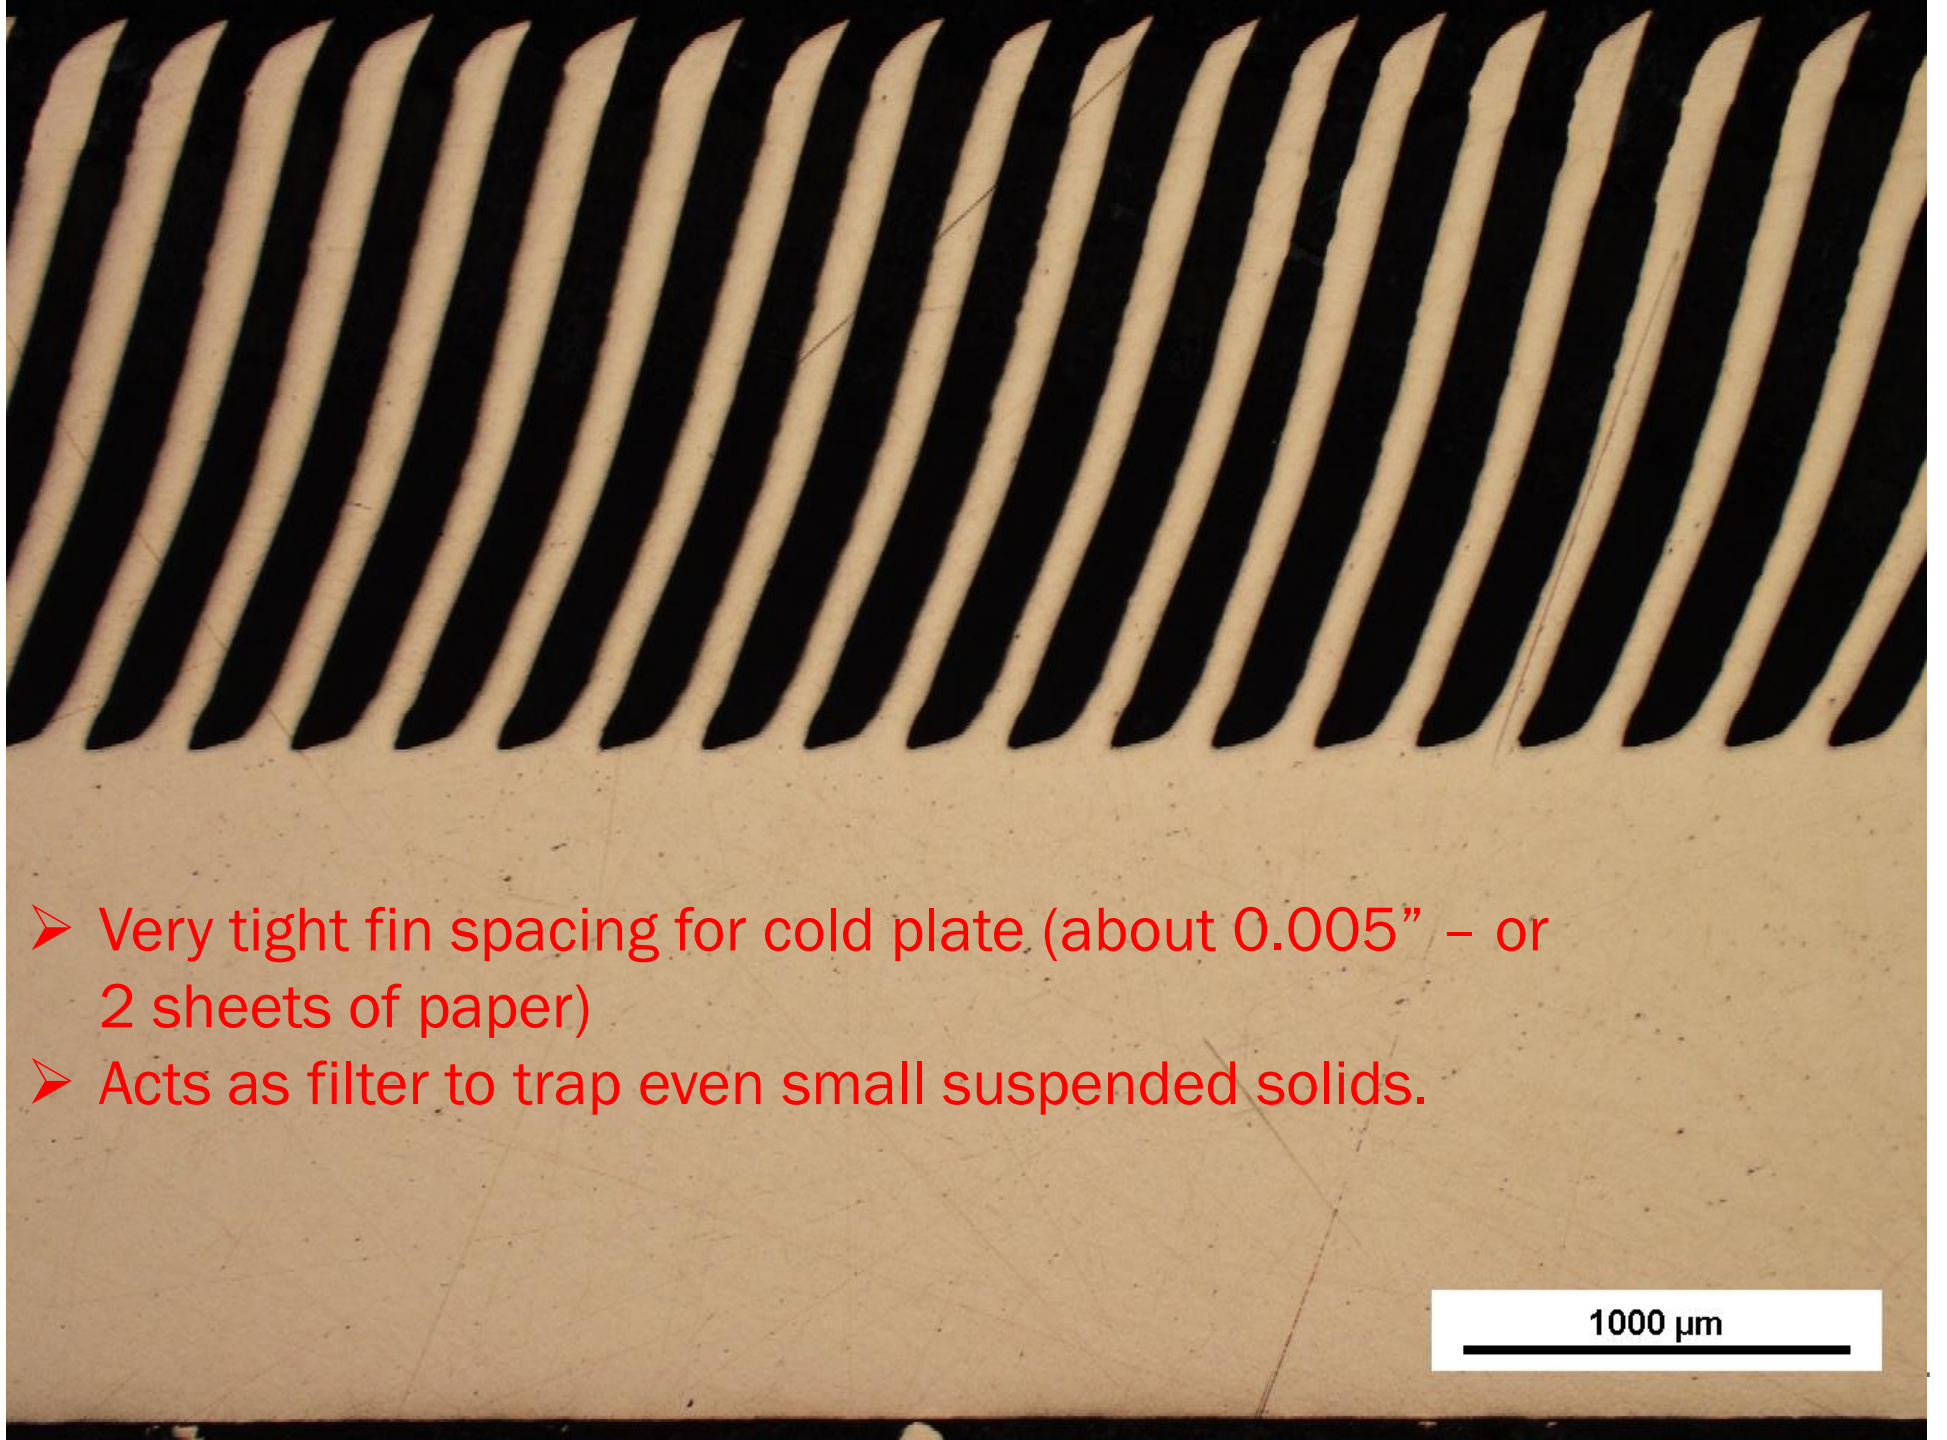
- Very tight fin spacing for cold plate (about 0.005" – or 2 sheets of paper)
- Acts as filter to trap even small suspended solids.
