Data Center Cooling System Failure

CRAH – Computer Room Air Handler Coils

Jim Dillon, Dorothy Collins and Philip Yu

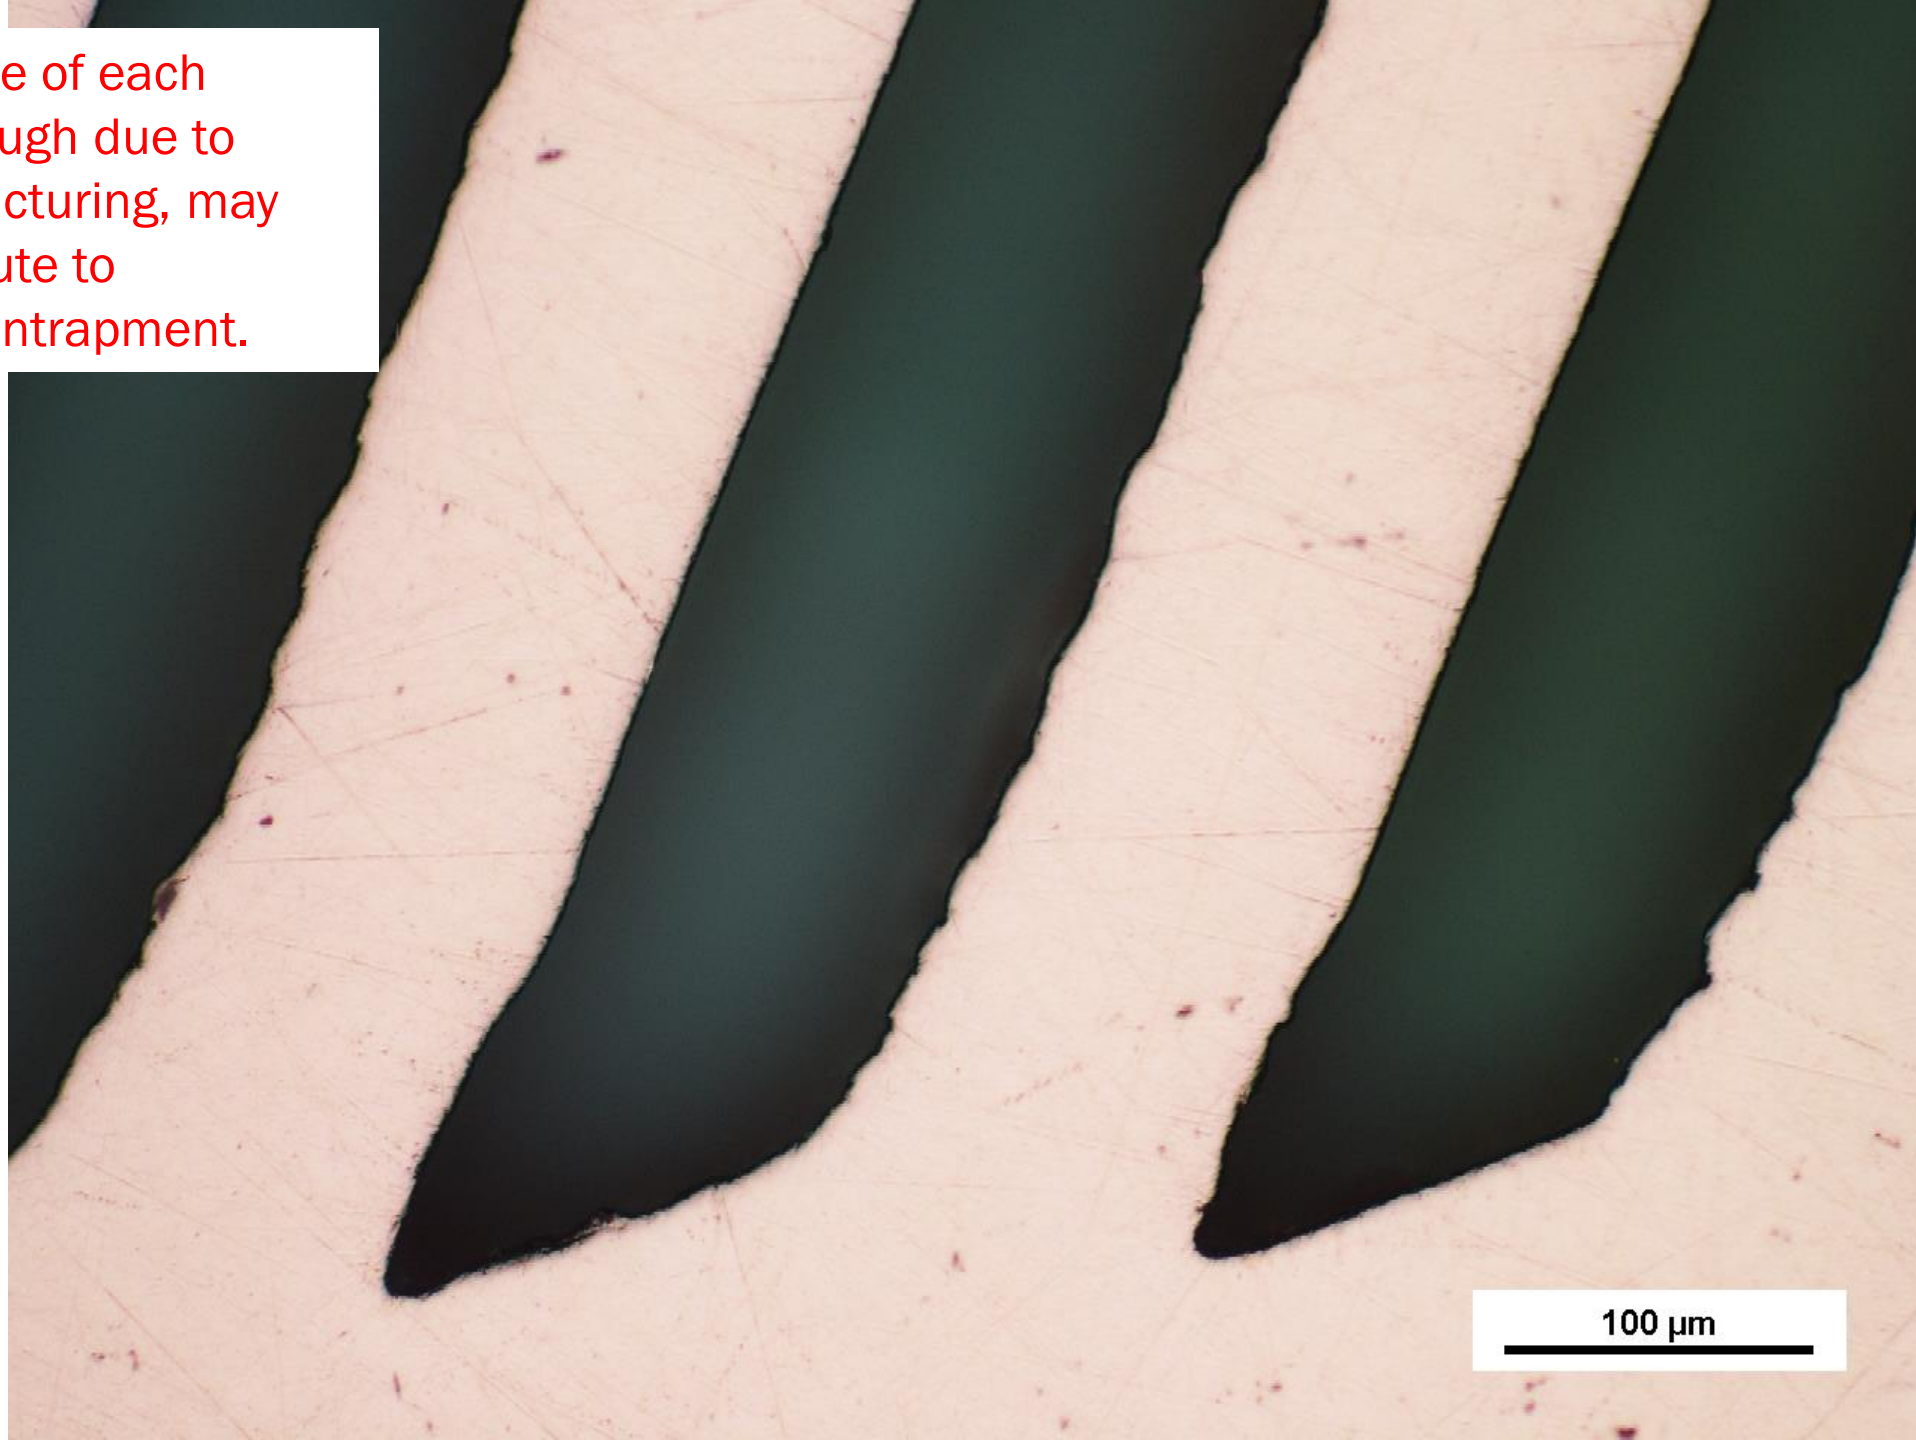
One side of each
fin is rough due to
manufacturing, may
contribute to
solids entrapment.
