Data Center Cooling System Failure

CRAH – Computer Room Air Handler Coils

Jim Dillon, Dorothy Collins and Philip Yu

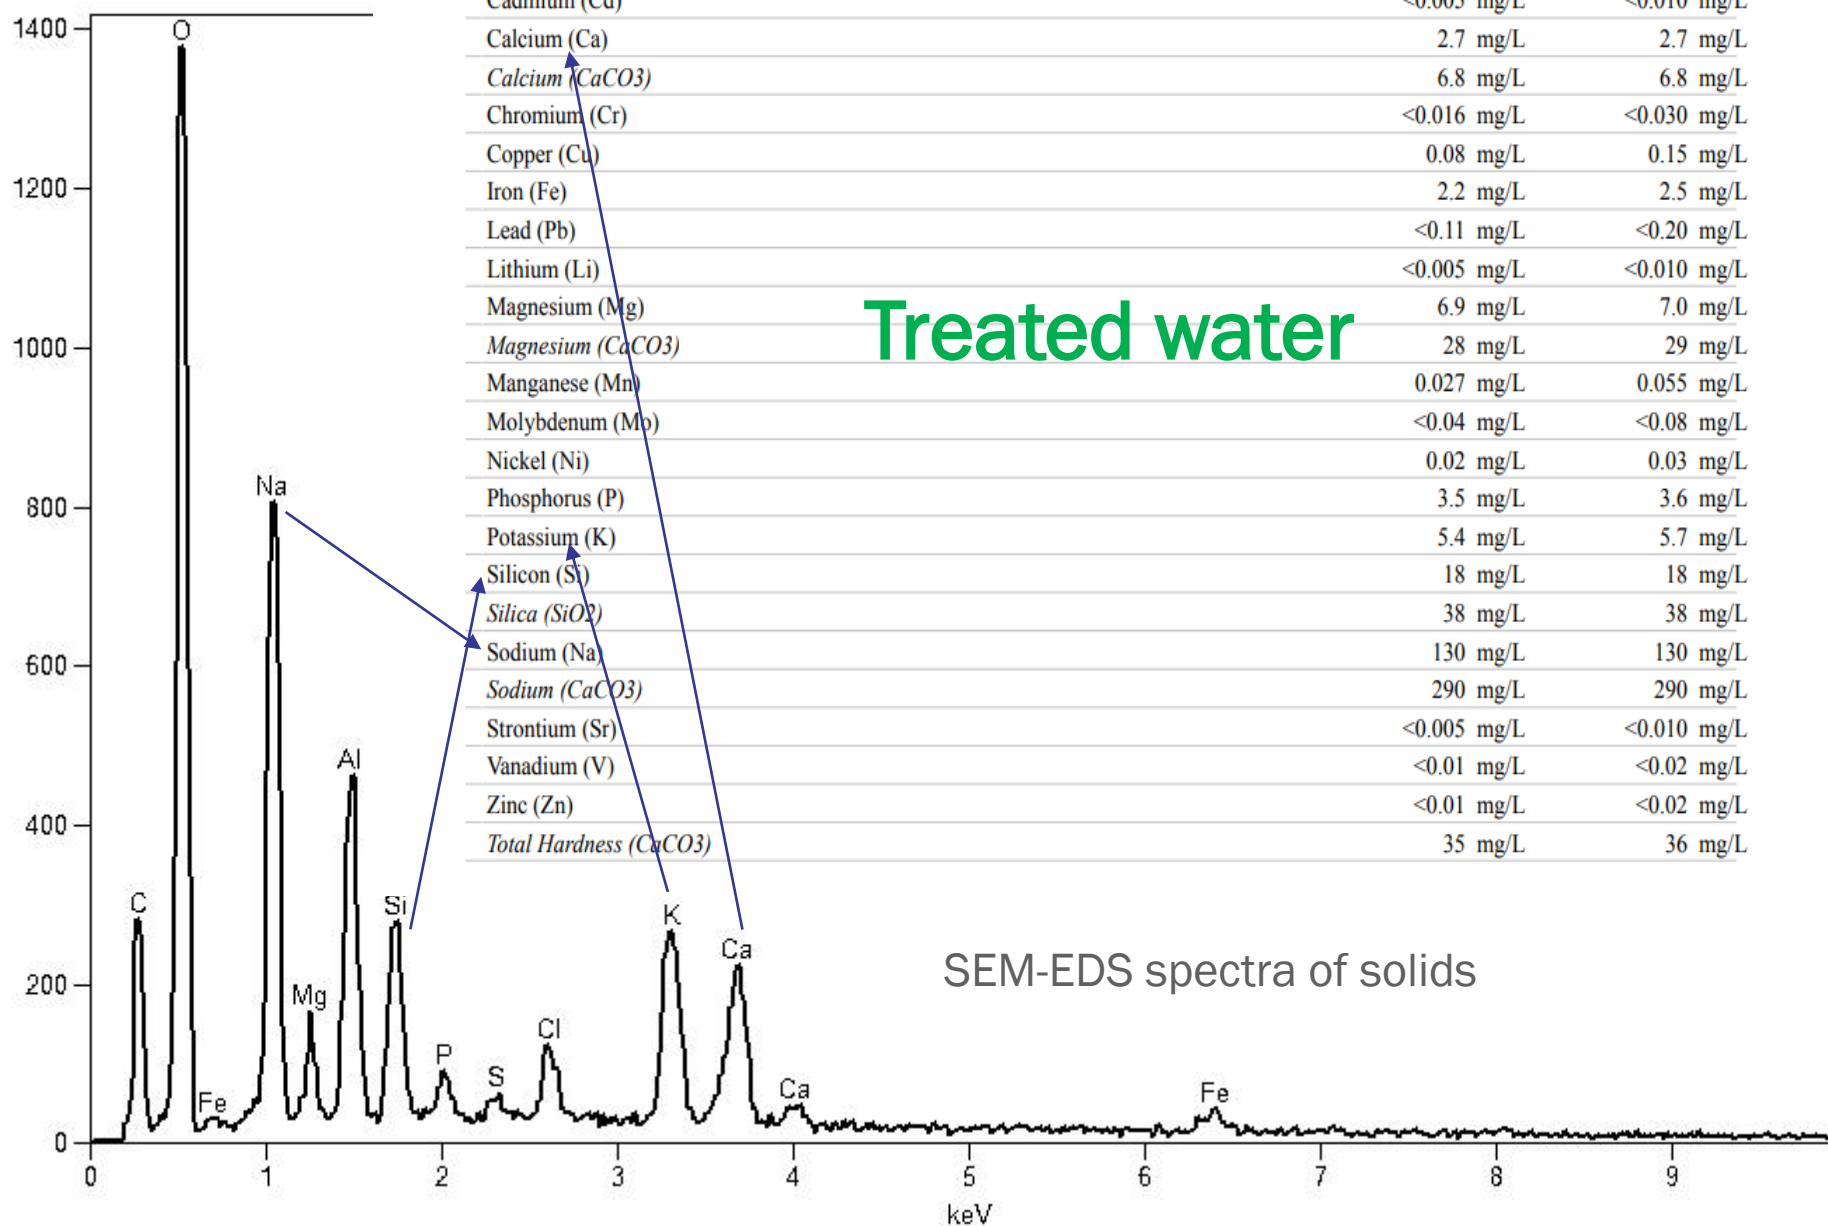
Chilled water leak in CRAH
coil with cooling water and
water solids on fins and in
condensate drip pan

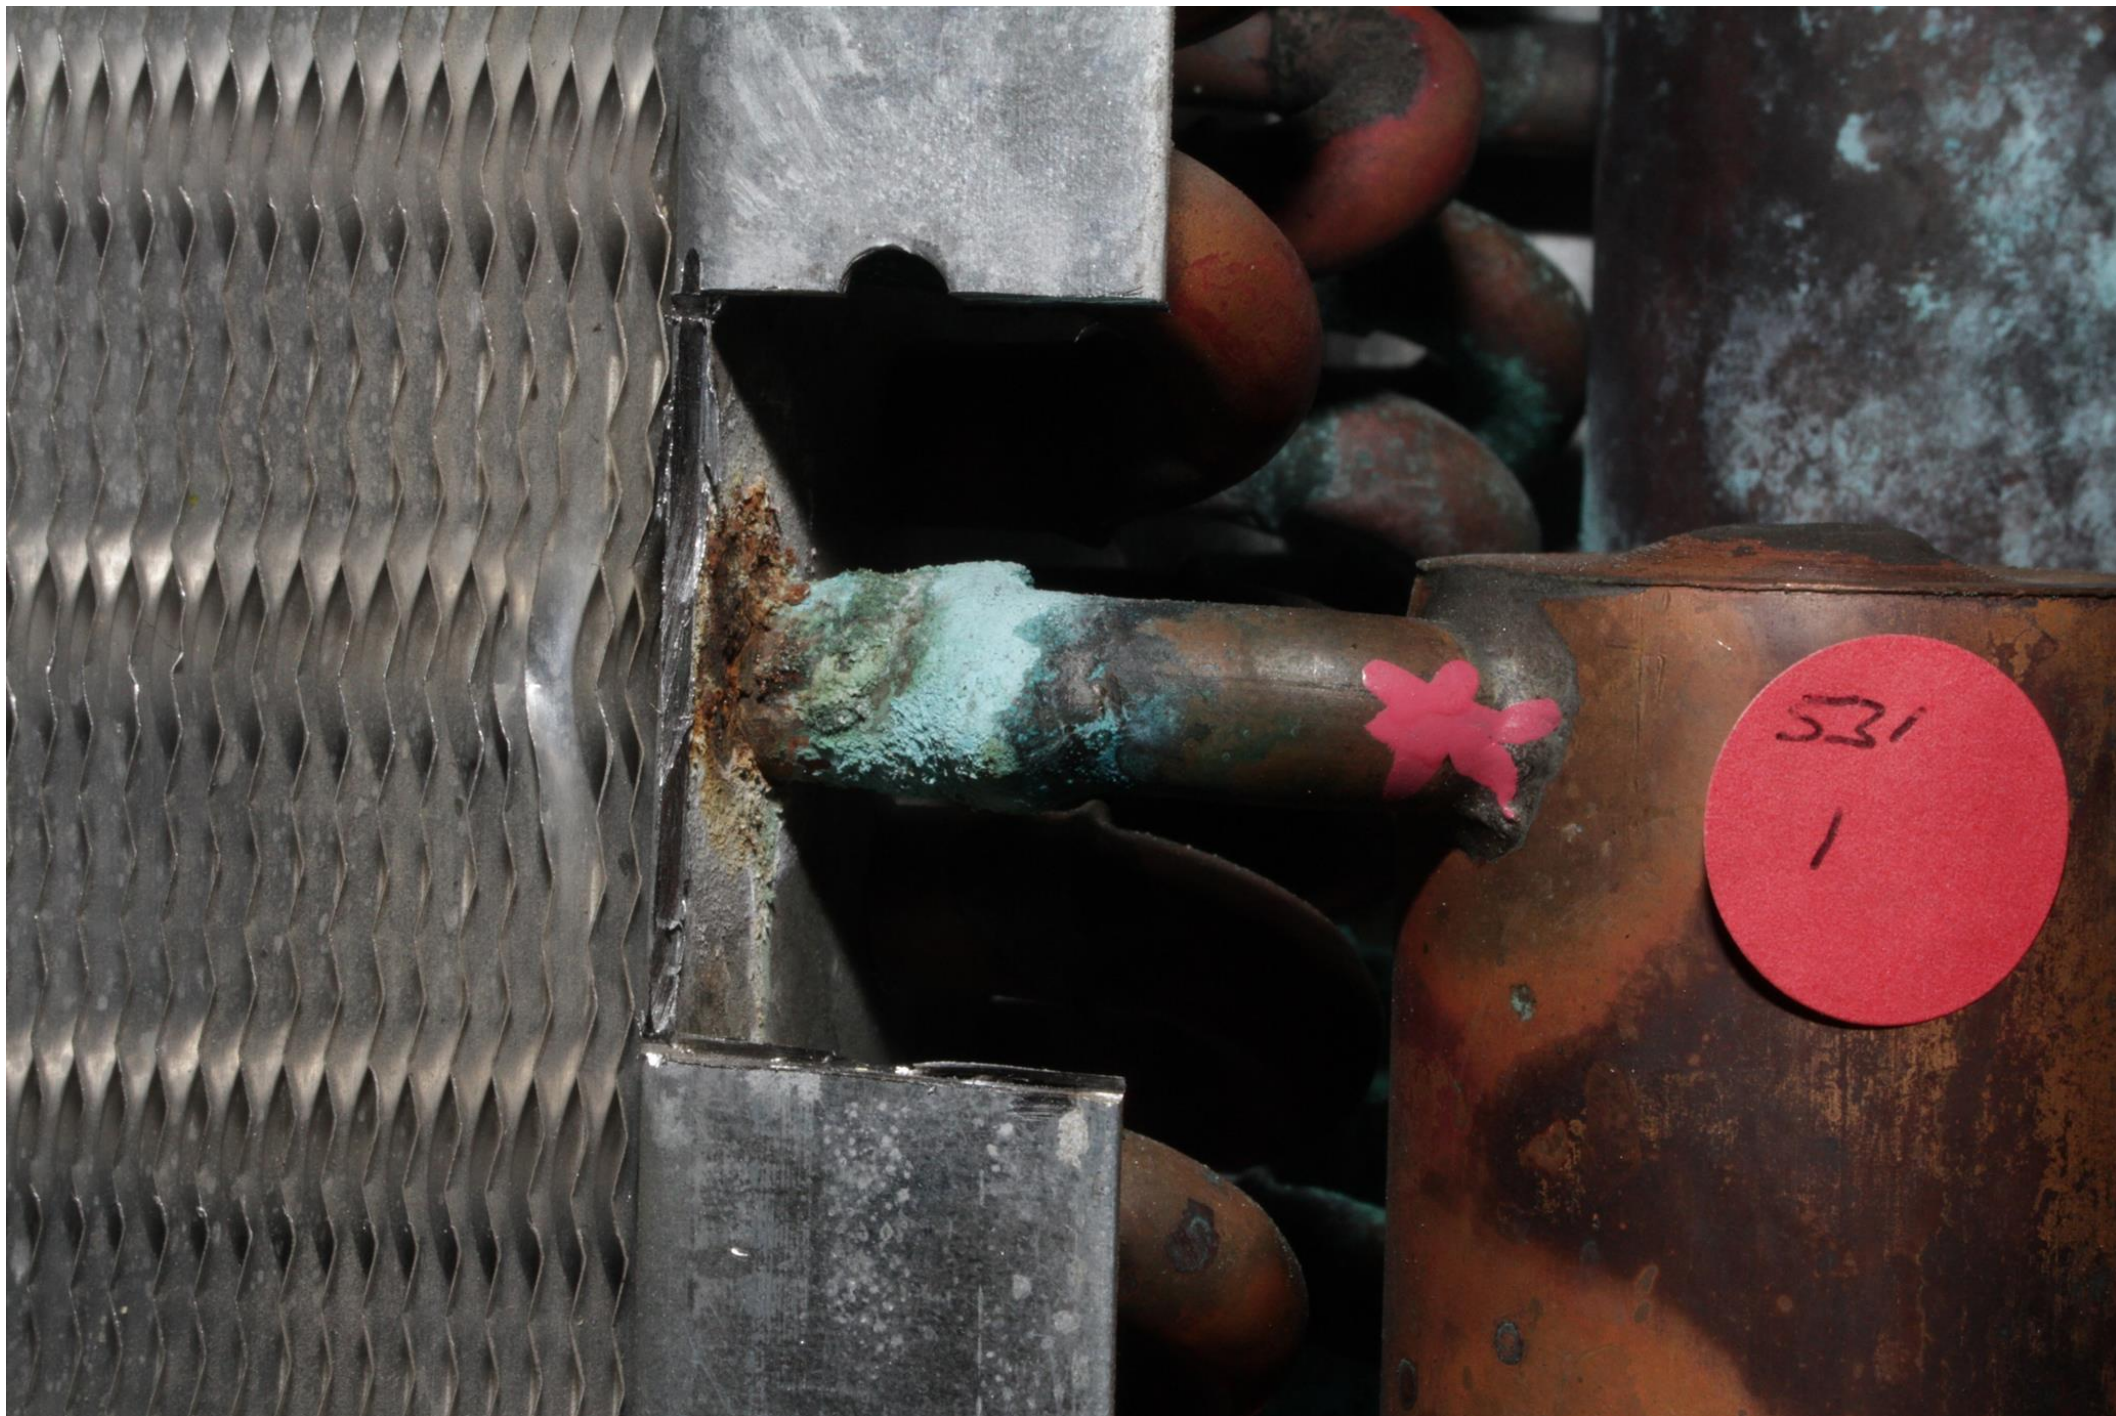
One of the coils failed a pressurized air leak test at two locations

- Leaks at end-most tubes connecting unsupported headers to coil tubes.

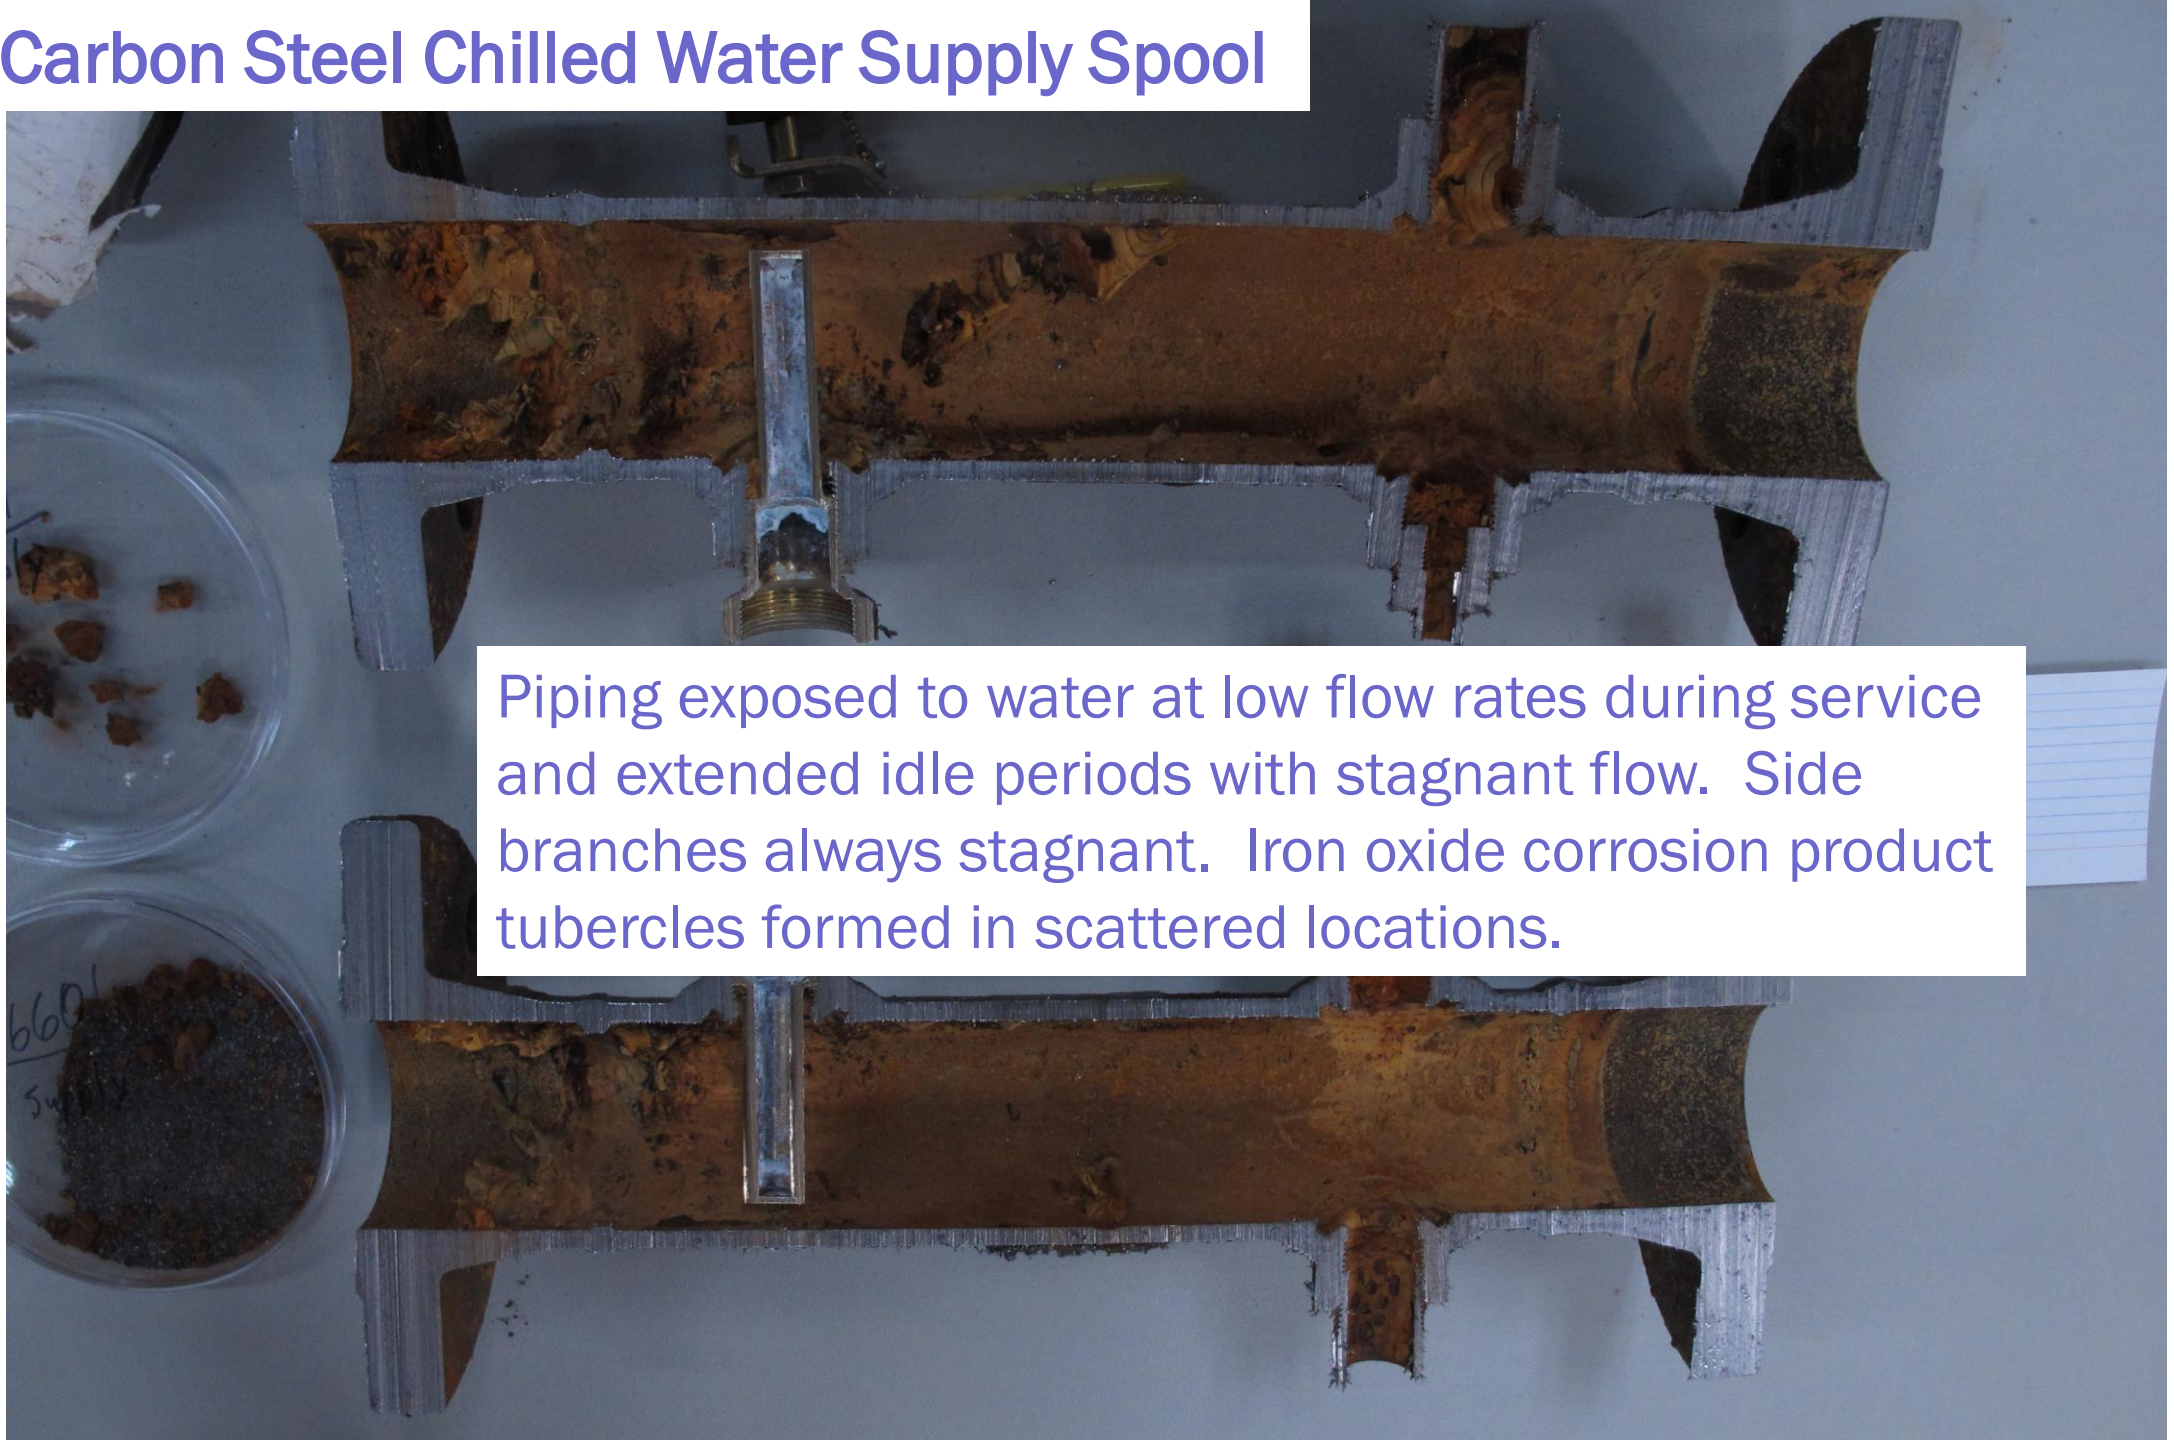
Carbon Steel Chilled Water Supply Spool

Piping exposed to water at low flow rates during service and extended idle periods with stagnant flow. Side branches always stagnant. Iron oxide corrosion product tubercles formed in scattered locations.

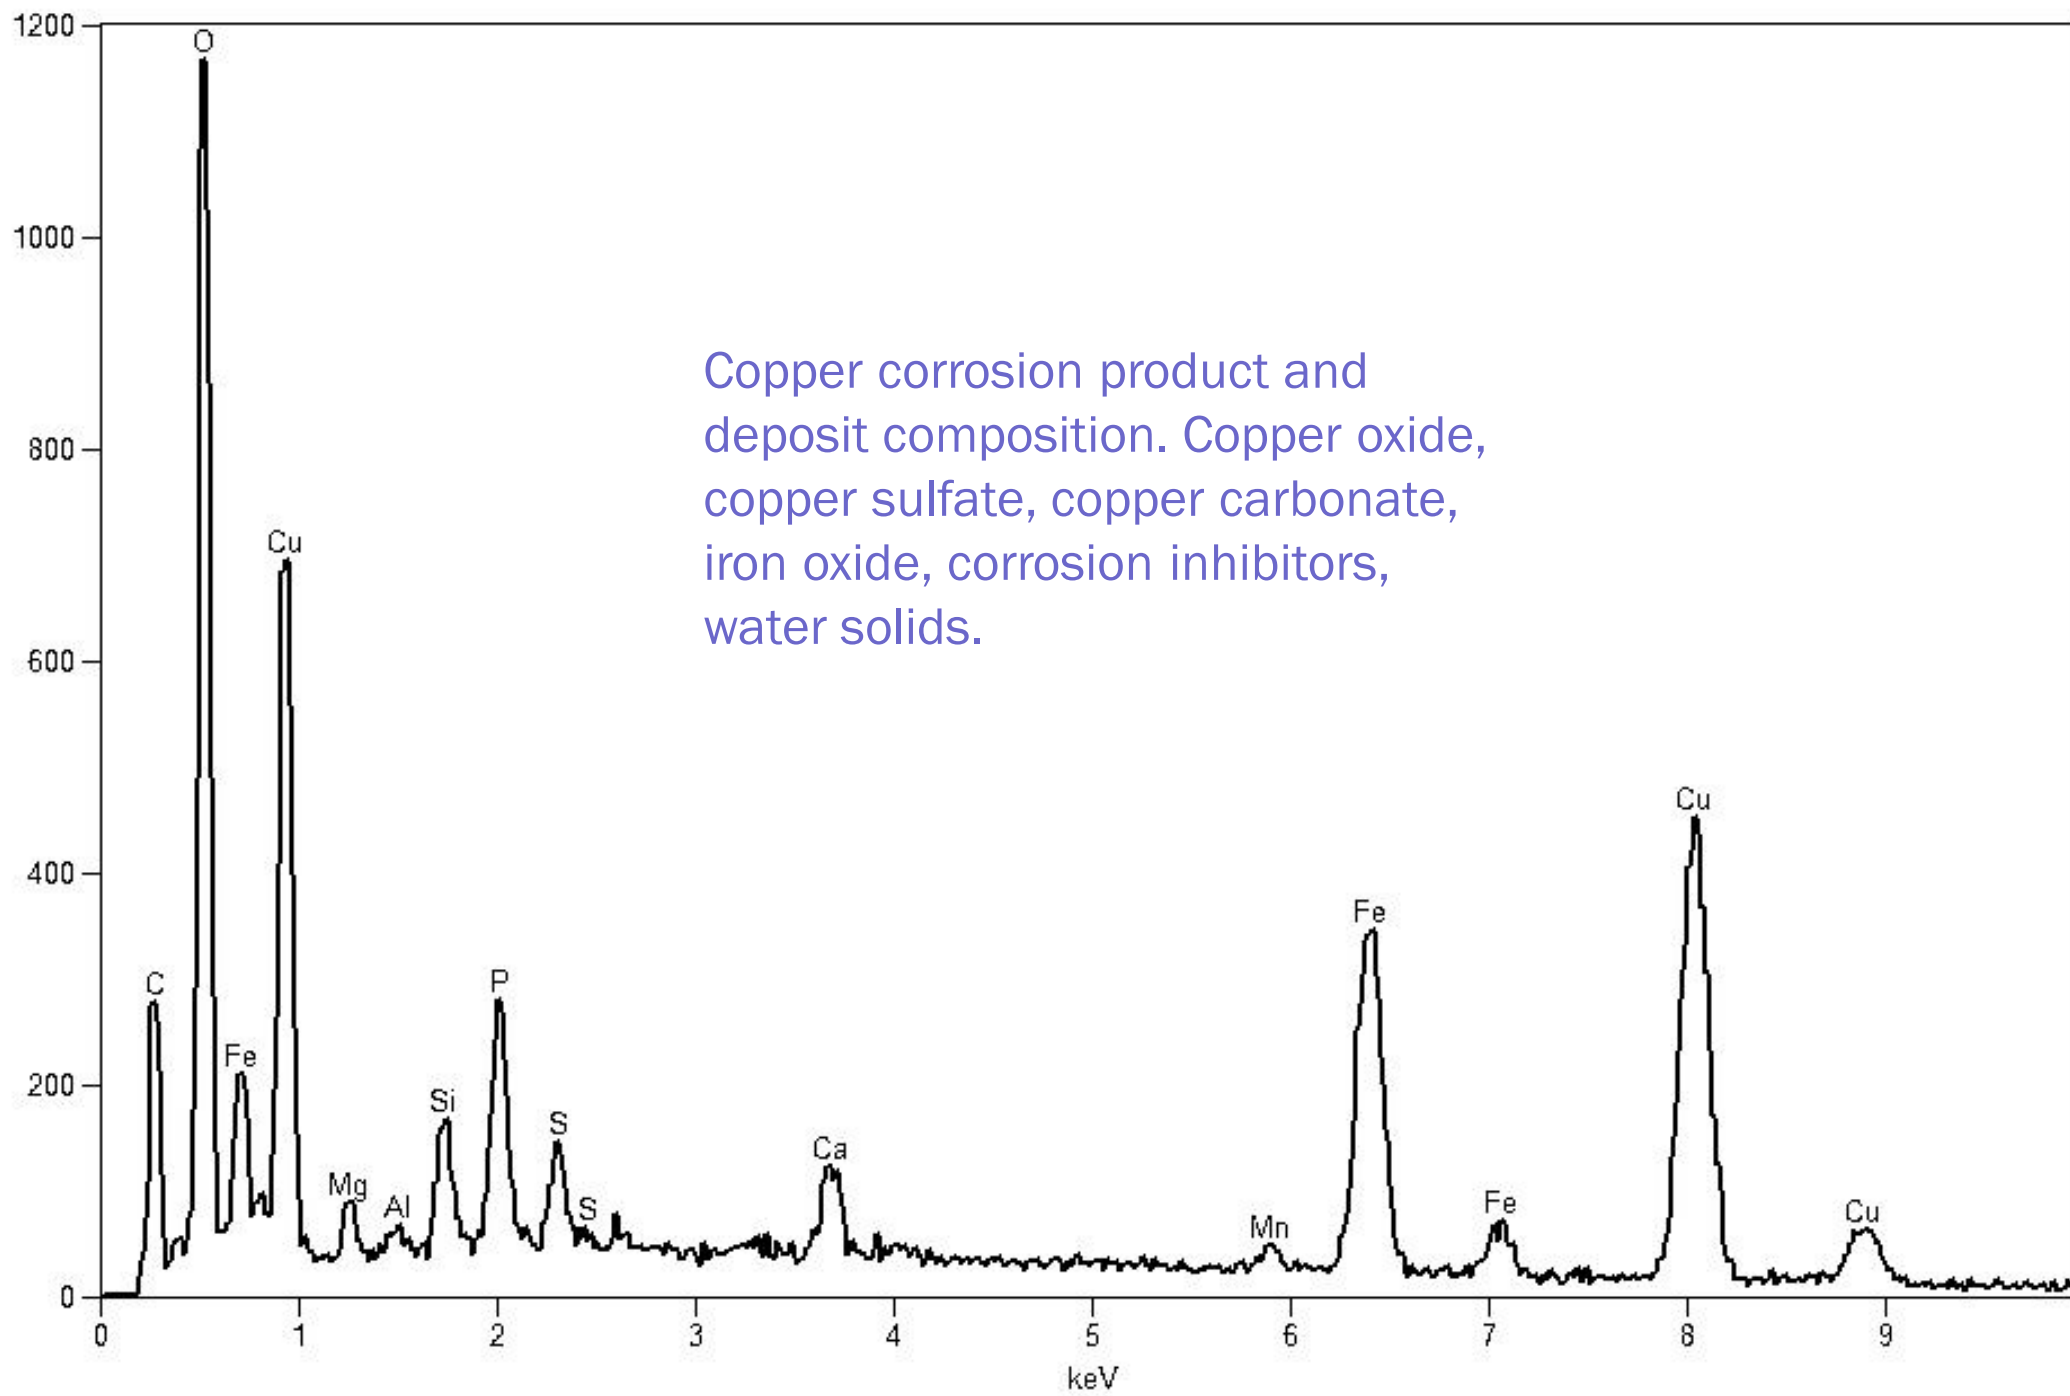
Corrosion at surface that was partially
occluded by deposits and corrosion
products. Copper oxide filled depression.
Corrosion caused by differential oxygen
Concentration cells and ion concentration cells.

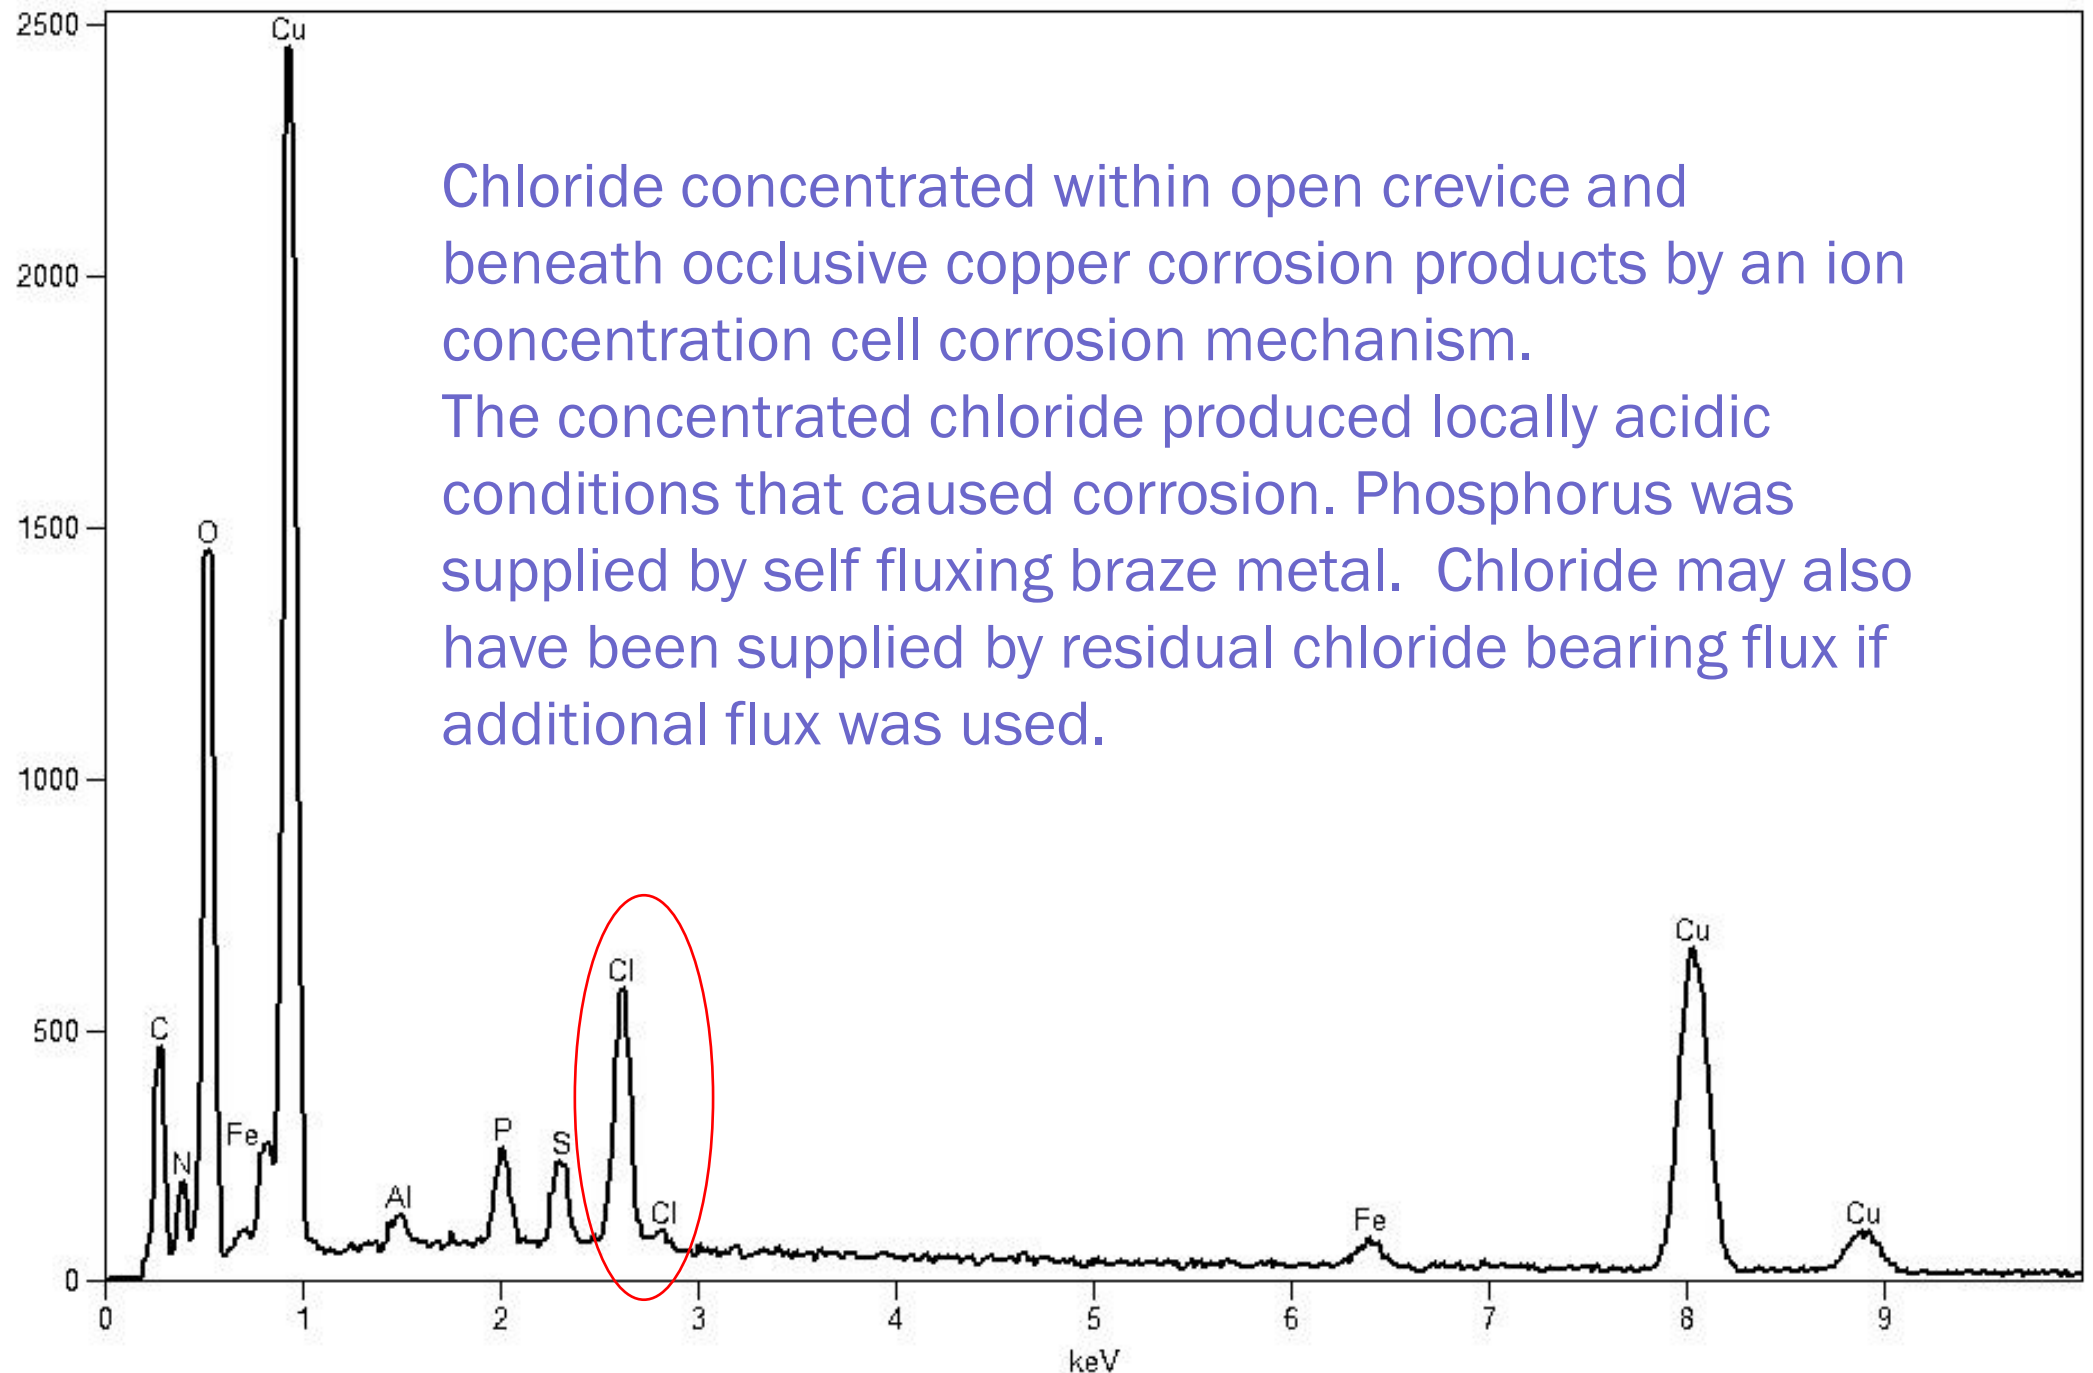
Corrosion within incompletely sealed
brazed joint for coil tube to U-bend.
Corrosion and corrosion product buildup
extends outward from end of joint.

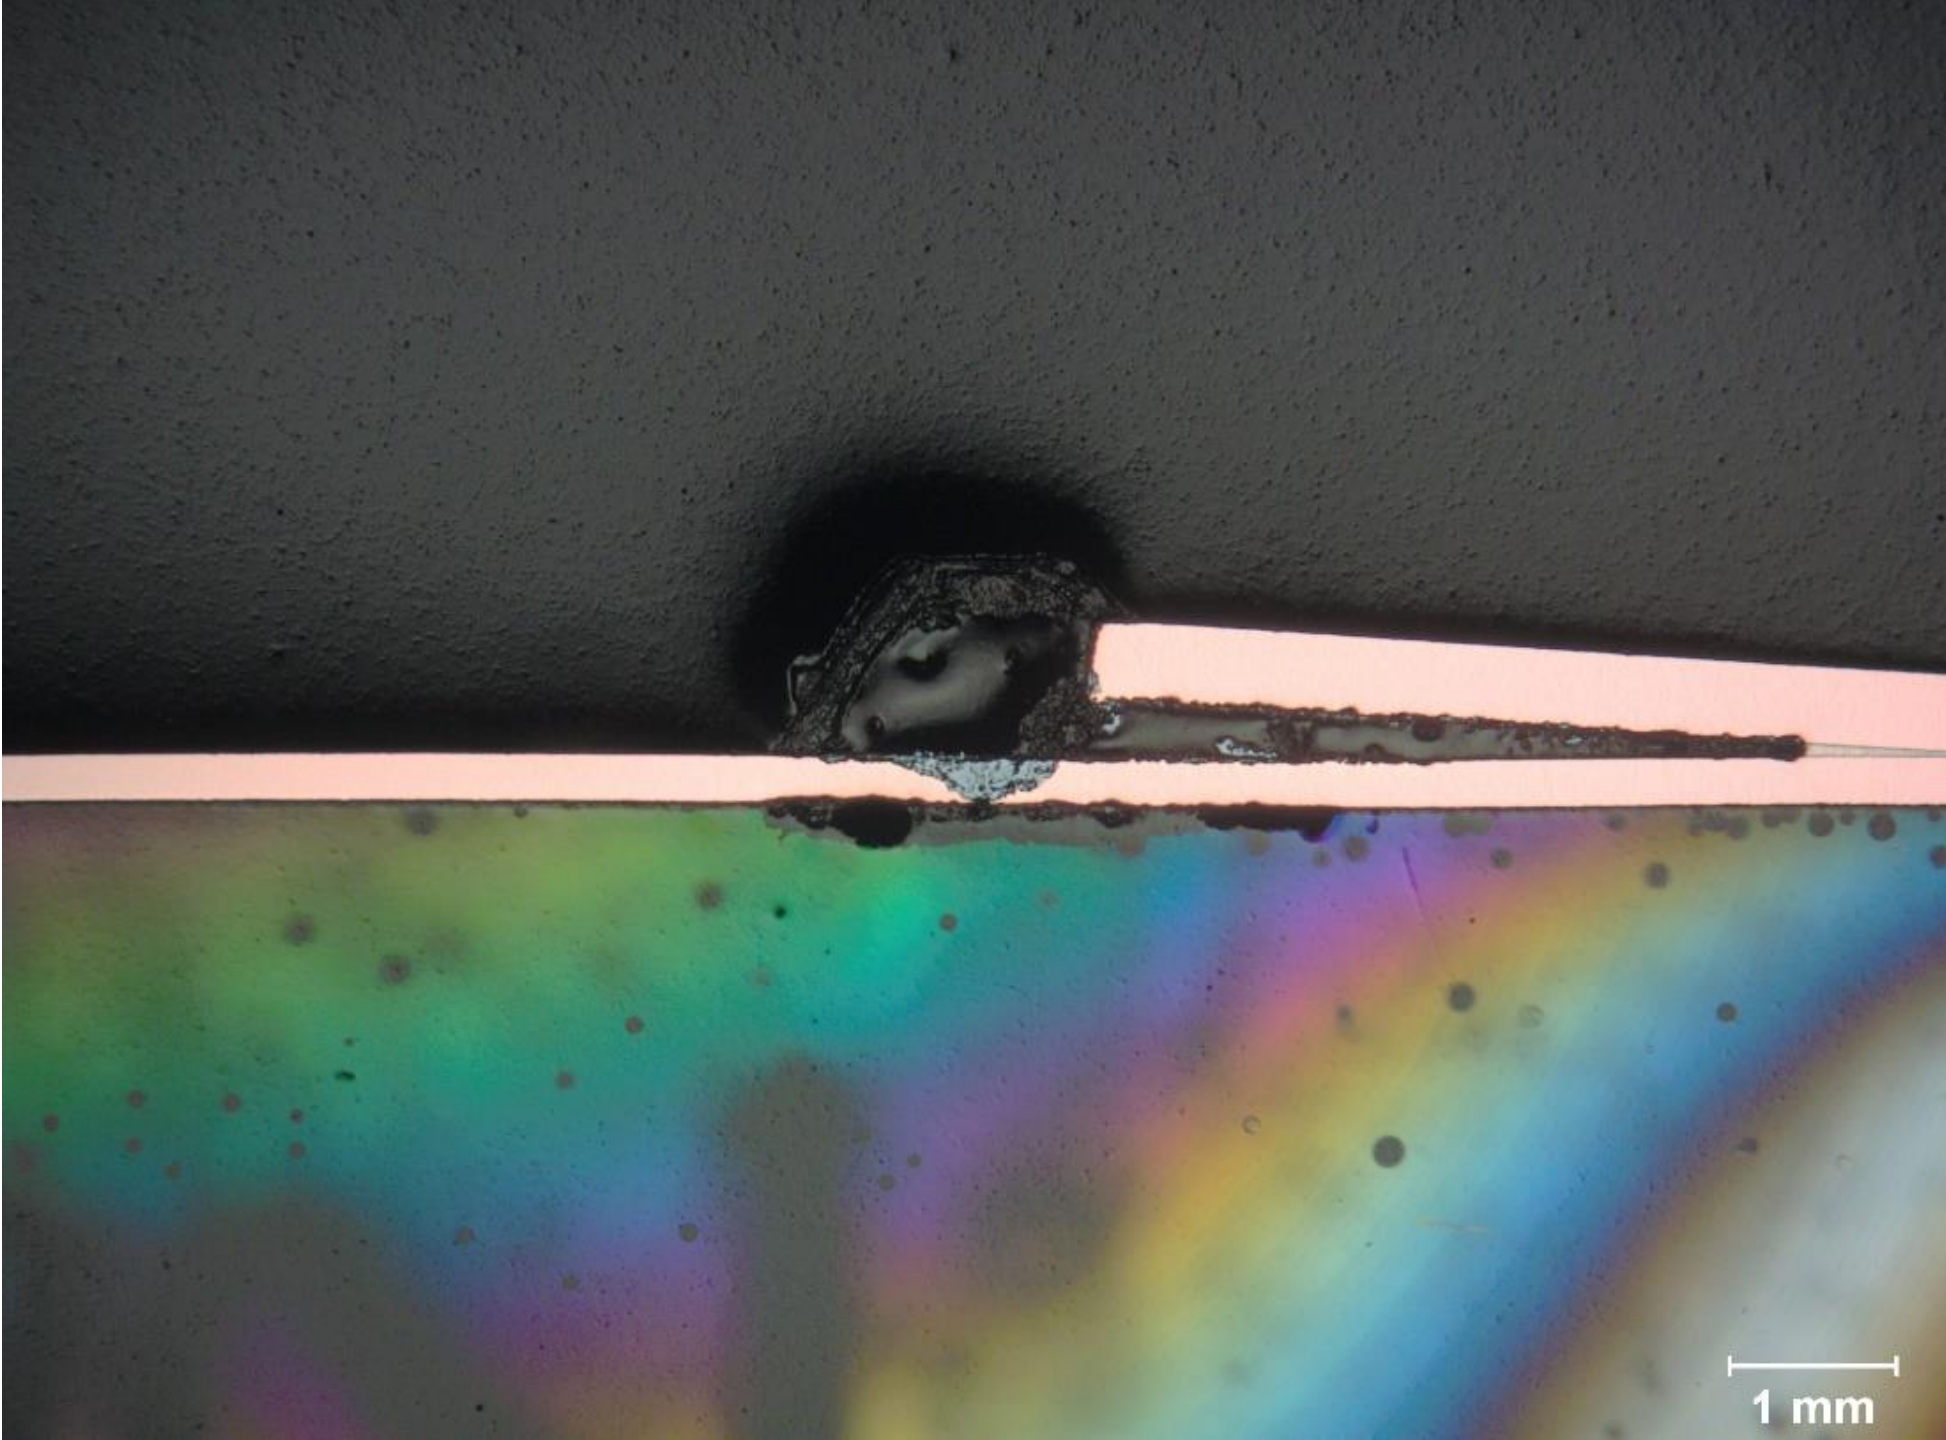
Crevice corrosion (Concentration cells)

- The accelerated corrosion in the unit analyzed was likely caused by crevices at the straight pipe / U-bend connections in conjunction with the presence of corrosive species in the environment.

- This conclusion was based on the following factors:
 - On the interior of the pipes, the corrosion was concentrated around the straight pipe / U-bend connections.

- Crevices were observed at these connections.
 - Chlorine and sulfur detected by EDS around the crevices suggests that corrosive ions in the chilled water migrated into the crevices.

- Crevice corrosion was likely initiated and promoted by detrimental changes in the local chemistry within the crevice, resulting in the accelerated rate of corrosion.

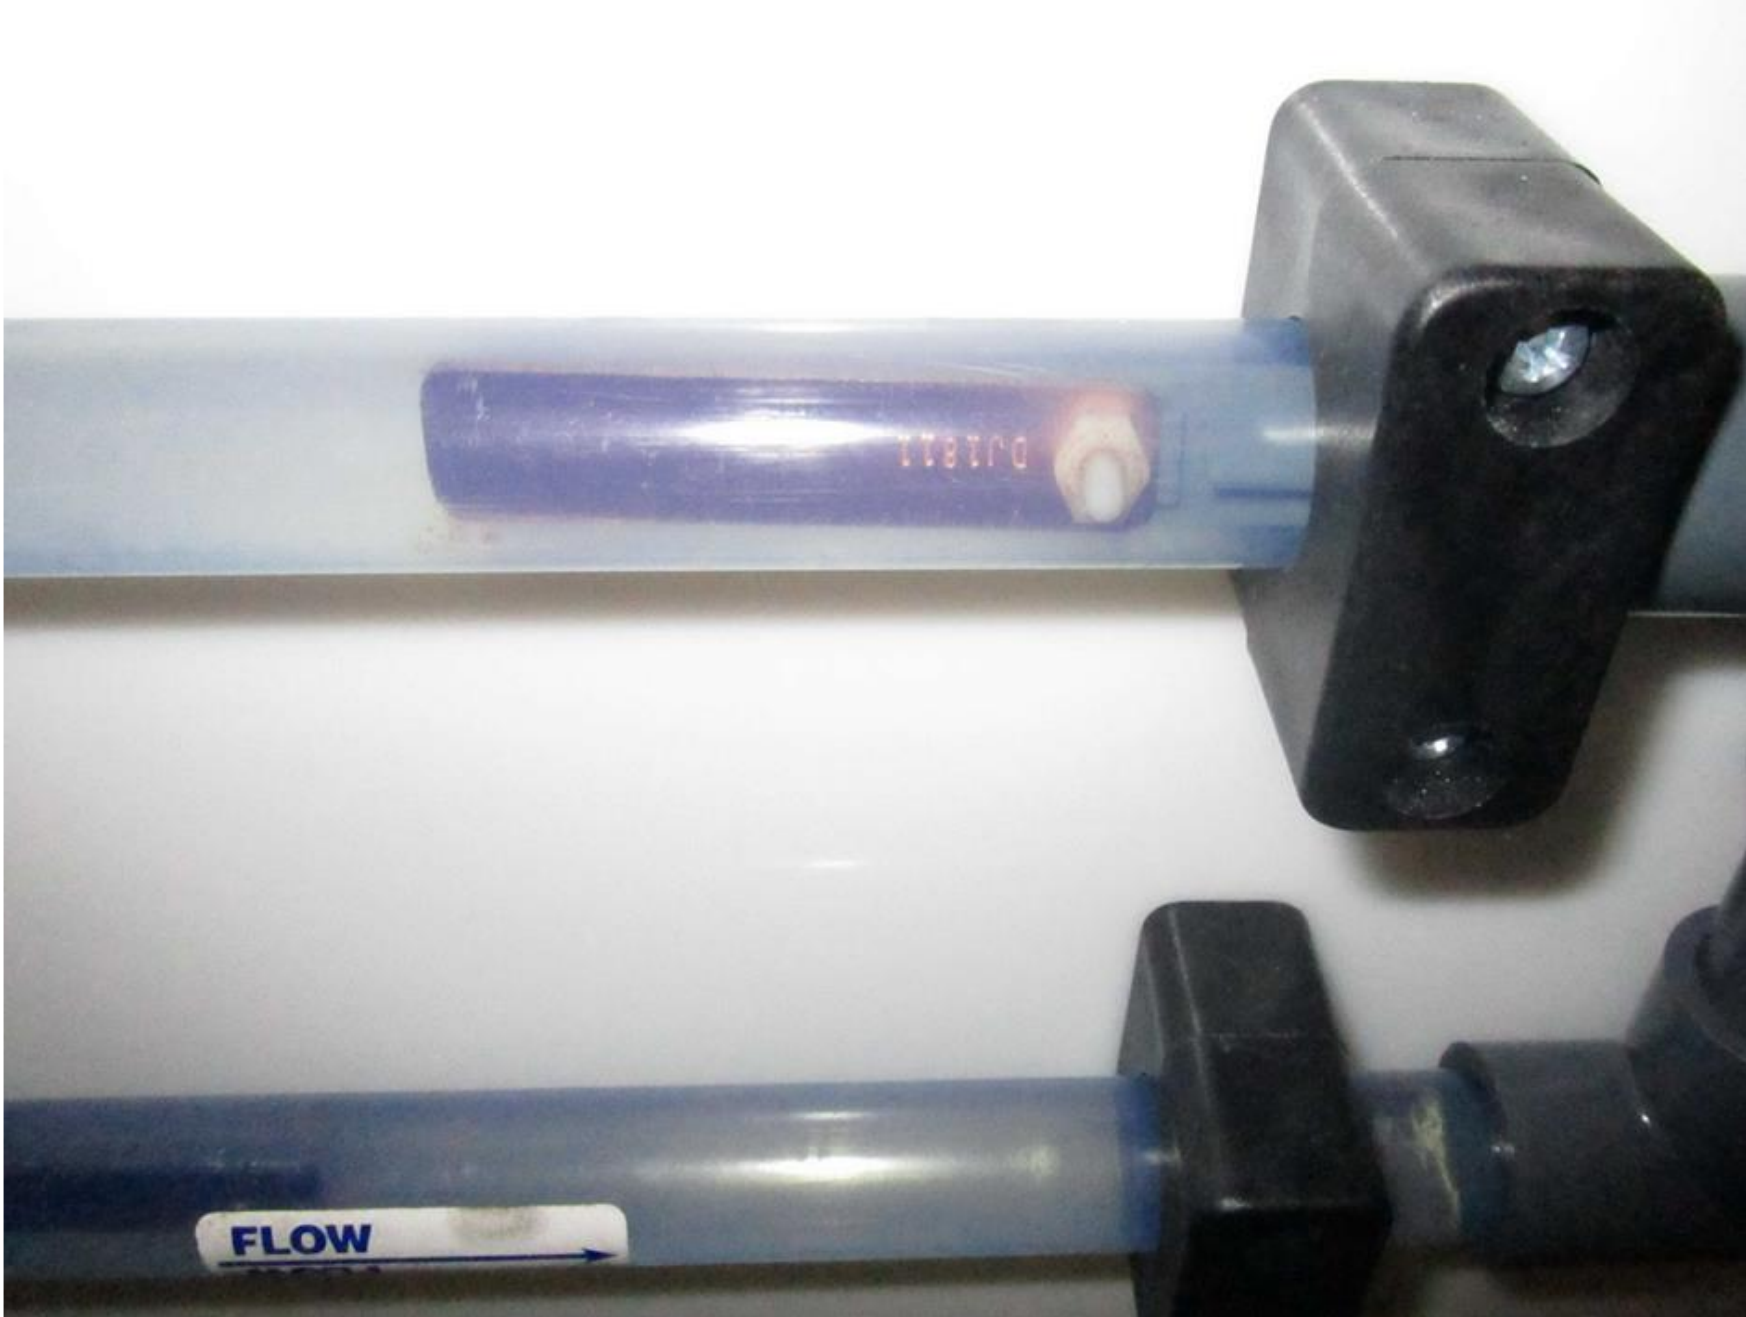
Corrosion Coupon Analysis

Copper and mild steel corrosion rates were always excellent. Coupon testing must be conducted at minimum flow rate of 1.5 ft/s as mandated by ASTM, with no flow variation.
